Rail Accident Report

**Track damage between Pencoed and Llanharan,
South Wales
6 March 2021**

Track damage between Pencoed and Llanharan, South Wales, 6 March 2021

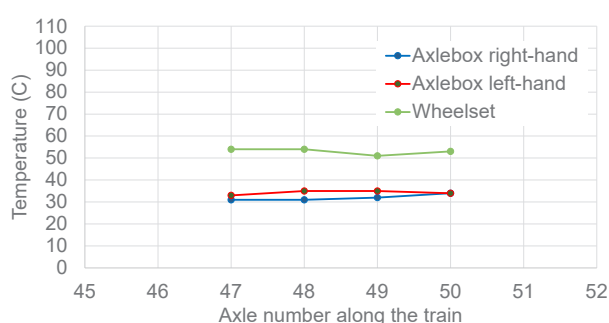
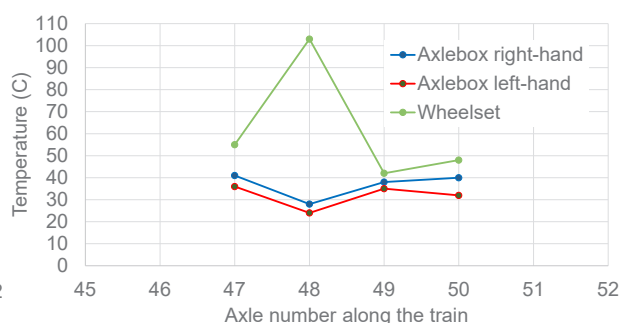
Figure 11: HABD records.¹²

- 78 Train 6A11 passed the HABD located in Pembrey at 22:59 hrs. RAIB reviewed the trace recorded for wagon GERS89016 on the HABD and concluded that there was no indication of any wheelset sliding as all wheels and axleboxes on the wagon were measured at very similar temperatures (figure 11 – left). This is confirmed by the CCTV footage of the train passing Llanelli station at 23:02 hrs which does not show any evidence of sparks being generated at the wheel/rail interface (figure 12) as would be expected if a wheelset had locked up.

- 79 Train 6A11 subsequently passed the HABD located at Briton Ferry at 23:52 hrs (figure 11 – right). The trace recorded for wagon GERS89016 on the HABD shows that the wheels of the trailing wheelset of the leading bogie were now running significantly hotter than the other wheels and that the axleboxes for that wheelset were cooler than the other axleboxes on this wagon. When a wheelset is sliding, the axlebox bearings will not be generating heat as they are not rotating, and significant heat will be generated in the wheels at the wheel/rail interface through friction. RAIB therefore interpreted these traces as indicating that, by the time the train passed Briton Ferry, the trailing wheelset of the leading bogie of wagon GERS89016 was, or had recently been, sliding.¹¹

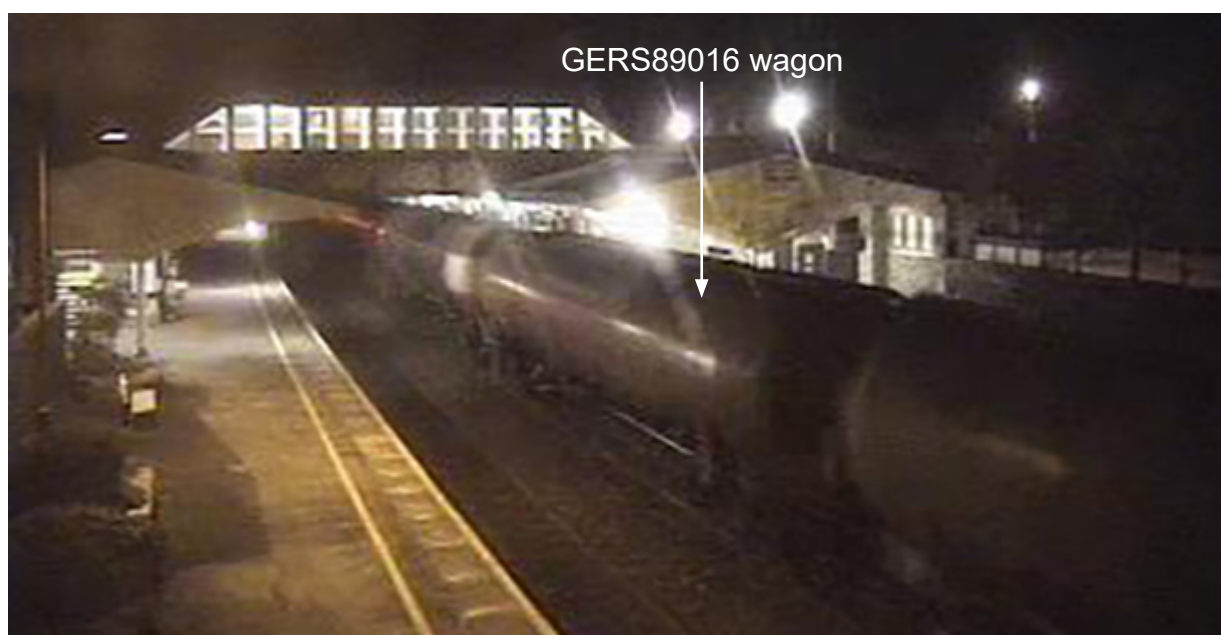
Figure 12: Wagon GERS89016 at Llanelli station.

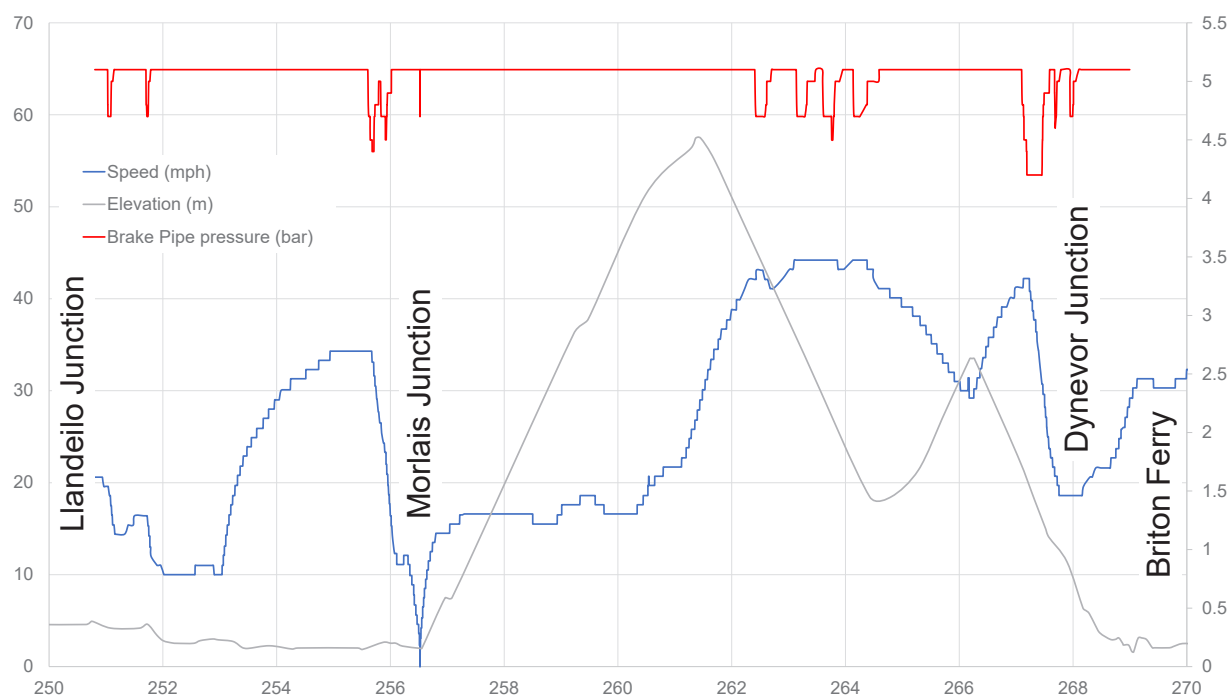
- 80 The on-train data recorder (OTDR) from the locomotive forming train 6A11 indicated that there were a number of braking events during the trip from Llandeilo Junction to Briton Ferry (figure 13). RAIB commissioned a study¹³ of the trip from Llandeilo Junction to Briton Ferry over the Swansea District line to determine whether any of the braking events along that line could have resulted in a wagon wheelset locking up and sliding.
- 81 The study concluded that there were braking events along the Swansea District line which could have been sufficient to lock up a wheelset, provided that the adhesion level was very low (0.05 or less). In particular, the study concluded that the braking event which took place as the train was descending from Lonlas Tunnel towards Dynevor Junction was the most likely source of the wheel slide as this was the largest brake application.

Figure 13: Brake applications along the Swansea District line.

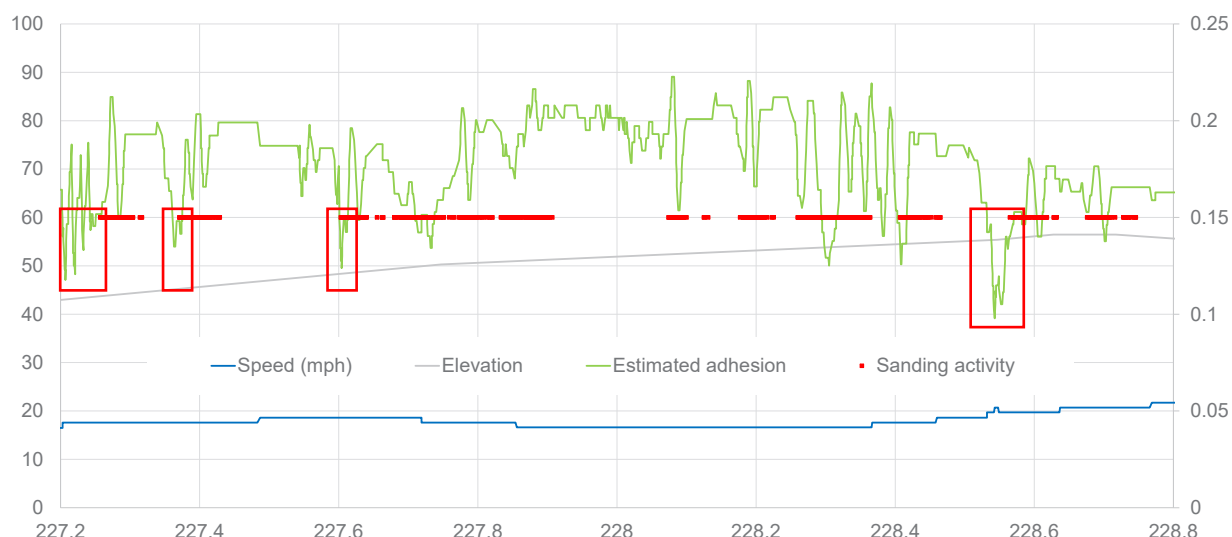
Figure 16: Detailed analysis of the adhesion curve for locomotive 60015.

- 92 The train then ascended the 1 in 120 gradient towards Lonlas Tunnel with the driver again commanding traction. The level of adhesion along that stretch was estimated to be around 0.1 (figure 15). As the train exited Lonlas Tunnel and started the descent towards Briton Ferry, the train recorded a 'wheel slip' indication on the OTDR. This indicates that the adhesion level in that area was very low as the traction system was not able to generate sufficient adhesion through its sanding and anti-slip function. The lowest point of the adhesion curve on figure 15 suggests an instantaneous un-sanded adhesion less than 0.05 (that is to say, very low).

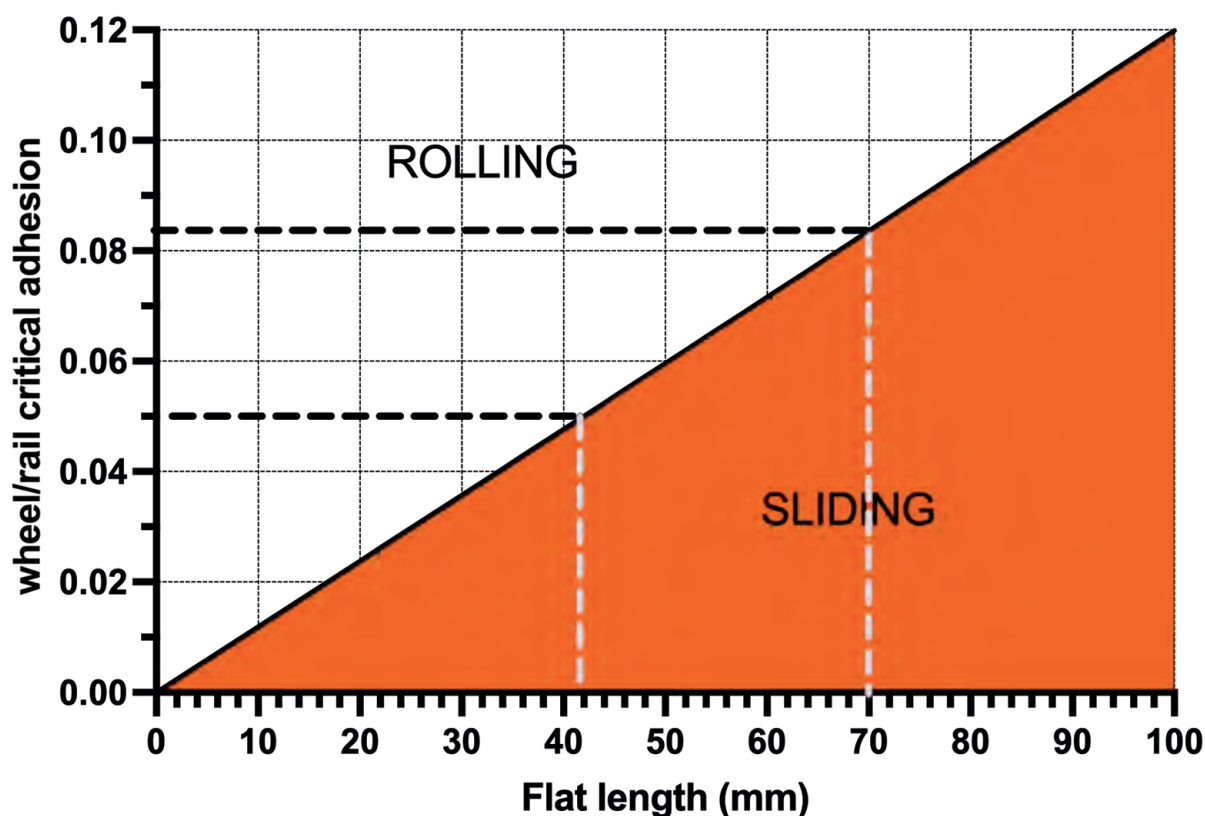
- 95 The study commissioned by RAIB (paragraph 80) calculated that the wheel flats would have grown to around 70 mm in length by the end of the brake application from Lonlas Tunnel towards Dynevor Junction. Figure 17, developed as part of the study, shows that with a wheel flat length of 70 mm, adhesion would have needed to be greater than 0.08 to get the wheelset to start rotating after the brakes were released. This suggests that the wheelset involved would have stayed locked after the brakes were released, assuming that the adhesion levels remained in a similar range, and that the wheel flats would have continued to grow.¹⁴

Figure 17: Plot showing the relation between wheel/rail critical adhesion and the flat length.

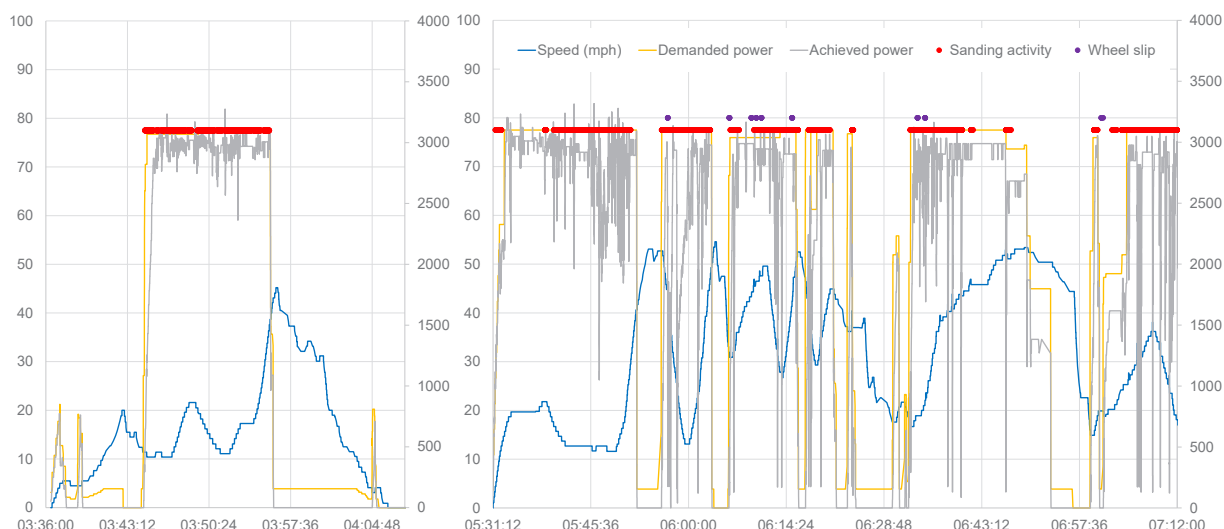
- 127 Figure 20 shows the analysis of the OTDR data from the locomotive involved in the Ferryside accident, presented in the same way as in figure 14, which shows data from the locomotive involved at Pencoed. Figure 20 shows numerous activities of the anti-slip function of the traction control system and associated sanding, combined with several instances of wheel slip activities being recorded. This suggests that the Ferryside locomotive (number 60001) was struggling for adhesion throughout its journey on the day of the accident and hence that very low adhesion was a possible causal factor to the Ferryside accident. RAIB's report into this accident has been updated accordingly by inclusion of an addendum.

Figure 20: Analysis of the OTDR data for locomotive 60001 on 30 October 2017.

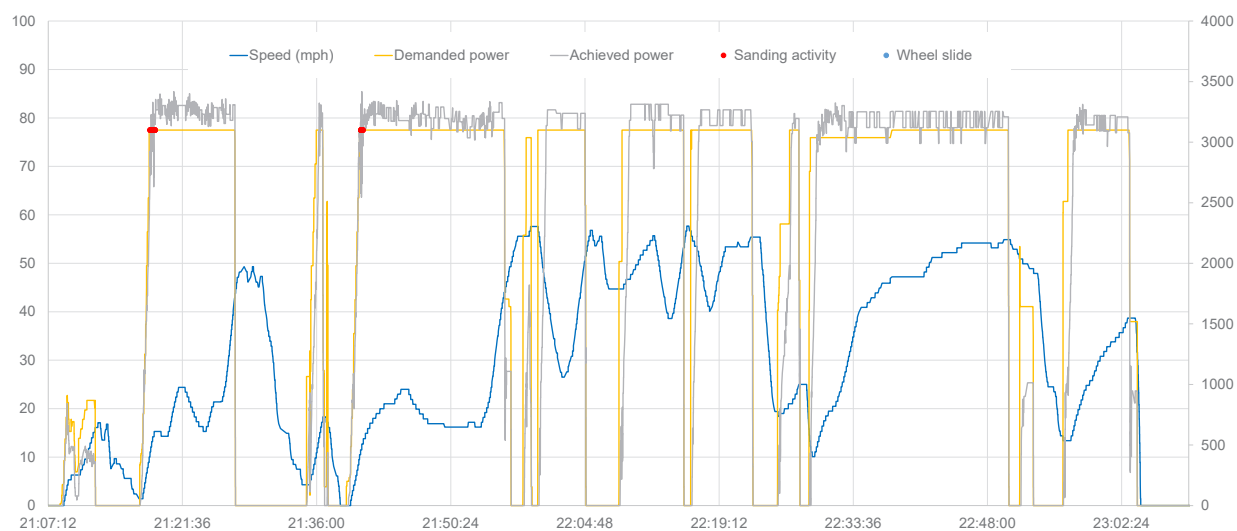
- 130 RAIB revisited the OTDR data of the locomotive (number 60062) involved in the Llangennech accident to determine whether there were signs of low adhesion being experienced during the journey. Figure 21 shows the analysis of the OTDR data presented in the same way as in figures 14 and 20. Figure 21 shows a very small amount of activity of the anti-slip function of the traction control system on departure from a standstill, combined with sanding activity. This suggests that the locomotive was not experiencing conditions of very low adhesion on its journey.

Figure 21: Analysis of the OTDR data for locomotive 60062 on 26 August 2020.
