Rail Accident Investigation Branch

# Rail Accident Report

**Track damage between Pencoed and Llanharan,  
South Wales  
6 March 2021**

Report 03/2023  
February 2023

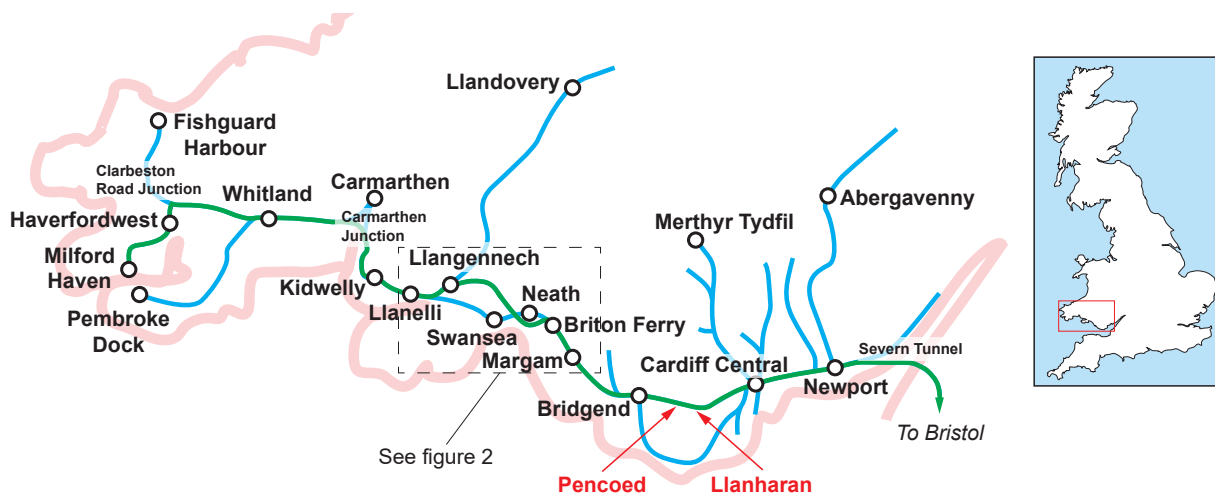
- 3 On the night between 5 and 6 March 2021, a wheelset on a wagon forming part of a freight train, reporting number 6A11, stopped rotating while the train was moving and developed severe wheel flats (front cover). The freight train involved was the 21:25 hrs departure from Robeston oil terminal, Milford Haven, to Theale oil terminal, near Reading. Later in the journey, this wheelset restarted rotating, and the impact caused by the wheel flats subsequently fractured two rails on the South Wales main line between Pencoed and Llanharan. These fractures were situated within a mile of each other (figure 1).

Figure 1: Route followed (in green) by train 6A11 along the South Wales main line.

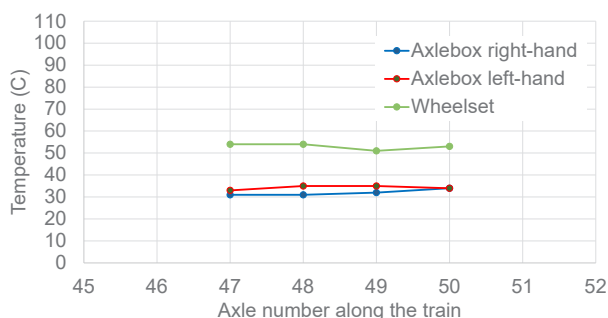
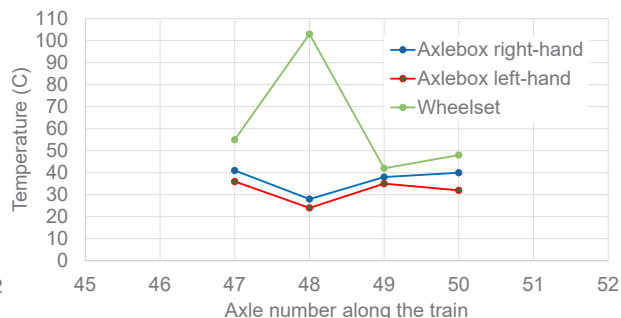
- 78 Train 6A11 passed the HABD located in Pembrey at 22:59 hrs. RAIB reviewed the trace recorded for wagon GERS89016 on the HABD and concluded that there was no indication of any wheelset sliding as all wheels and axleboxes on the wagon were measured at very similar temperatures (figure 11 – left). This is confirmed by the CCTV footage of the train passing Llanelli station at 23:02 hrs which does not show any evidence of sparks being generated at the wheel/rail interface (figure 12) as would be expected if a wheelset had locked up.

- 79 Train 6A11 subsequently passed the HABD located at Briton Ferry at 23:52 hrs (figure 11 – right). The trace recorded for wagon GERS89016 on the HABD shows that the wheels of the trailing wheelset of the leading bogie were now running significantly hotter than the other wheels and that the axleboxes for that wheelset were cooler than the other axleboxes on this wagon. When a wheelset is sliding, the axlebox bearings will not be generating heat as they are not rotating, and significant heat will be generated in the wheels at the wheel/rail interface through friction. RAIB therefore interpreted these traces as indicating that, by the time the train passed Briton Ferry, the trailing wheelset of the leading bogie of wagon GERS89016 was, or had recently been, sliding.<sup>11</sup>

Wagon GERS89016 at Pembrey

Wagon GERS89016 at Briton Ferry

Figure 11: HABD records.<sup>12</sup>

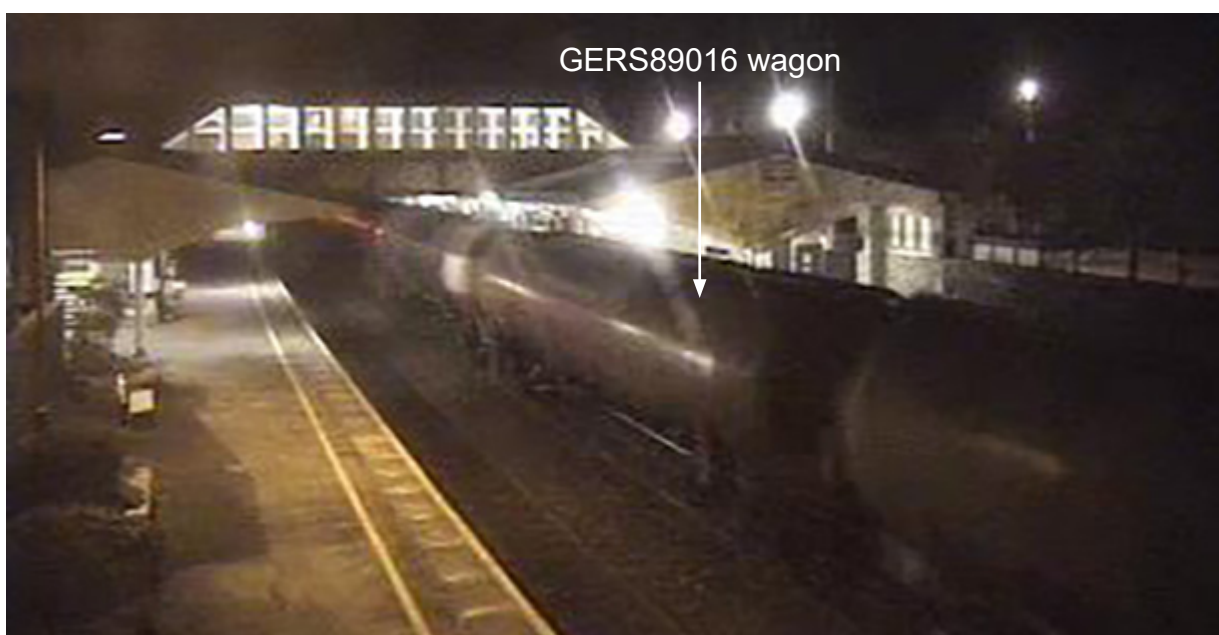
Figure 12: Wagon GERS89016 at Llanelli station.

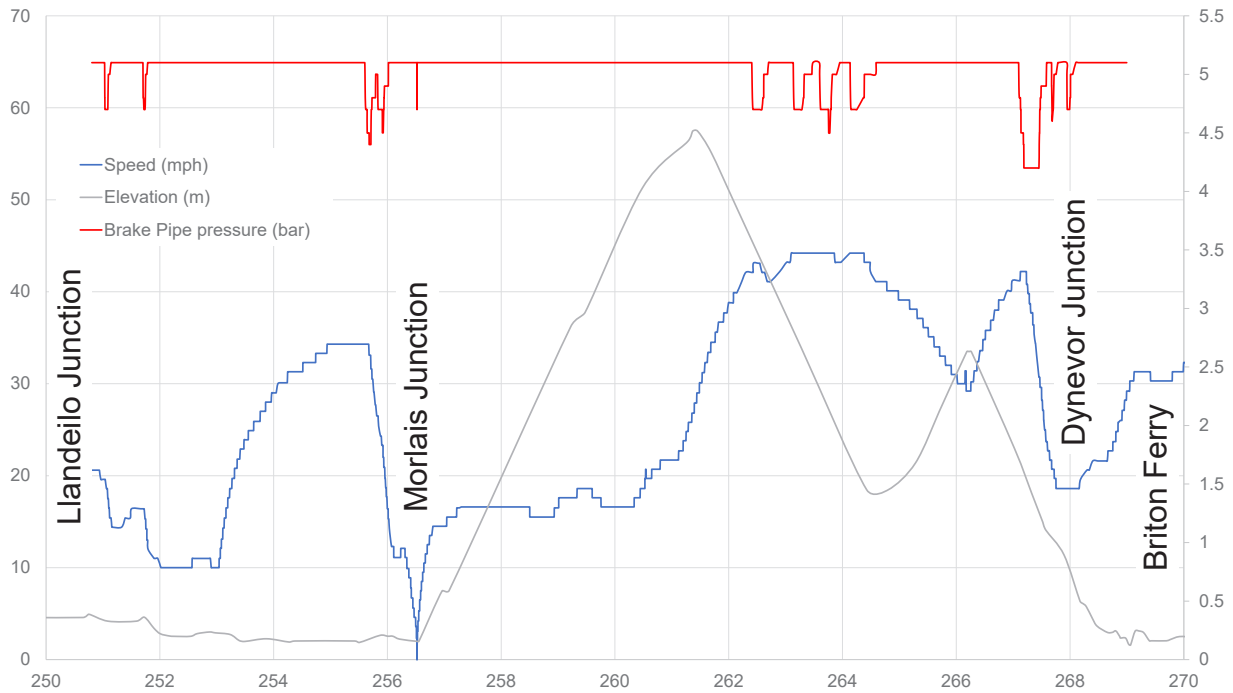
- 80 The on-train data recorder (OTDR) from the locomotive forming train 6A11 indicated that there were a number of braking events during the trip from Llandeilo Junction to Briton Ferry (figure 13). RAIB commissioned a study<sup>13</sup> of the trip from Llandeilo Junction to Briton Ferry over the Swansea District line to determine whether any of the braking events along that line could have resulted in a wagon wheelset locking up and sliding.
- 81 The study concluded that there were braking events along the Swansea District line which could have been sufficient to lock up a wheelset, provided that the adhesion level was very low (0.05 or less). In particular, the study concluded that the braking event which took place as the train was descending from Lonlas Tunnel towards Dynevor Junction was the most likely source of the wheel slide as this was the largest brake application.

Figure 13: Brake applications along the Swansea District line.

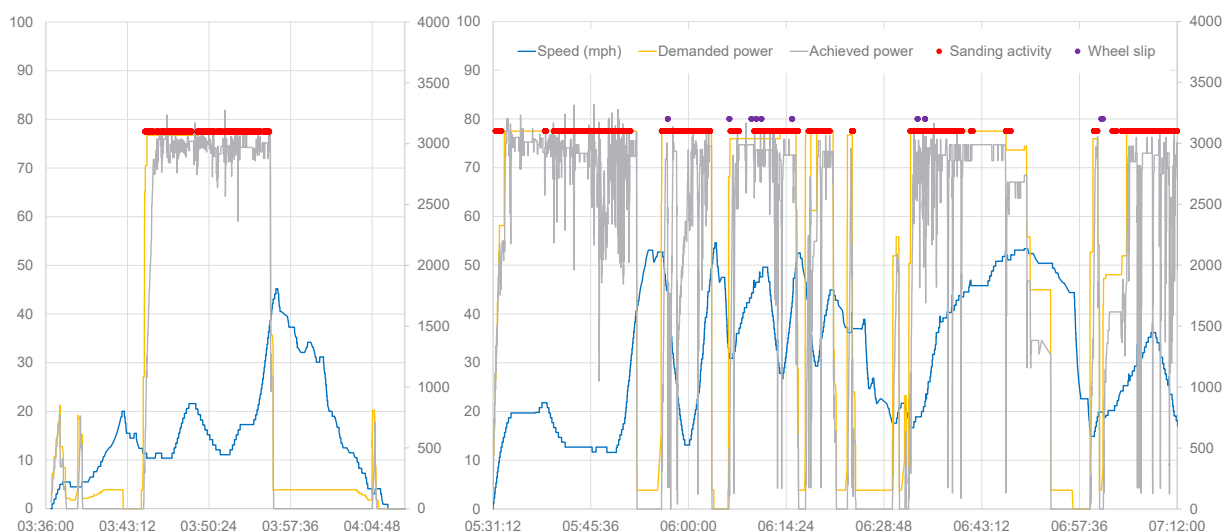
126 RAIB reanalysed the OTDR data of the locomotive involved in the Ferryside accident to determine whether there were also signs of very low adhesion being experienced during the journey.

127 Figure 20 shows the analysis of the OTDR data from the locomotive involved in the Ferryside accident, presented in the same way as in figure 14, which shows data from the locomotive involved at Pencoed. Figure 20 shows numerous activities of the anti-slip function of the traction control system and associated sanding, combined with several instances of wheel slip activities being recorded. This suggests that the Ferryside locomotive (number 60001) was struggling for adhesion throughout its journey on the day of the accident and hence that very low adhesion was a possible causal factor to the Ferryside accident. RAIB's report into this accident has been updated accordingly by inclusion of an addendum.

Figure 20: Analysis of the OTDR data for locomotive 60001 on 30 October 2017.

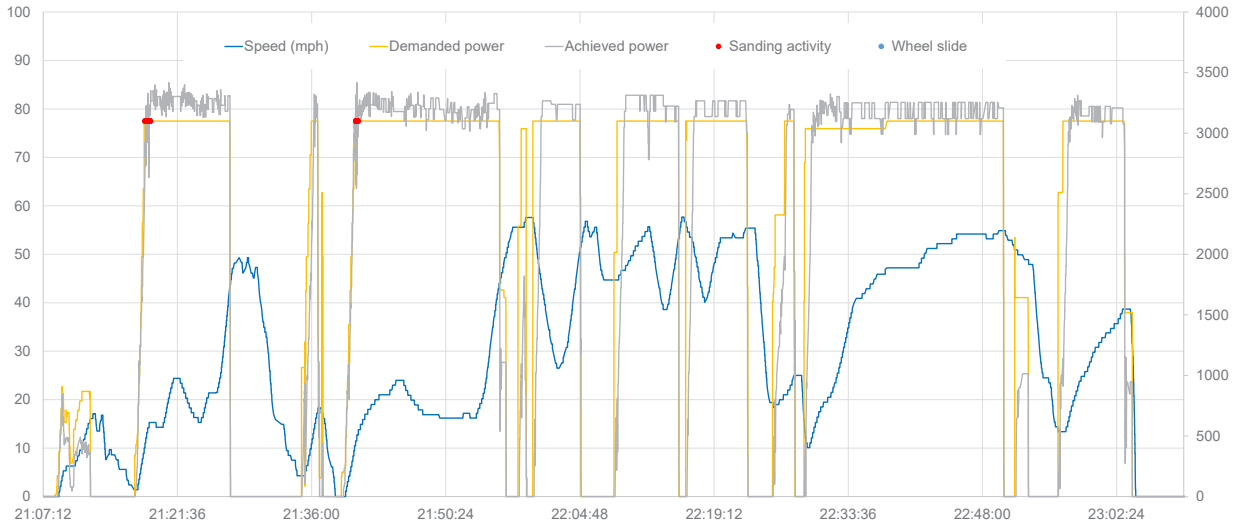
- 130 RAIB revisited the OTDR data of the locomotive (number 60062) involved in the Llangennech accident to determine whether there were signs of low adhesion being experienced during the journey. Figure 21 shows the analysis of the OTDR data presented in the same way as in figures 14 and 20. Figure 21 shows a very small amount of activity of the anti-slip function of the traction control system on departure from a standstill, combined with sanding activity. This suggests that the locomotive was not experiencing conditions of very low adhesion on its journey.

Figure 21: Analysis of the OTDR data for locomotive 60062 on 26 August 2020.
