Rail Accident Report

Track worker struck by train near Chalfont & Latimer station, Buckinghamshire 15 April 2022

Report 05/2023
May 2023

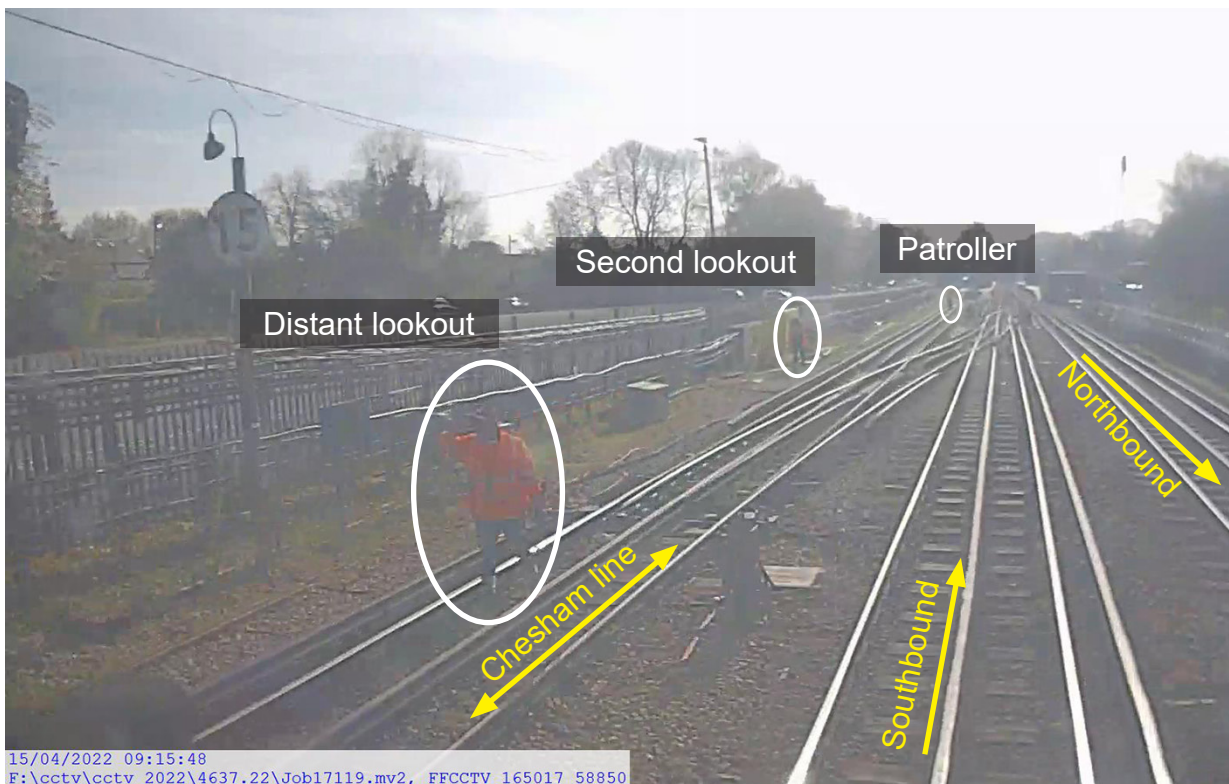
- 30 At approximately 09:15 hrs, train 2C13, a southbound Chiltern Railways train, approached the work group. Witness evidence suggests that when the distant lookout sounded a warning for this train, which was relayed to the patroller by the second lookout, all three track workers were in the four-foot¹ of the southbound line. FFCCTV images from train 2C13 showed that the second lookout moved to the Chesham single line cess, while the distant lookout and the patroller moved to the Chesham single line four-foot. This was not a recognised place of safety to stand in while the train passed (figure 4).

Figure 4: FFCCTV image from train 2C13 (courtesy of Chiltern Railways).
