AAIB Bulletin

6/2023

Published 8 June 2023

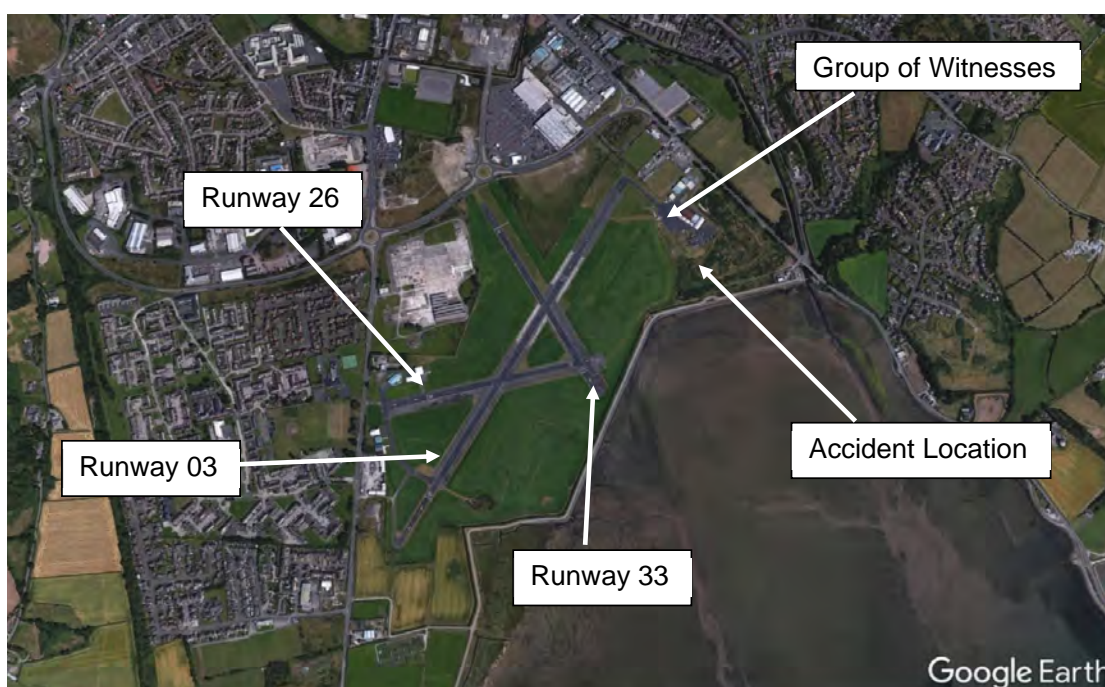
Figure 1

Newtownards Airport showing the accident and witness locations

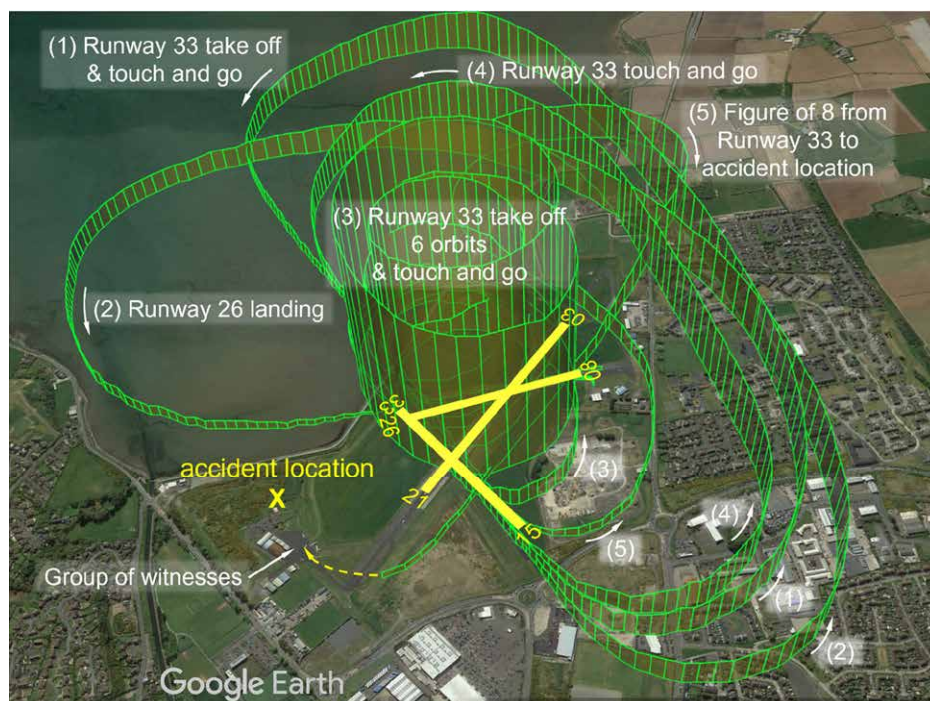
The aircraft then took off again and flew an 'S' turn to approach Runway 03 (Figure 2 – Point 5). During this turn the angle of bank reached 59° with the aircraft at 370 ft agl. The aircraft then flew a low pass parallel to Runway 03 at approximately 70 ft above the ground. At the end of the runway the aircraft made a right turn passing over the people stood next to the vintage bus. Witnesses estimated the aircraft's bank angle was over 60°. One witness described the aircraft "travelling more in the direction of its belly rather than forward". It was reported that the engine sounded "normal" and was at "full power". The last data point, recorded as the aircraft turned right, showed the aircraft was at 72 ft agl, with 71° angle of bank, travelling at an indicated airspeed of 86 kt and a normal acceleration¹ of 1.91 g.

Figure 2
Flight path of accident flight

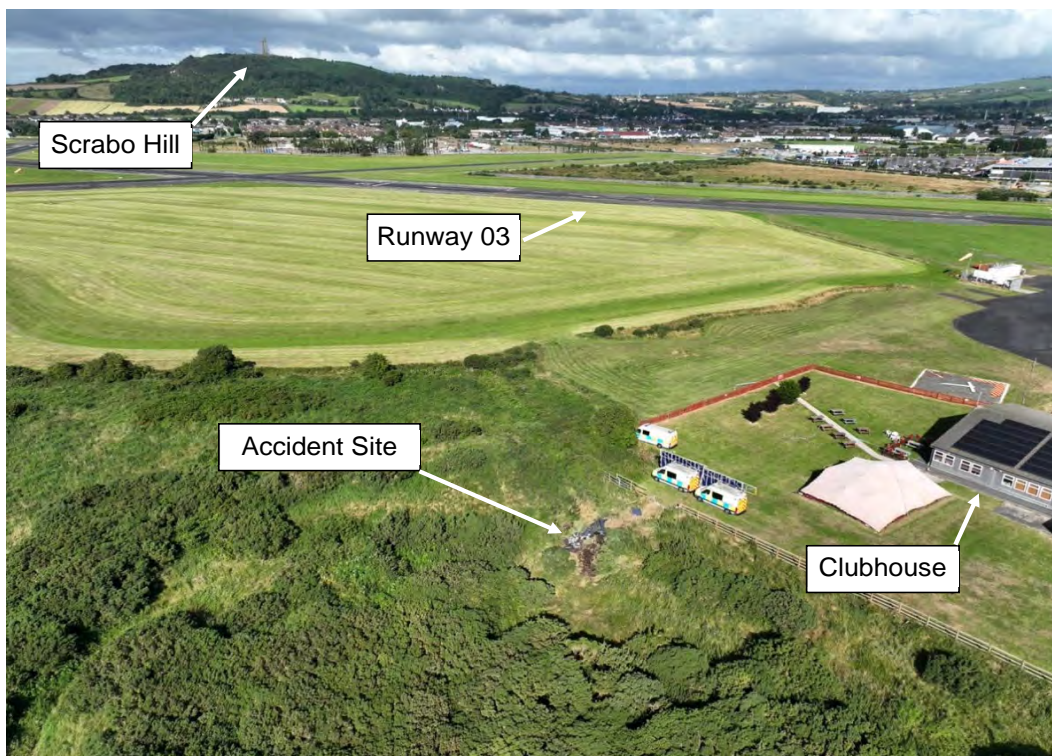
Figure 3

The aircraft struck the ground on the airfield boundary just to the south of the flying club and airport cafe buildings. Witnesses ran to the accident site and airport staff collected the airport fire vehicle. They reached the aircraft within a few seconds but there was no sign of life from the occupants. A fire started on the right side of the fuselage but this was extinguished by the airport fire crew and the local fire service, who arrived shortly after the accident.

Accident site location

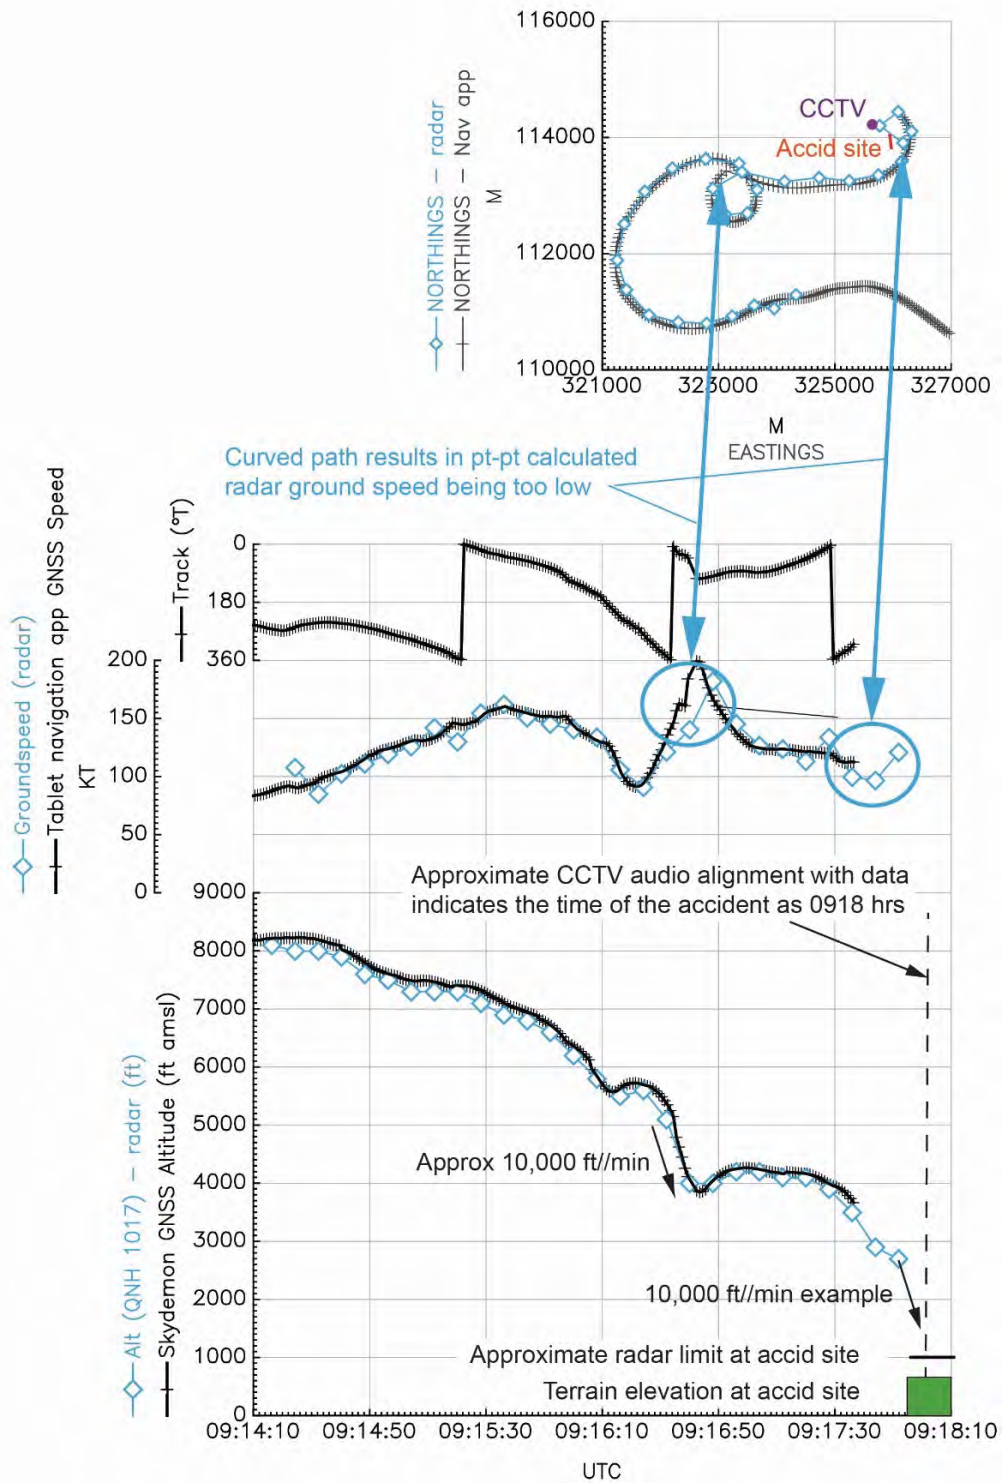
The aircraft was fitted with an ATC transponder but was not detected by secondary radar until the D&D Cell asked the pilot to switch the transponder on. The secondary radar recordings from Clee Hill and Burrington radar facilities were provided. Burrington radar provided the most complete recording of the end of the flight but stopped approximately 2,000 ft above the accident site. Figure 10 shows the data for the duration of the secondary radar recording and data from the navigation app over the same period.

End-of-flight radar, navigation app data and CCTV audio signature data

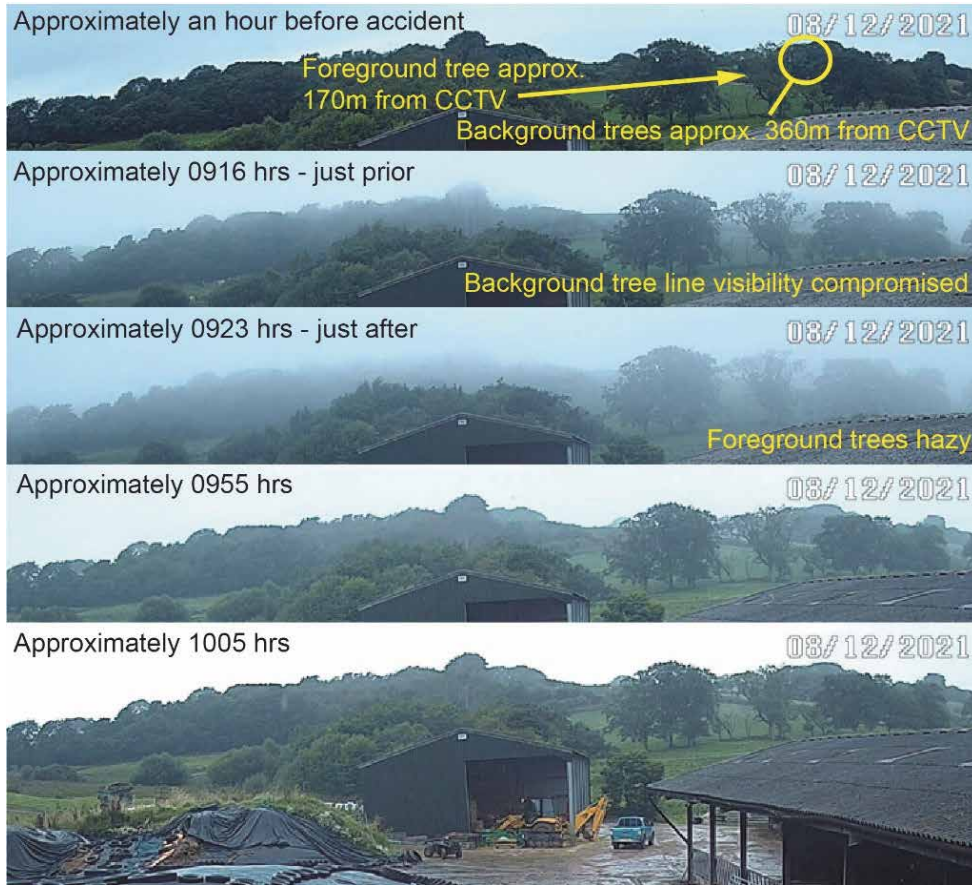
Figure 11

CCTV from a local farm did not show the aircraft but provided evidence of the visual conditions before, during and after the accident (Figure 11). The times shown compensate for errors in the embedded timestamps.

The tree line that is about 360 m from the camera was clearly visible in the recorded image an hour before the accident but was no longer visible in the period leading up to and after the accident. Trees about 170 m from the camera also became hazy at about the time of the accident. Ground level visibility significantly improved over the next hour.

Cropped snapshots from one of the CCTV cameras on a local farm showing changing visibility in the area

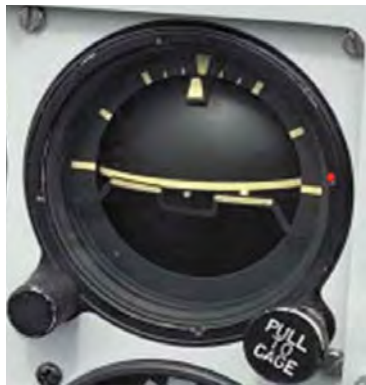
G-BXBU was not certified to fly in IMC or icing conditions. It did however have some instruments installed which would aid IMC flight, such as an attitude indicator (AI). The AI on G-BXBU was a Horizon Bendix J-8 model (Figure 16), featuring yellow markings on an entirely black background. In more modern AI's the symbolic sky and ground have representative colourings that are more instinctive in helping pilots to determine the attitude of the aircraft without outside visual reference (Figure 17).

Figure 16
Horizon Bendix J-8 Model

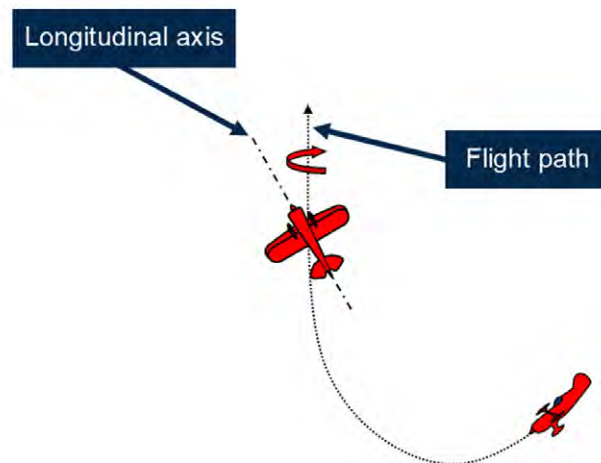
Figure 1

G-BOXV took off from Runway 26 at approximately 0900 hrs. The pilot turned left on departure and climbed to position the aircraft south of the runway before commencing his aerobatic manoeuvring. Mobile phone video taken by an eyewitness showed the aircraft completing three distinct aerobatic manoeuvre combinations before, when approaching the eastern end of the airfield, it pulled up into a vertical climb from approximately 420 ±50 ft agl on a broadly easterly heading. While the aircraft did not stay in the video frame for all the subsequent manoeuvring, it could be seen that the aircraft was rolled left through approximately 450° as it climbed. The nature of the rolling motion indicated the pilot likely had some left rudder applied during the roll because G-BOXV's longitudinal axis was not closely aligned with the aircraft's upward flight path (Figure 1).

Pull up into vertical roll
(not to scale)

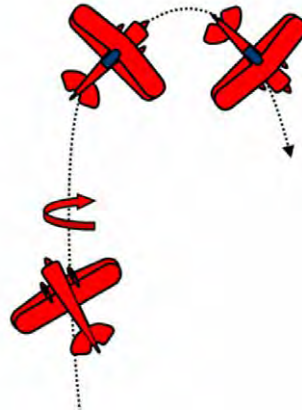
Figure 2

The aircraft continued climbing until reaching an estimated apex height of 1,100 ±200 ft agl. At the top of the manoeuvre G-BOXV was banked to approximately 90° right wing low with the nose 30°- 45° above the horizon. The nose of the aircraft then dropped progressively lower while the bank was maintained (Figure 2). During the transition from nose-up to nose-down, G-BOXV's nose appeared to fall more due to gravity than as the result of significant rudder application generating the right yaw.

Apex of the climbing manoeuvre
(not to scale)

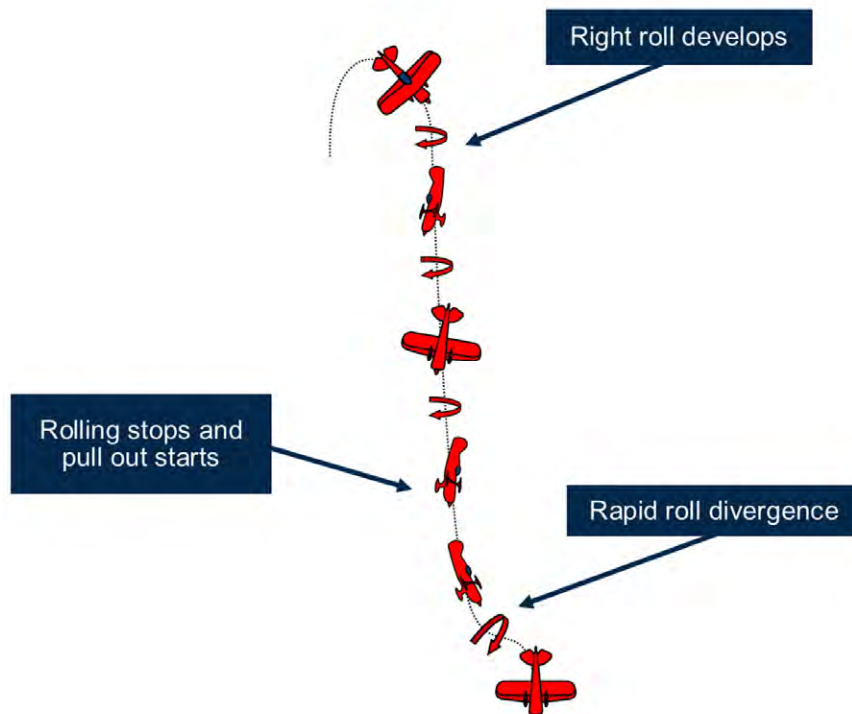
Figure 3

As the nose dropped through an estimated 45° nose-down, the aircraft began rolling right and the nose dropped further to approximately 80° nose-down (Figure 3). The aircraft continued rolling right, passing 360° of roll in approximately 2½ seconds. Audio recording from the mobile telephone footage corroborated eyewitness evidence that the engine rpm reduced, likely to idle, shortly after the aircraft began rolling during the descent.

Downwards flight path
(not to scale)

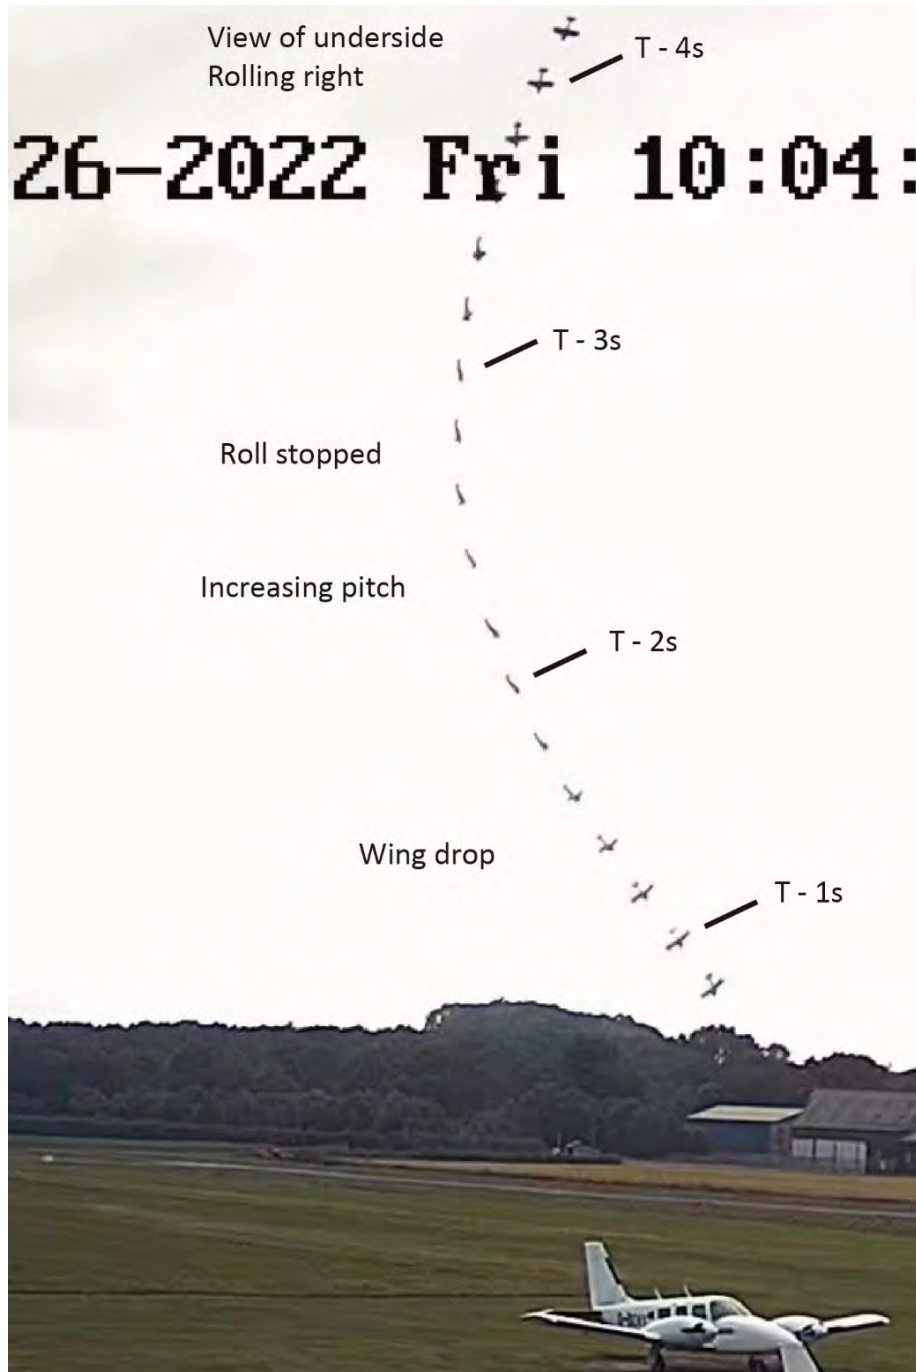
CCTV cameras captured the lower parts of some of the manoeuvres and the impact with the ground. The field of view of the CCTV cameras did not extend up enough to capture higher parts of the manoeuvres flown, including the final accident manoeuvre. Figure 5 shows the final descent captured on CCTV.

Compound image of cropped CCTV snapshots 0.2 seconds apart until 0.8 seconds before contact with the ground

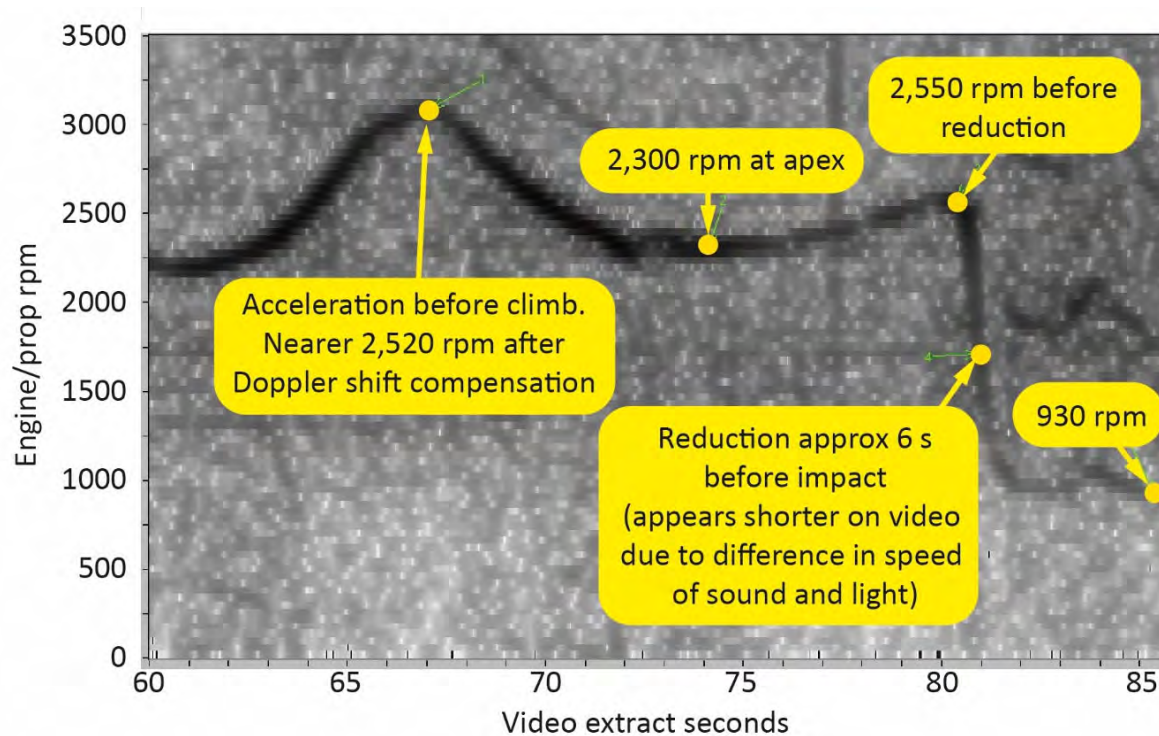
Figure 6

The mobile phone video also captured the sound of the propeller (Figure 6). The frequency of the recorded tone is related to the speed of the propeller but is also affected by doppler shift due to the aircraft moving towards or away from the recording device. In this case the frequency shift was predominantly due to the initial speed of the aircraft at the start of the manoeuvre being largely towards the recording position. With fixed pitch propellers, such as the one in use, the speed of the propeller is affected by airspeed and the throttle position.

The audio recorded a sharp drop in propeller speed which, after factoring in the time taken for the sound to travel from the aircraft to the mobile phone, was about six seconds before impact. No sound of the impact was identified as the audio was swamped at this point by voices at the recording location.

Spectrum analysis of the audio track of the mobile phone recording showing tone due to propeller blade noise. Scale halved to reflect propeller rpm rather than blade passes per minute

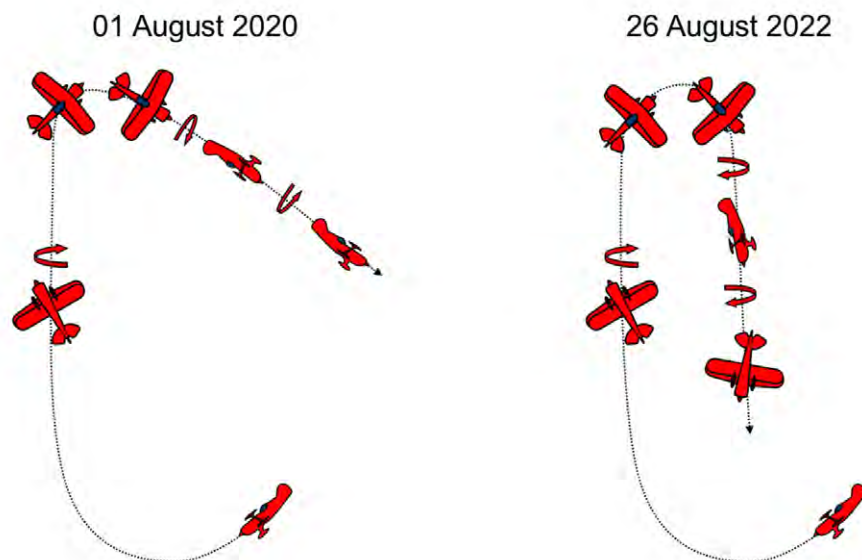
Figure 10

While no supporting documentation could be found, the investigation was provided with video footage taken on 1 August 2020 of the pilot flying a climbing manoeuvre like that which preceded the accident. This video showed the aircraft pulling up into the vertical before rolling left through 450°. This roll, like the one in the accident manoeuvre, was off-axis to the left and finished with a steeply banked 'knife-edge' over the top. As the aircraft's nose dropped below the horizon, the pilot held the pitch attitude at approximately 45° nose-down with the aircraft inverted for about one second before rolling erect and continuing the 45° descent. In the August 2020 video, the transition from nose-up to nose-down was more dynamic than on the accident flight; visually, the aircraft appeared to have more airspeed approaching the apex and the right yaw looked more positively controlled. Additionally, on

the accident flight the aircraft remained close to 90° angle of bank as the nose dropped, while for the August 2020 manoeuvre, the bank angle was closer to 120°, thus requiring less yaw but more pitch to bring the nose down to the desired angle. A simplistic comparison of the accident manoeuvre with the one from 1 August 2020 is shown at Figure 10.

Comparison of 1 August 2020 manoeuvre and accident manoeuvre
(not to scale)

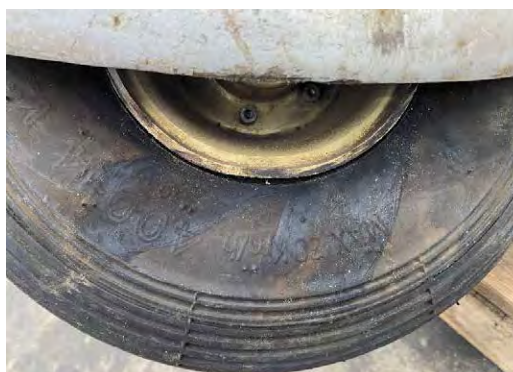
Figure 3

The wreckage was recovered to the AAIB for detailed examination. Continuity of the flying controls was confirmed, along with the engine controls. Witness marks on the fuselage correlated to the flaps being deployed to their full (landing) configuration at the time of the accident. There was evidence of over compression on the left side of the nose landing gear tyre and there was slight deformation of the wheel hub (Figure 3). A detailed engine teardown revealed that the engine was probably performing normally prior to the accident.

Damage to the nose landing wheel

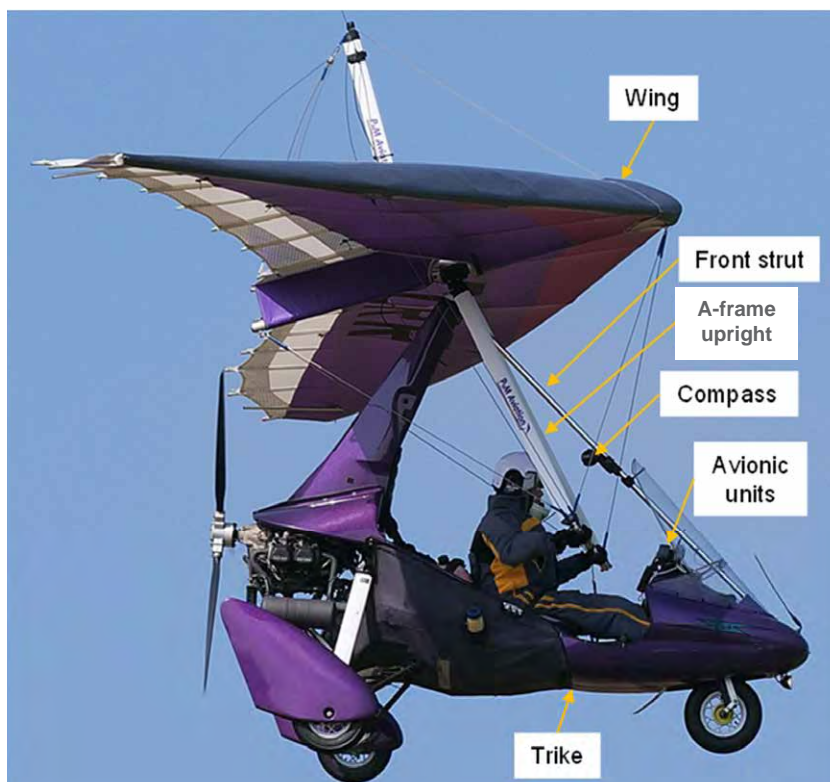
Figure 1

Examination of the engine controls and brake systems did not show any faults or anomalies. The front strut was intact with most of the aircraft damage occurring to the wing and the A-frame, with the right upright and its top knuckle having failed in overload. All the damage to the aircraft was consistent with it rolling onto its side.

There was evidence of blood inside the nylon sleeve that covered the front strut and on the lower section of the right upright.

G-CGRR pictured in flight showing significant features
(Image used with permission)

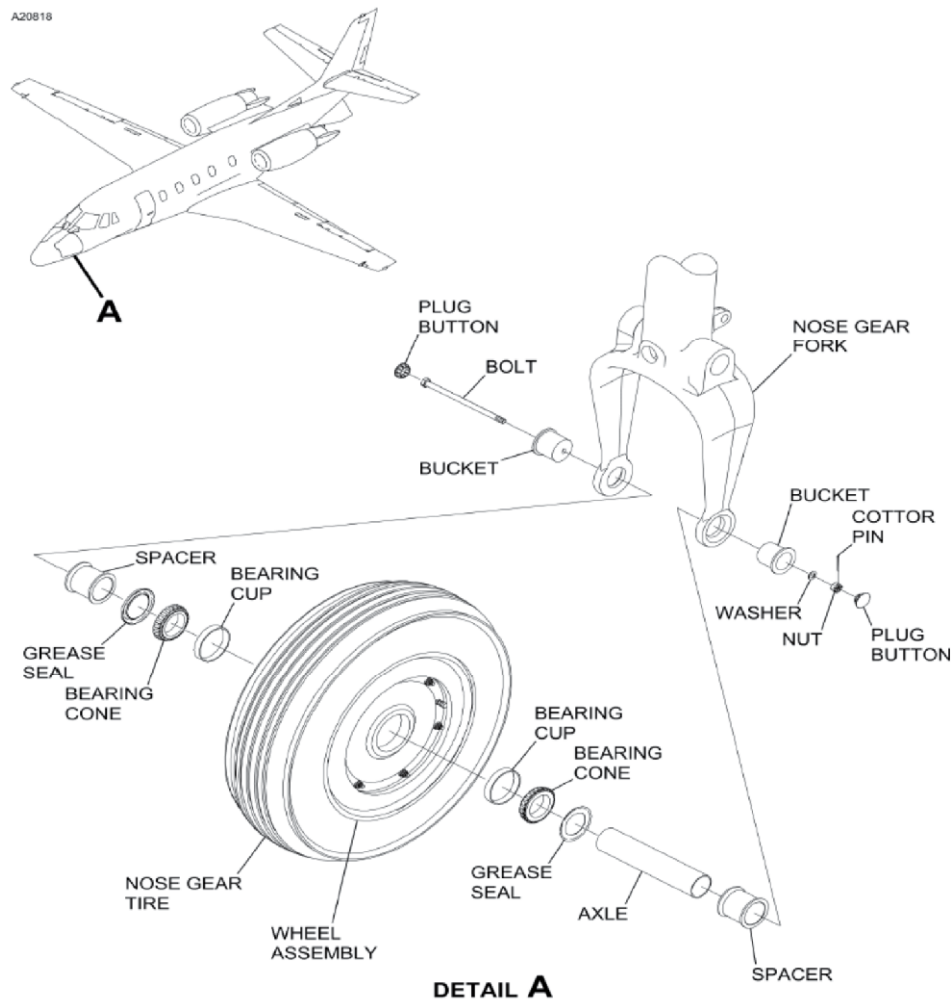
Figure 2

The nosewheel assembly on EC-KPB was last replaced in September 2021 and had been fitted for 337 flying hours and 230 cycles. Prior to being fitted, the wheel assembly had been reconditioned in accordance with the manufacturer's component maintenance manual. Grease was applied at the time it was fitted. According to the Aircraft Maintenance Manual (AMM) no maintenance was required to be carried out on the wheel since it was fitted, and none was carried out.

It was not possible to establish whether the bearings were new or re-used when they were fitted during the wheel reconditioning, but they would have been inspected at the time. It is likely that they were of similar usage; however, this could not be confirmed.

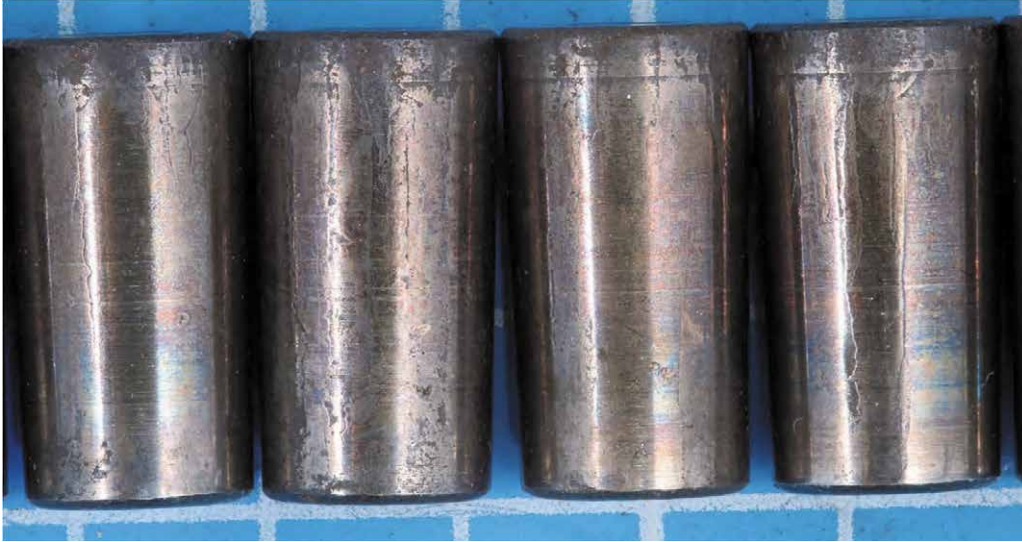
Figure 3

Roller bearings from the non-failed bearing, exhibiting linear and circumferential pitting

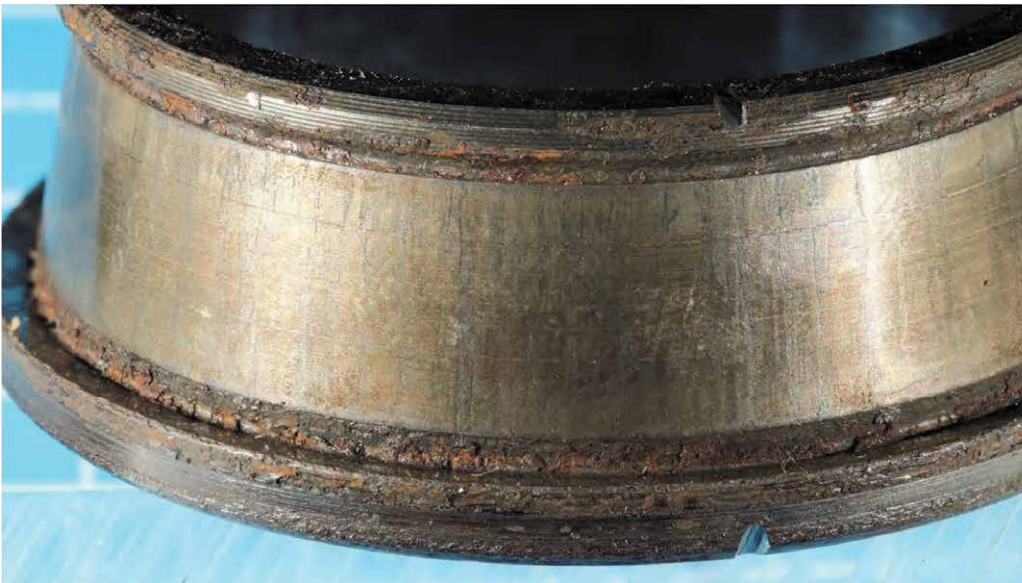
Figure 4

Roller bearing cone from the non-failed bearing, exhibiting linear pitting and corrosion around the track shoulder indicating the onset of corrosion

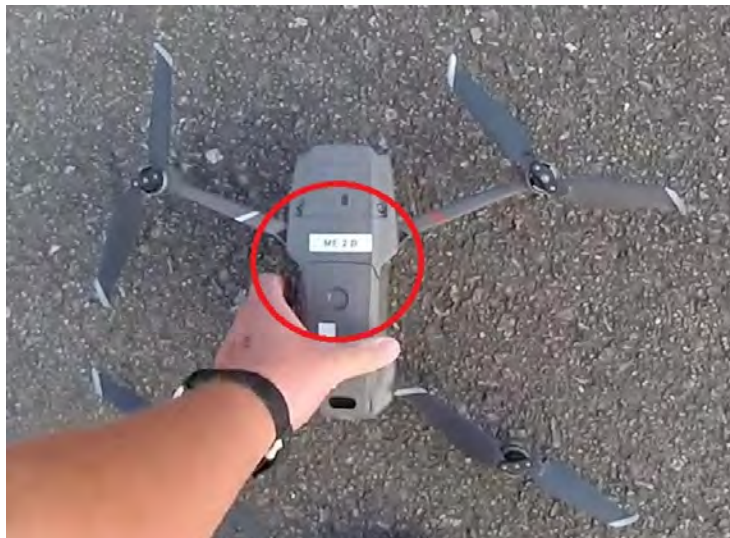
Figure 2

The remote pilot was wearing a video camera (bodycam) which showed him setting the aircraft on the ground prior to takeoff (Figure 2). The operator and remote pilot reported that this image shows that the gap between the battery and airframe is larger than it should be when the battery is correctly installed. This picture was sent to the aircraft manufacturer and they stated that it was not possible to judge from this image if the battery was partially attached or not, or whether it was swollen or not.

Image from the pilot's bodycam prior to takeoff

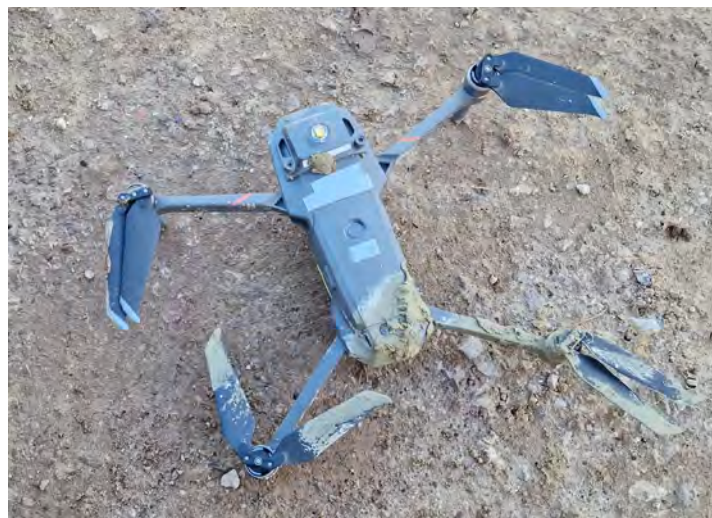
Figure 1

The UA was observed to fly in an erratic manner, and the pilot stated he had limited lateral control available to enable him to fly it into a clear area. It came close to houses under construction and stopped responding to control inputs. The pilot described it as then “appearing to descend too fast, despite the propellers spinning”, before going out of sight behind some construction materials. The UA struck a site worker on their arm, dropped into some cement, and fell to the ground. The site worker was not injured.

UA after falling to the ground
