Service Inquiry

Into the death of a Royal Air
Force parachute instructor at
RAF Weston on the Green

2 September 2021

SERVICE INQUIRY INTO THE DEATH OF A ROYAL AIR FORCE PARACHUTE INSTRUCTOR DURING A FORCE DEVELOPMENT DAY AT RAF WESTON ON THE GREEN ON 2 SEP 2021

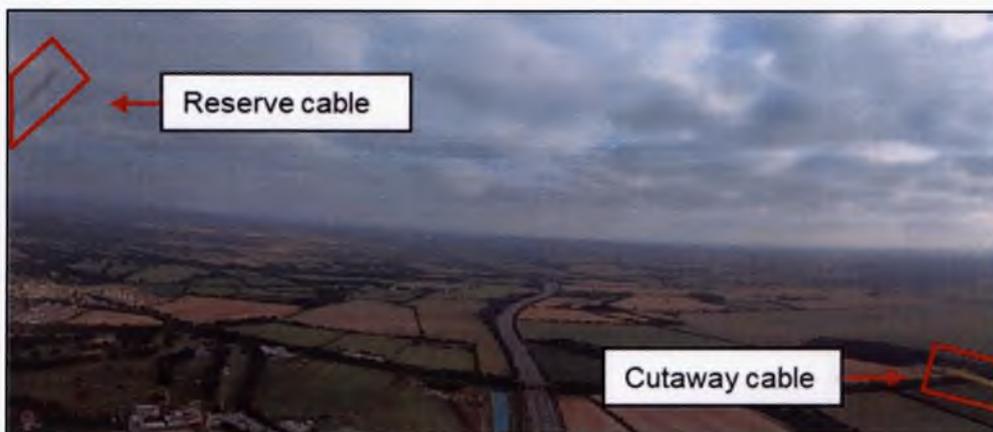
Figure 1.3.8 – Cutaway and reserve cables, 05.289sec before impact.

h. Between 1,515ft and 984ft agl some further movement could be seen before the yellow cable of the main canopy cutaway system came into view, shortly followed by the metal reserve release cable. (Figure 1.3.8).

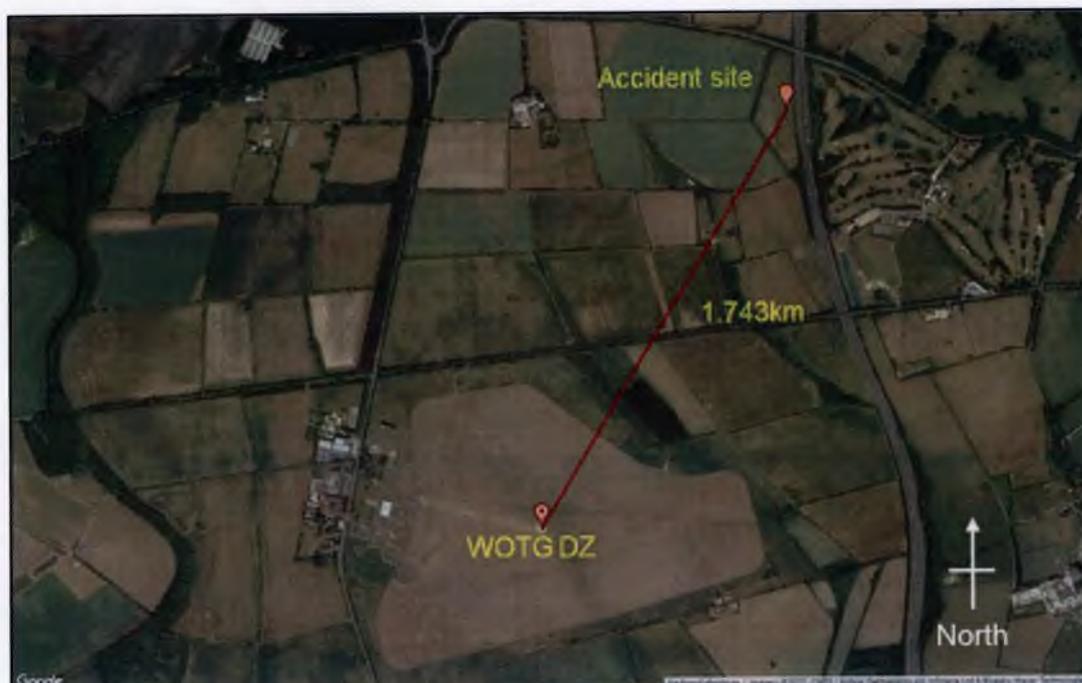
Figure 1.4.4 – Distance of accident to WOTG DZ.

1.4.22. At 18:08 on 2 Sep 2021 an NPAS helicopter located Sgt Fisk in a field at latitude 51.892101 N, longitude 1.207220 W, 1.743km from WOTG DZ (Figure 1.4.4). Imagery from the NPAS helicopter provided the panel with an overview of the scene prior to emergency services attendance.

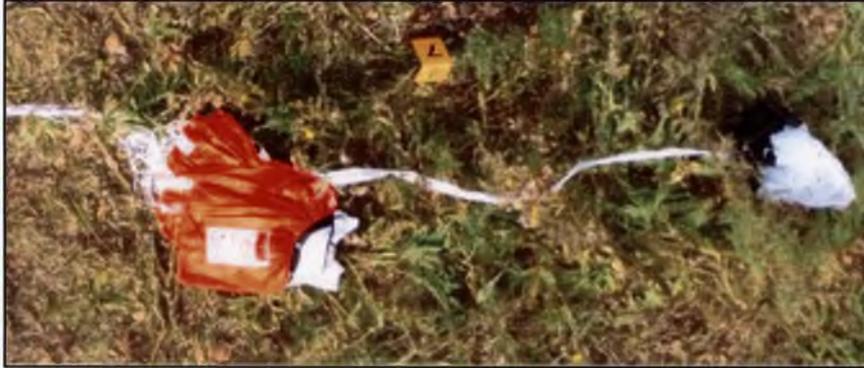
Figure 1.4.6 – Disturbed reserve parachute, free-bag and pilot chute.

chute.

g. The reserve pilot chute was fully extended with the top cap towards the free-bag.

1.4.25. The panel conducted a comparison of the imagery provided from the NPAS helicopter and the post-accident scene to identify any differences. The panel noted that an image of the free-bag from the NPAS footage showed the reserve canopy still packed within the free-bag, with the reserve pilot chute resting approximately one metre away. The panel was unable to determine from this image whether the reserve pilot chute was still entangled.

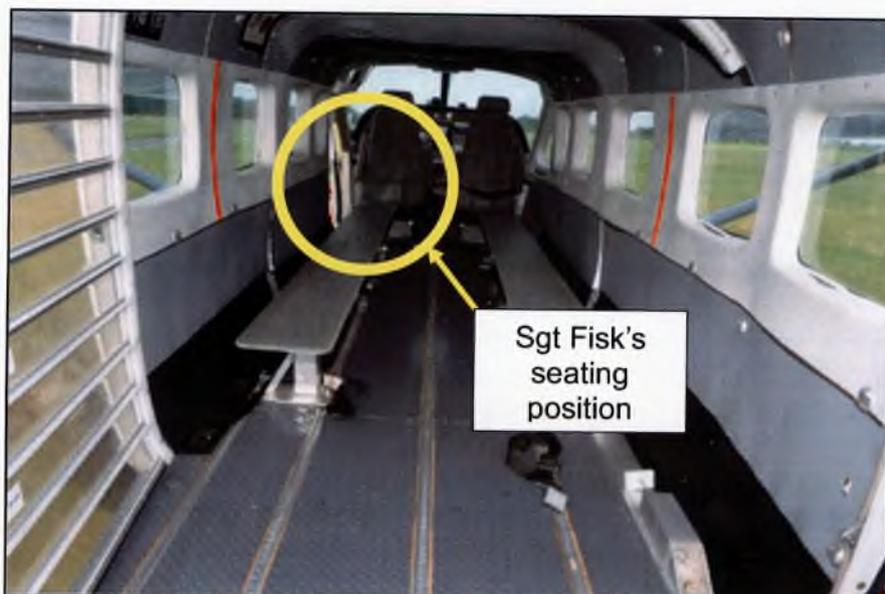
Figure 1.4.10 – Sgt Fisk's seating position within the aircraft looking forward.

1.4.44. The panel reviewed all available footage of Sgt Fisk's movements on the aircraft. PJI 1's footage showed Sgt Fisk initially sat on the port side of the aircraft, facing aft, which would have placed her BOC toggle towards the aircraft smooth internal panelling (Figure 1.4.10). Once groups one and two had exited the aircraft, PJI 3 moved to the aircraft door ready to exit with the tandem pair and Sgt Fisk. PJI 3's footage captured Sgt Fisk standing up in the centre of the aircraft and moving to her exit position. Therefore, there was no opportunity for the BOC toggle to interact with the aircraft whilst moving towards the aircraft door. On departure, PJI 3's footage captured Sgt Fisk in a stable freefall position. It did not indicate anything other than the BOC toggle stowed within its pocket.

1.4.45. The panel assessed that Sgt Fisk's BOC toggle was retained in the correct position during the ascent, exit from the aircraft and in freefall. It was therefore very likely that the BOC toggle was only displaced during attempts to deploy her main pilot chute. The panel concluded that the main pilot chute had not been extracted during the parachutist checks, from any interaction with the aircraft, or, up to the point PJI 3's camera footage no longer captured Sgt Fisk and, therefore, was **not a factor**.

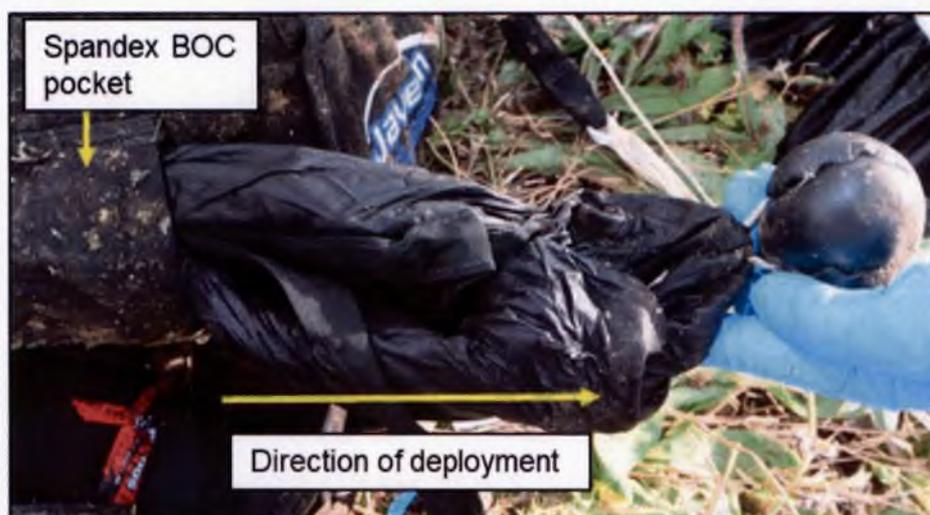
Figure 1.4.12 – Main pilot chute being extracted by TVP.

1.4.51. The QinetiQ report noted that the elasticated pocket of Sgt Fisk's parachute container was of a typical size, shape and tautness, with no indication that excessive force would be required to deploy the main pilot chute. The pocket and main pilot chute assessment completed by QinetiQ provided the panel with an understanding of the force required to extract a main pilot chute. The report identified that the extraction force for parachute system two was 'higher than typical and represents a magnitude that may be difficult for a parachutist to achieve'. Whilst analysing these results the panel considered how the pressure of the of the main canopy within the container may have affected Sgt Fisk's main pilot chute pull force during freefall and assessed that it

1.4.53. The panel found no evidence that the parachute system would have malfunctioned if Sgt Fisk had been successful in deploying the main pilot chute. The reason as to why she was unable to complete this action could not be determined, a human factors error could therefore not be ruled out of the accident sequence. The panel concluded that Sgt Fisk's inability to deploy the main pilot chute was a **Contributory Factor**.¹⁰⁹

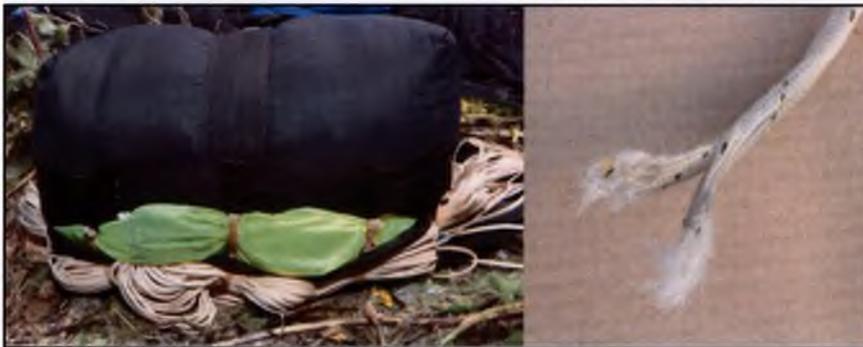
Figure 1.4.13 – Main canopy bag and closure loop.

1.4.63. **The separation of the main canopy deployment bag from the container.** The TVP images captured at the accident site showed the main canopy deployment bag extracted from the container (Figure 1.4.13 (left)). This was evident in the NPAS helicopter footage of the scene prior to disturbance by the emergency services but was not consistent with Sgt Fisk's GoPro™ camera footage, which did not show any sign that the main pilot chute, bridle, or main canopy deployment bag had been deployed. The main canopy deployment bag was retained within the main container by four flaps secured by a pin through a nylon closure loop. Inspection of this closure loop showed evidence of significant damage with a break at the loop end (see Figure 1.4.13 (right)). This break would have released the retaining pin and permitted the main container flaps to open.

1.4.64. The panel assessed that it was highly likely that the main canopy closure loop snapped during the initial contact with the ground, allowing the main canopy deployment bag to be expelled from the main container. The panel concluded that the main canopy deployment bag was ejected from the container at the point of impact and was, therefore, **not a factor**.

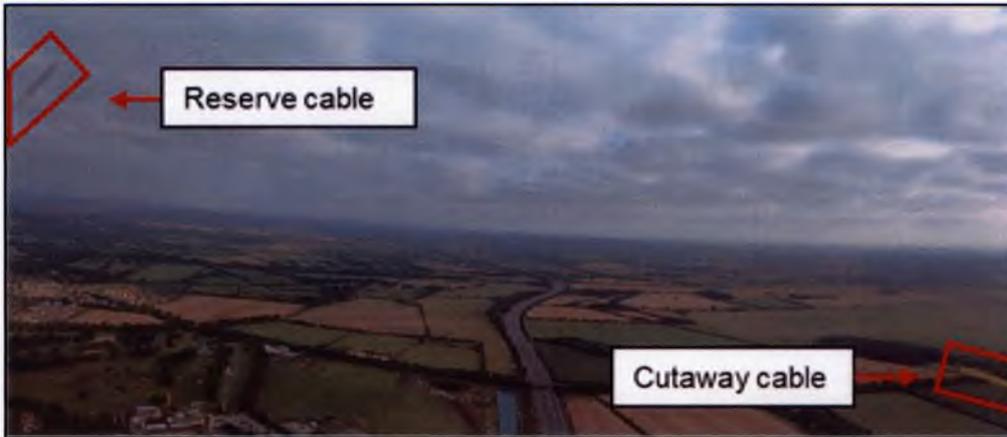
Figure 1.4.14 – Cutaway and reserve cables as seen on Sgt Fisk’s GoPro™ footage.

1.4.75. The GoPro™ footage provided an image in which both the cutaway and reserve cable can be seen (Figure 1.4.14), indicating that Sgt Fisk had completed her EP. The height at which point both the cutaway and reserve cables were observed was 793ft agl, 5.3sec before contact with the ground.

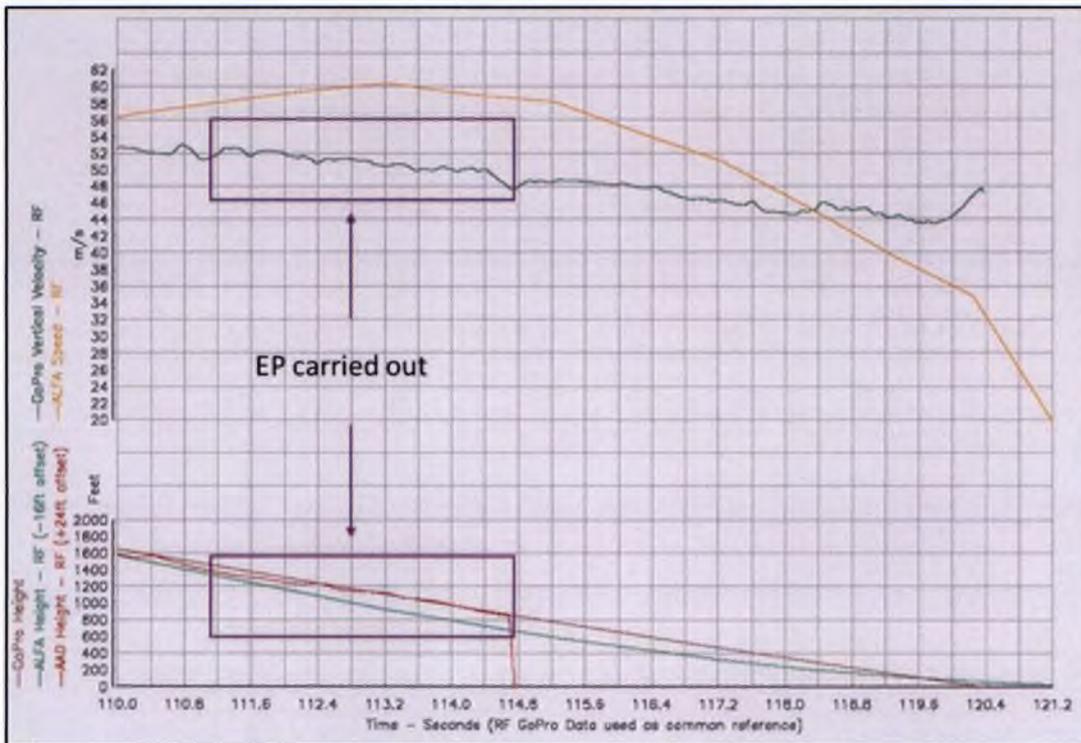
Figure 1.4.15 – GDAS velocity and height graph.

1.4.76. The movements identified prior to seeing the cables indicated that the EP was likely to have been conducted between 1,532ft and 793ft agl (Figure 1.4.15). The key movements observed during that 4.4sec period are detailed below.

- a. **Look.** At 1,532ft agl, a rapid head movement down was seen with a camera pitch angle from -3.7° to -50.1° .¹¹⁵
- b. **Locate.** A period from 1,489ft to 1,302ft agl shows head and body movement that could be associated with an attempt to locate the cutaway and reserve handles.
- c. **Cutaway.** At 1,041ft agl, movement is seen which brought the view towards the horizontal, followed by the cutaway cable coming into view 0.37sec later.
- d. **Pull reserve.** A slow left turn that ceased at 898ft agl which was likely to be associated with the operating of the reserve handle.
- e. **Arch.** At 828ft agl the view returns to the horizontal indicating a stable on heading (SOH) position, followed by the reserve cable being seen on camera 0.26sec later.

1.4.81. Recommendation. Deputy Commander Operations should convene a working group across Defence sports parachute associations, display teams and AT providers to define the minimum height that a sports parachutist must have initiated the emergency procedures, in order to standardise the guidance within Defence.

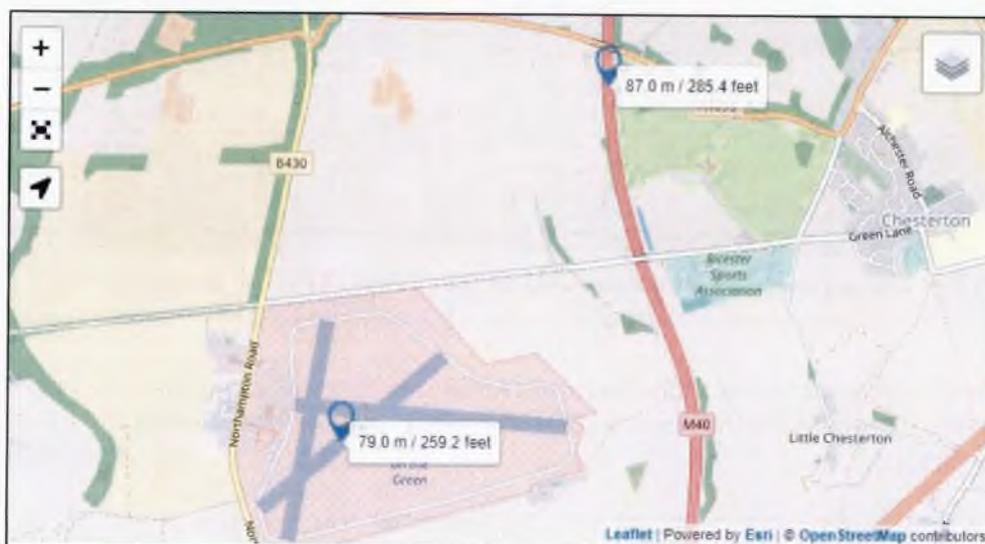
Figure 1.4.18 – Ground heights for AAD flight cycle initiation and activation.¹¹⁸

1.4.87. The panel was able to identify the flight cycle start location as latitude 51.878060 N, longitude 1.223602 W with a ground elevation of 259ft above mean sea level (amsl). It was also able to identify the location at which the AAD cutter operated as latitude 51.892407 N, longitude 1.206396 W with a ground elevation as 285ft amsl (Figure 1.4.18). This equated to an elevation difference of +26ft. However, when averaged against other online mapping applications, this provided a difference of +24ft.

1.4.88. The AAD automatically took into account the freefall velocity and increased the firing height accordingly. This accounted for the activation height being annotated as approximately 70ft higher than the default setting of 750ft agl. Based on the ground elevation difference between the flight cycle start point and AAD activation point, the reported activation height of 820ft would have equated to 796ft agl above the accident site. The panel noted that within

1.4.92. The panel concluded that the local topography surrounding a DZ could reduce the AAD cutter activation height below the manufacturers' recommended minima and considered this to be an **Other Factor**.

1.4.93. **Recommendation. Deputy Commander Operations should convene a working group across Defence sports parachute associations, display teams and AT providers to define the automatic activation device minimum height settings for each parachuting discipline, in order to mitigate the risks associated with low level malfunctions.**

1.4.94. **Recommendation. Deputy Commander Operations should convene a working group across Defence sports parachute associations, display teams and AT providers to define the procedures for the setting of the automatic activation device height settings in order to mitigate the risks of uneven topography around drop zones.**

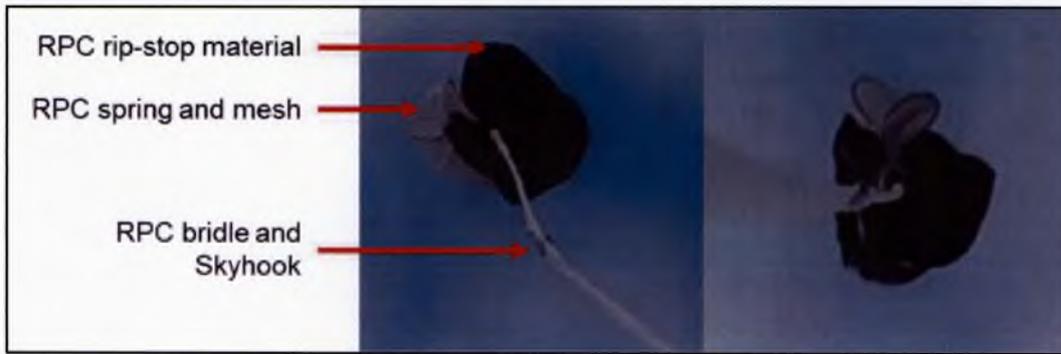
Figure 1.4.20 – Malformed reserve pilot chute, 2.153sec and 0.084sec prior to impact.

1.4.96. Photographic and video evidence provided the panel with images of Sgt Fisk's RPC before and after the accident. The footage from her GoPro™ captured two occasions where the RPC was in a different configuration to that seen in Figure 1.4.19. It was the panel's opinion that the RPC spring had not fully extended, with the mesh material appearing to be positioned above the rip-stop nylon. The panel assessed it as very likely that the configuration of Sgt Fisk's RPC seen in Figure 1.4.20, was the result of an entanglement. The panel, therefore, investigated how this malformation could occur and how it may have affected the deployment of the reserve canopy.

1.4.121. It was, therefore, the opinion of the panel that during the accident it was extremely likely turbulent wake exacerbated any hesitation of the RPC and affected both the reserve pilot chute and bridle in such a way that it led to an entanglement and subsequent malformation. The panel concluded that the malformed RPC was a **Causal Factor**.

1.4.104. **Recommendation. Air Officer Commanding No. 22 Group is to lead an urgent review of the emergency procedures for a parachuting total malfunction, in order to ensure that the risk associated with this malfunction remains as low as reasonably practicable and tolerable.**¹²⁵

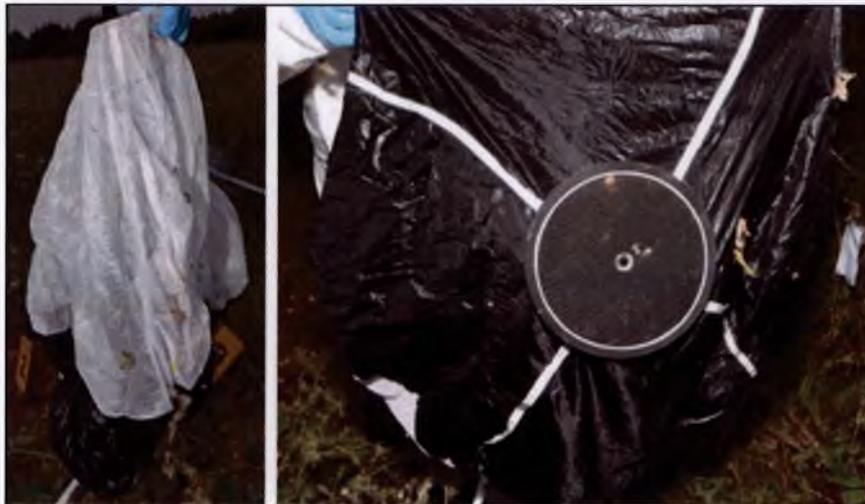
Figure 1.4.22 – RPC as seen following the accident.

1.4.99. Sgt Fisk's RPC was deemed serviceable at the time of the reserve inspection and repack. This was completed and recorded by a JSPC(W) rigger on 14 Apr 2021.¹²¹ The TVP photographs of the RPC taken following the accident showed it had returned to its normal shape, with no signs of the malformed state seen previously in the GoPro™ footage (Figure 1.4.22).

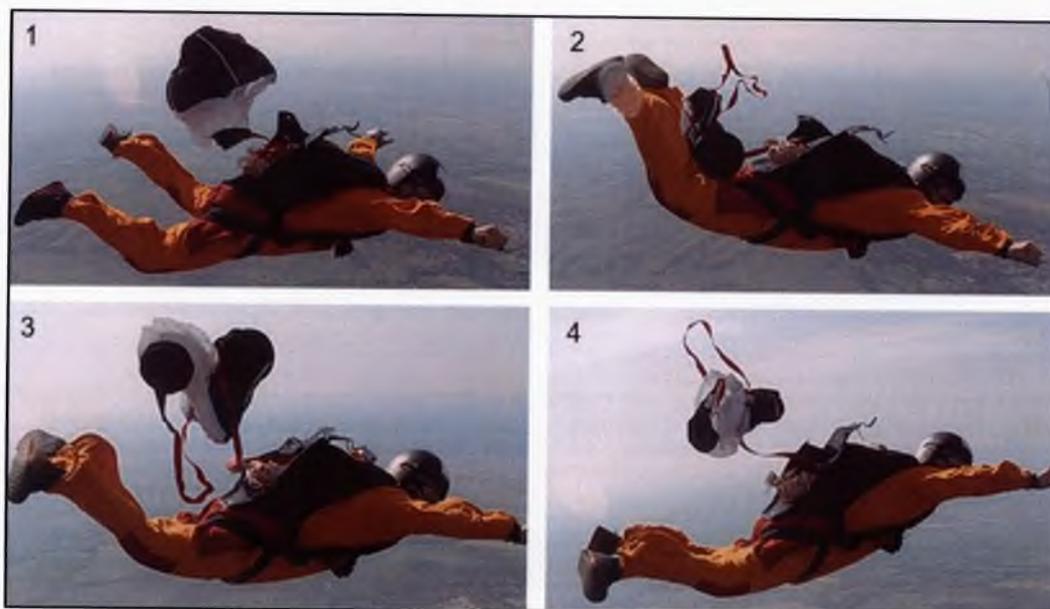
Figure 1.4.30 – Spring pilot chute caught in turbulent wake.

1.4.113. Pilot chutes deployed by a spring extractor were commonly used within Defence to deploy main or reserve parachute systems. Spring extractor hesitation was a known phenomenon and was caused by the pilot chute being trapped within the turbulent wake of a parachutist. Although the spring extractor was designed to overcome the effects of turbulent wake, the panel found an example of spring extractor hesitation in JSAT activity (Figure 1.4.30) during which the pilot chute was trapped in the chaotic airflow.

1.4.114. The panel observed that spring extractor hesitations had predominately been witnessed during main parachute deployments. However, as turbulent wake was not limited to one small area above the parachutist, it was extremely likely that a hesitation of the RPC was plausible. The panel recognised that the potential addition of container interaction (see 1.4.100) affecting the RPC performance would increase the likelihood of an RPC hesitation. The panel found no evidence of any guidance or procedures surrounding pilot chute hesitation within British Skydiving or JSPC(W) documentation.

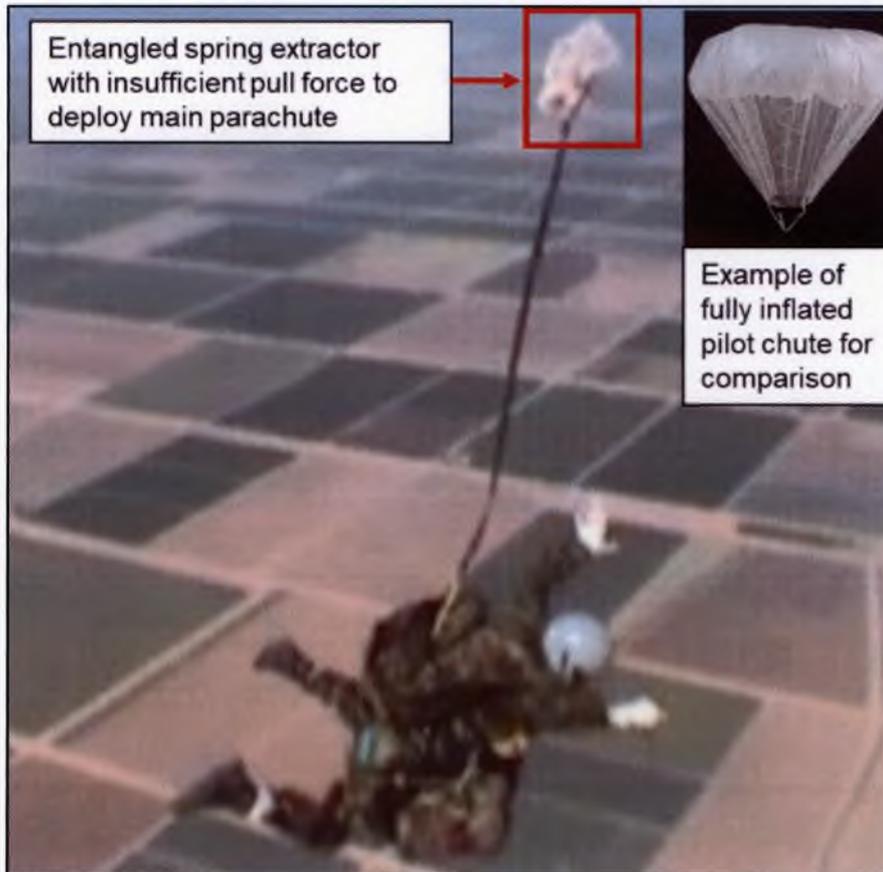
Figure 1.4.32 – Pilot chute entanglement.¹³²

1.4.120. The panel was provided with additional evidence of situations in which a bridle had interacted with a spring activated pilot chute and had resulted in an entanglement (Figure 1.4.32). A video file showed two different UK military systems used for FE@R parachuting activity, both fitted with spring extractor deployed main canopies. It was evident from the footage that the performance of the spring extractor had been affected by the parachutist's turbulent wake, allowing the bridle to become entangled with the pilot chute.

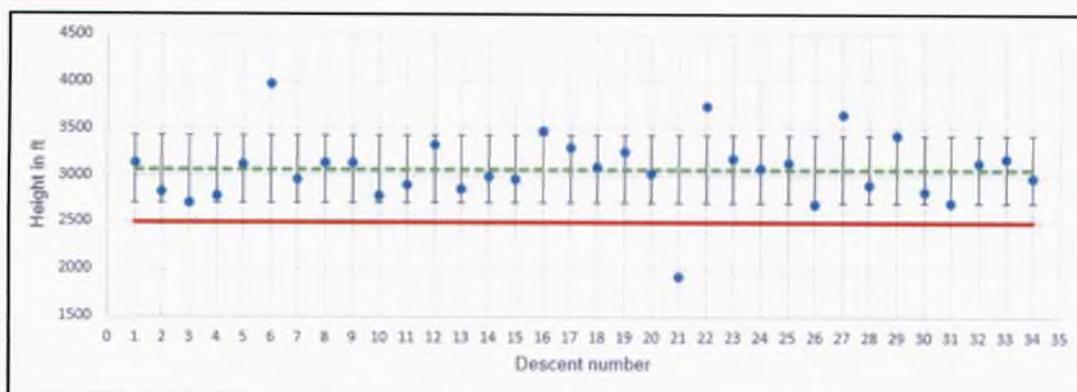
1.4.209. This data also provided details of the main canopy deployments¹⁶⁰ for her previous 35 descents, which showed a mean main canopy deployment height of 3,066ft agl with a standard deviation of 359.57ft (Figure 1.4.41 and Figure 1.4.42).¹⁶¹

Figure 1.4.41 – Sgt Fisk ALFA canopy deployments.

¹⁶⁰ ALFA canopy deployment height recorded at a deceleration to 90mph (+/- 1mph).

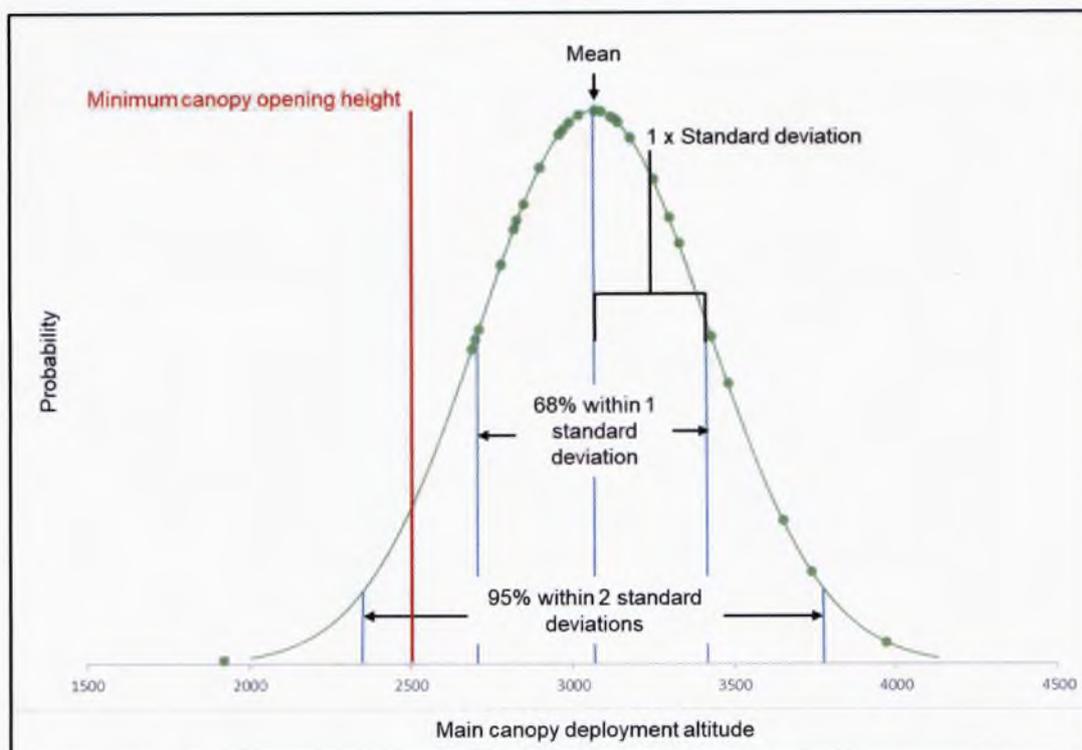
Figure 1.4.42 – Sgt Fisk canopy deployment, standard deviation.

1.4.210. The panel confirmed that Sgt Fisk had held the appropriate British Skydiving qualifications for the activity she was undertaking, and was regarded as an experienced and competent individual within both military and sports parachute training systems. Analysis from her ALFA data demonstrated that she operated within the bounds of the regulations set by the BSOM and the JSAT POM, however, it was noted that a single deviation was recorded on the ALFA on 3 Aug 2021. The panel could not find any evidence to link the exit altitude recorded for this descent directly against other available data sources and was, therefore, unable to determine whether the entry was valid. As this entry was inconsistent with the overall trend of Sgt Fisk's descent record, the panel considered it inconclusive. When judging this occurrence against the full range of data downloaded from Sgt Fisk's ALFA it was considered that there was little evidence to warrant further investigation and it was, therefore, determined to be **not a factor**.

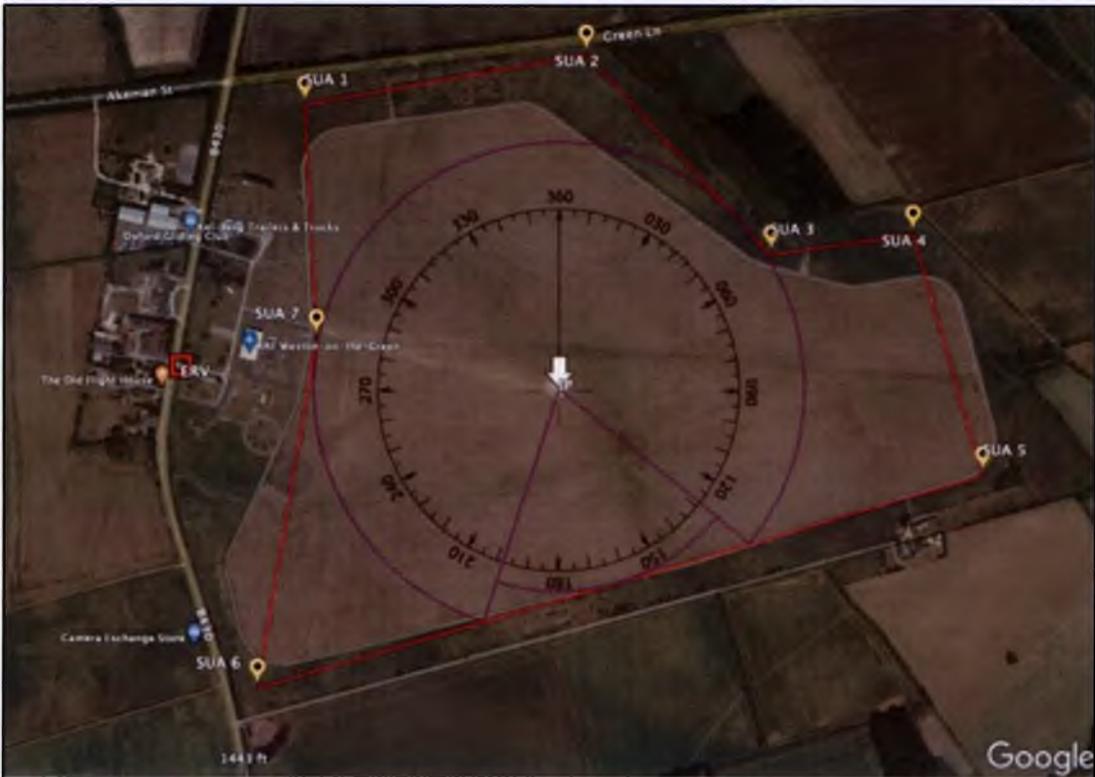
Figure 1.4.45 – RAF WOTG DZ safe useable area (within the red boundary).

1.4.236. The panel recognised that No. 22 Gp had carried out significant work to align RAF WOTG with the requirements of a Defence Aerodrome for both JSAT and FE@R activity. The panel concluded that WOTG DZ met all the requirements to conduct parachuting activity in support of Defence parachuting, including AT and FD, and was deemed **not a factor**.

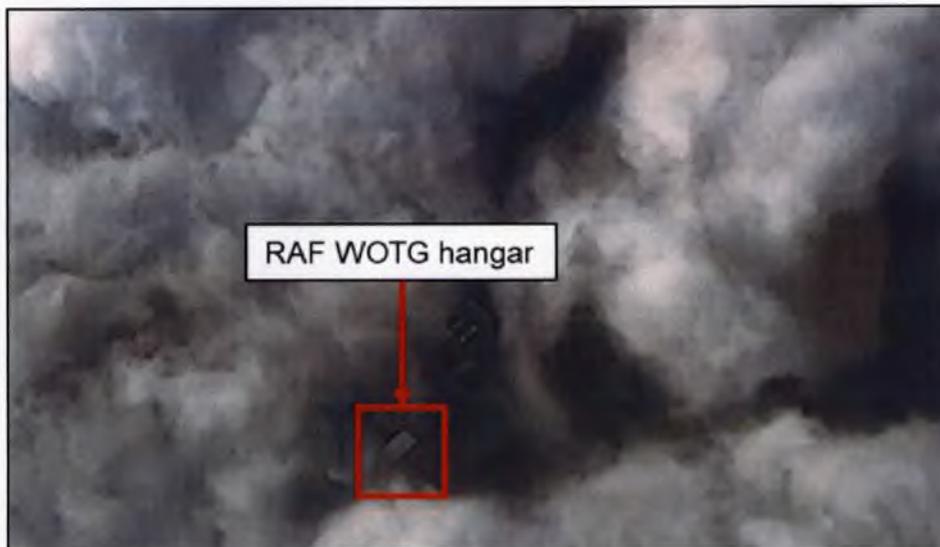
1.4.256. PJI1, acting as JM for sortie four provided evidence that at the point of exit a layer of cloud between the ground and aircraft was visible but had significant gaps allowing identification of the WOTG main hangar (Figure 1.4.48).

Figure 1.4.48 – RAF WOTG hangar seen on sortie four.

1.4.257. Data showed that Sgt Fisk passed through the cloud layer between approximately 3,500ft and 3,000ft agl, in what appeared to be a gap, as seen from the aircraft.

1.4.259. The panel determined that the forecast was consistent with the meteorological conditions on the day, including cloud and wind limitations laid down in the BSOM and, therefore, concluded that the weather was **not a factor**.

1.4.260. **Recommendation.** Deputy Commander Operations should convene a working group across Defence sports parachute associations, display teams and AT providers to define the meteorological limitations to be used for Joint Service Adventurous Training parachuting activity.

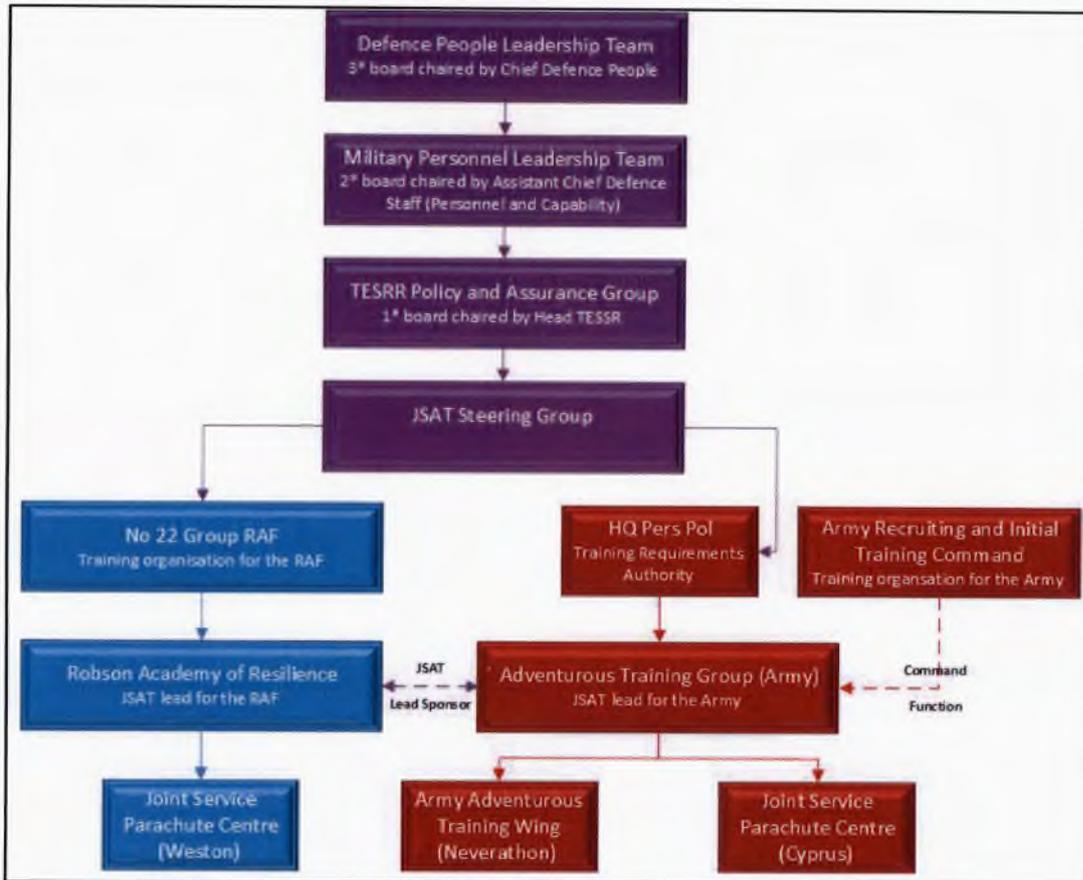
Figure 1.4.50 – Organisational structure for JSAT parachuting.

1.4.275. **JSAT parachuting sS sponsor.** Although the RAF were nominated as the sS sponsor for JSAT parachuting, JSP 419 was unclear as to the boundary of responsibility delegated to the role. Defence policy usually defines key language in the glossary or as an annex in the form of a terms of reference (TOR). However, the panel was unable to clearly determine the authority of the sponsor other than through inference within the regulations. The panel identified that whilst sS sponsors for AT were designated within JSP 419, the lack of clear guidance as to the duties and responsibilities for sS sponsors was unhelpful in identifying the sponsor’s authority to direct activity.

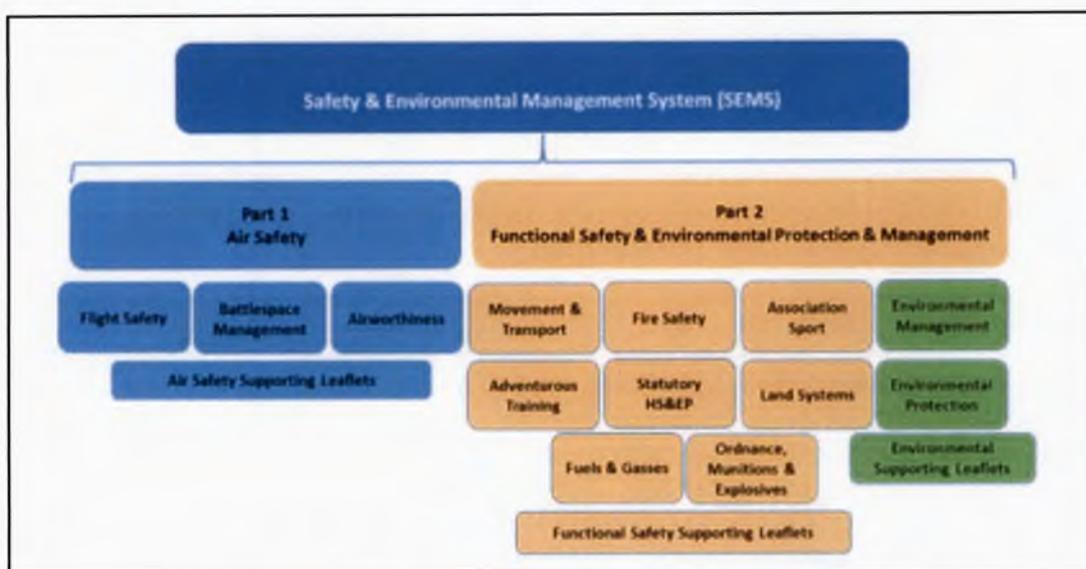
Figure 1.4.51 – Air safety vs functional safety.

1.4.306. The panel assessed the management of JSAT parachuting within the various levels of RAF safety publications to be contradictory. AP8000 and the No. 22 Gp Functional Safety Management Plan (FSMP) directed that all AT should be managed under functional safety, with no perception of additional safety or other factors that would require further mitigations. However, the JSAT air activities Air Safety Management Plan (ASMP) produced by No. 22 Gp, required the activity to be managed under elements of the air safety construct, due to the organisation identifying this as the safer way of managing JSAT parachuting safety.

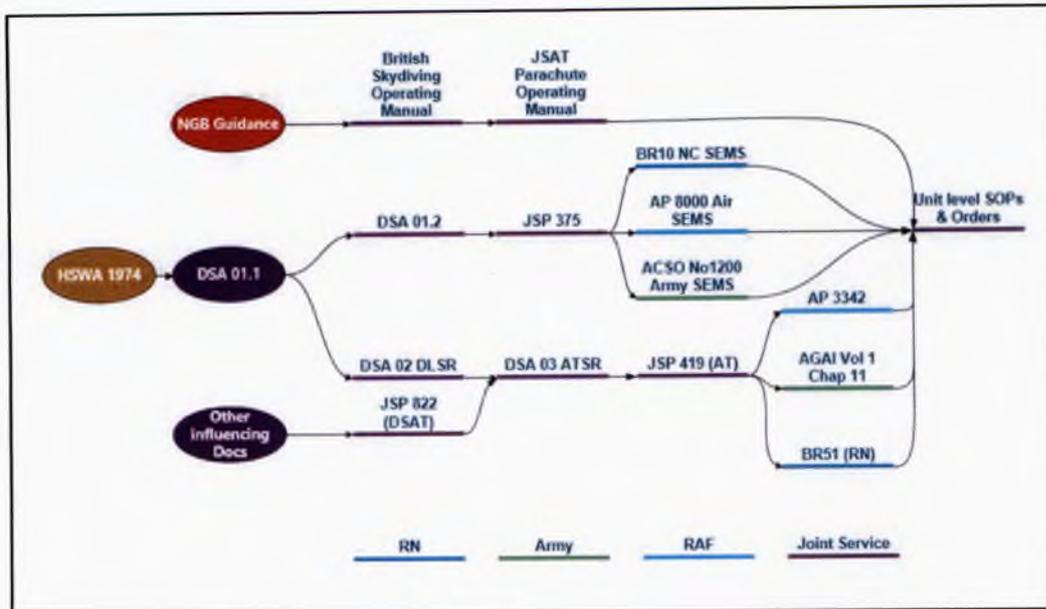
1.4.318. Figure 1.4.52 shows the documentation required to be applied to JSAT parachuting activity. This does not include any additional advice notes, memoranda, or other parenting documents. It was the panel's opinion that it was extremely difficult to digest and analyse the detail, which, when combined with subtle differences between TLB terminology and intent, added to an already confusing picture. Many subordinate documents unnecessarily duplicated information, which increased the time taken to understand whether any changes had been made to higher orders, and which also had the potential to provide out-of-date information due to misaligned review periods. In addition, some subordinate documentation used a confusing mix of terminology, predominantly caused by a lack of direction in parent documents as to which terms should be utilised and how they should be interpreted.

Figure 1.4.52 – JSAT parachuting policy documents.

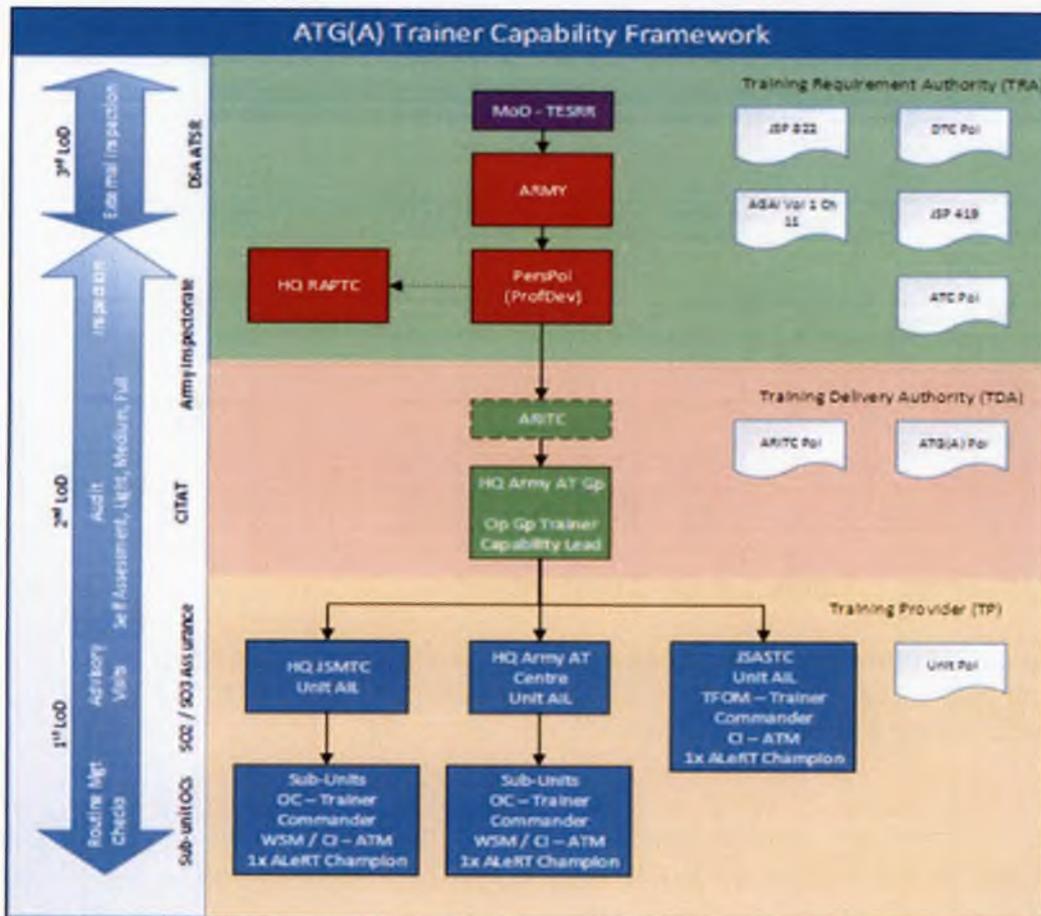
1.4.364. Within this training governance structure Comdt RAR was directly involved in the decision making of all three of these positions. As the RAF OF5 representative on the JSAT Steering Group (TRA), the Comdt RAR was also the TDA for RAF JSAT parachuting, and sat as the senior officer within the training providing unit.¹⁸⁵ This made the Comdt RAR responsible for all four elements involved in this training system (Figure 1.4.53). In comparison, Figure 1.4.54 shows the Army's AT governance structure which demonstrated suitable separation between each of the authorities and the training provider.

Figure 1.4.54 – ATG(A) Trainer Capability Framework.
