Rail Accident Investigation Branch

# Rail Accident Report

**Train overspeeding at Spital Junction,  
Peterborough  
17 April 2022**

Report 06/2023  
July 2023

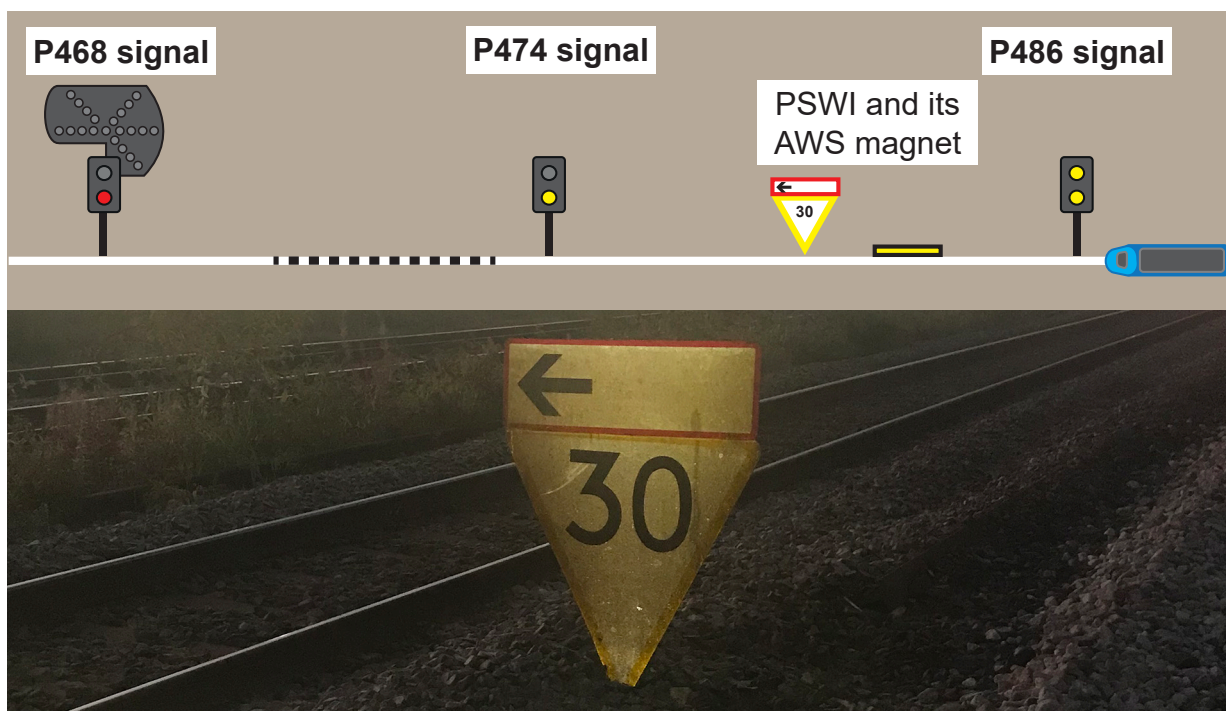
Figure 10: The location of the PSWI in relation to the other signalling equipment and an image of it (courtesy of Network Rail).

- 41 Train drivers on Network Rail infrastructure are provided with lineside signs to provide a point of reference where a permissible speed changes. Drivers are warned of a large speed reduction by a permissible speed warning indicator (PSWI). Trains approaching Spital Junction on the Up Fast line pass a PSWI which warns drivers about the reduction in speed for the 30 mph (48 km/h) divergence for the routes towards platforms 1 and 2. Figure 10 shows the PSWI and its location in relation to the other signalling equipment. The sign shows the 30 mph (48 km/h) permissible speed for the divergence and a directional arrow to indicate that it applies to the tracks to the left of the Up Fast line, that is, to the lines which lead to platforms 1 and 2.

- 42 The PSWI is placed at the required deceleration distance of 2058 metres from the point of divergence, which is the distance needed for a train travelling at the permissible speed of 125 mph (201 km/h) to slow to 30 mph (48 km/h) for the divergence. This distance placed the PSWI between P486 and P474 signals. This PSWI, which is located between signals, is provided with its own automatic warning system (AWS) magnet situated about 180 metres on the approach to the PSWI sign. When a train passes over the magnet, it causes an audible warning in the cab which the driver must acknowledge within a specified time, or an emergency brake application will occur. The aim of this AWS warning is to alert the driver to the PSWI, which in turn aims to remind the driver about the slower speed divergence that is ahead.

107 On the approach to Peterborough station, the driver had received a warning at P486 signal, another for the PSWI, and another at P474 signal. Using the same warning type for different types of hazards exacerbates the problem of routine acknowledgment, as this places more demands on drivers to differentiate between the warnings. Additionally, the warning for the PSWI was between those for two of the cautionary signal aspects. This sequence, and the driver's previous experiences, may have led to them not associating the specific PSWI warning with a diverging route being set ahead of the train.

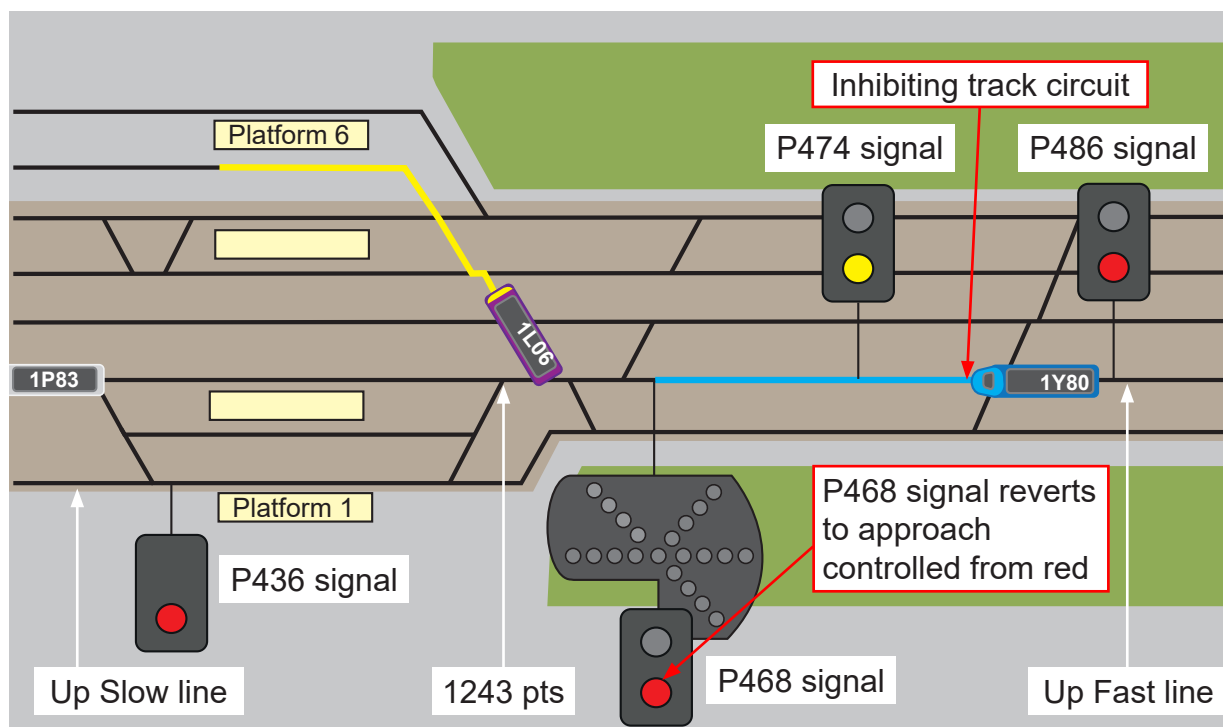
Figure 13: The position of trains 1P83, 1L06, and 1Y80 at 10:17:02 hrs.

- 69 At 10:17:02 hrs, with train 1L06 still occupying the Up Fast line, train 1Y80 was travelling at around 32 mph (51 km/h) and slowing down as it approached and passed P486 signal displaying a single yellow aspect. Train 1Y80 then occupied track circuit T7726 which inhibited P474 signal from showing a single flashing yellow aspect (paragraph 40). At this time, P474 signal was not visible to the driver of train 1Y80. Because of the proximity of train 1Y80 to P468 signal, it was prevented from using flashing yellow control, and was approach released from a red aspect (figure 13).

100 However, displaying flashing yellow aspects is conditional upon the location of the train approaching the signals and the status of the route set beyond the signal (paragraph 40). Because of the proximity of train 1Y80 to P468 signal, and because the route beyond P468 signal had not at that time been set, the signal was approach released from red. In this state, flashing aspects on P486 and P474 signals were inhibited. This means that no flashing aspects were shown to the driver of train 1Y80.

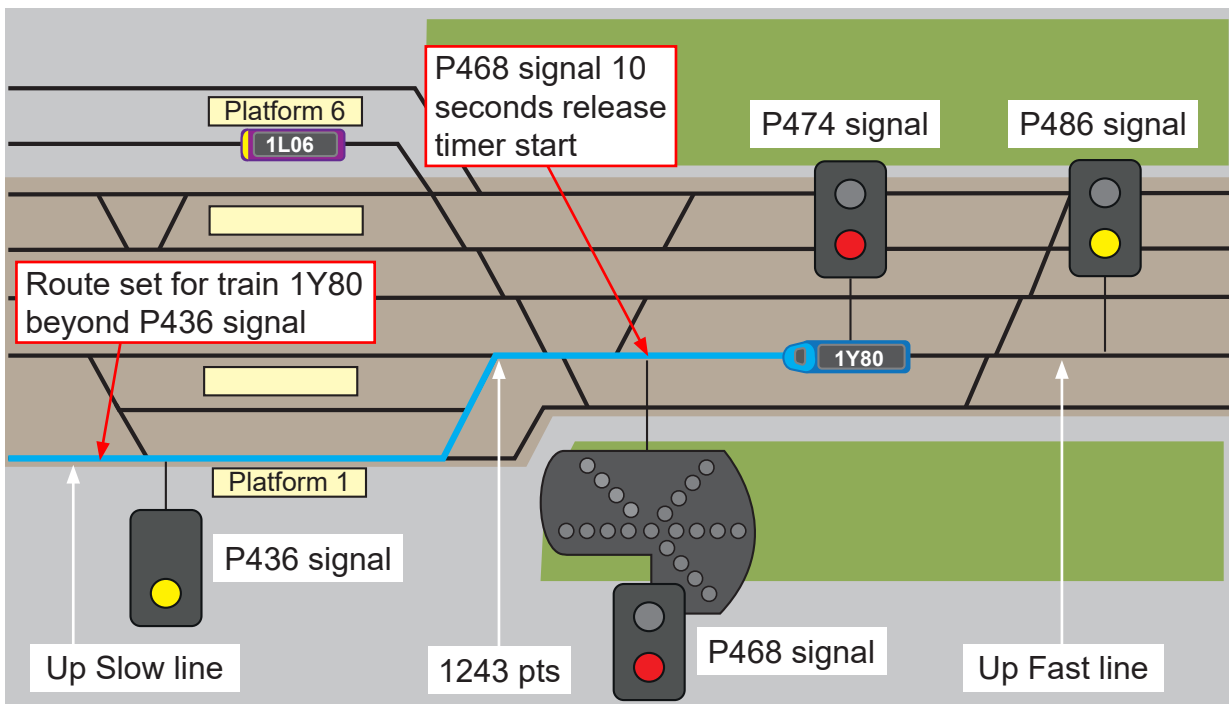
Figure 15: The position of trains 1L06 and 1Y80 at 10:18:58 hrs with 1Y80 having just passed P474 signal.

73 At 10:18:58 hrs, train 1Y80 reached track circuit T7724, having just passed P474 signal previously displaying a single yellow aspect. This started the 10-second timer which, once expired, would allow the release of P468 signal (figure 15). By this time P468 signal, which was showing a red aspect, was visible to the driver of train 1Y80.

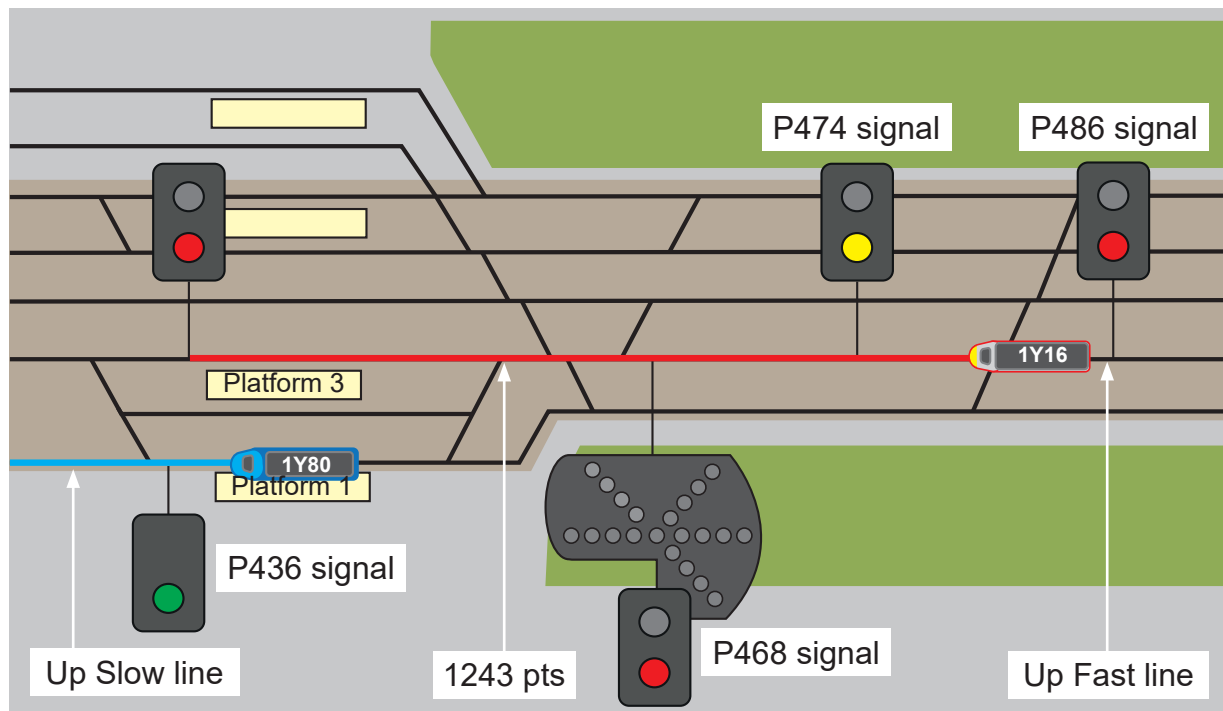
Figure 19: The position of trains 1Y80 and 1Y16 at 10:20:40 hrs.

- 77 At 10:20:40 hrs, the train stopped just before reaching P436 signal at the south end of platform 1 (figure 19). The late running train 1Y16 arrived at platform 3 around 2 minutes later.

- 78 Once train 1Y80 had stopped, the driver called the signaller to report that they had passed through the junction at excessive speed and requested that P436 signal ahead of the train was replaced to show a stop aspect. The driver requested some time to compose themselves as they were shaken by the event. The driver did not realise at this stage that they had not seen the junction indicator on P468 signal and was confused about what had happened.

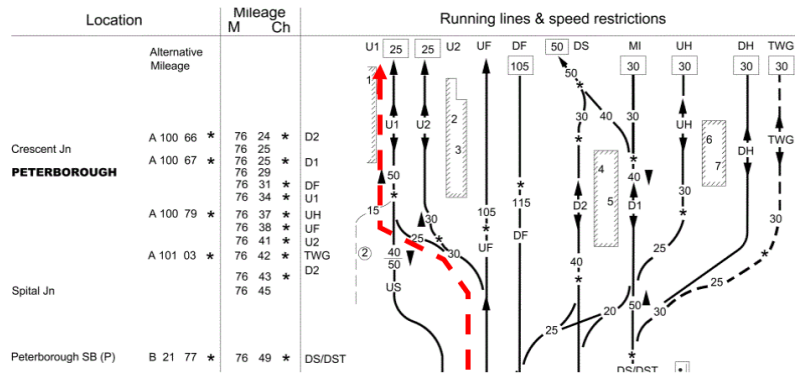
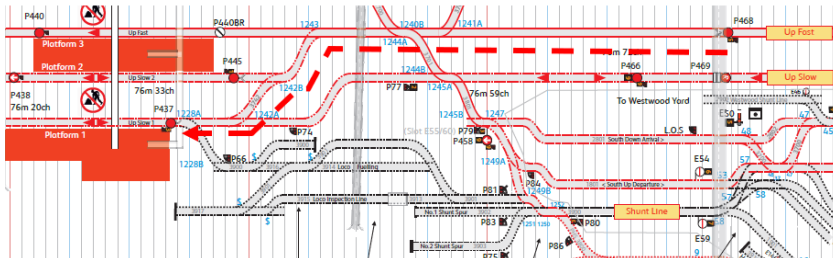
## P468 to Peterborough Platform 1

On 4<sup>th</sup> May 2023 an incident occurred in which a train travelled over the route from the Up Fast East Coast Main Line P468 signal to Peterborough platform 1 at approximately 60mph. The permitted speed for this route is 25mph.

A similar incident occurred on 17/04/22 in which a train passed over the route at approximately 75 mph. This incident is currently being investigated by the Rail Accident Investigation Board.

Please ensure the Permanent Speed Restriction at these points is included in your Route Risk Assessments and is covered in driver training material and assessments.
