Rail Accident Investigation Branch

Rail Accident Report

Embankment washout under a passenger train at Haddiscoe 30 January 2022

Report 07/2023
July 2023

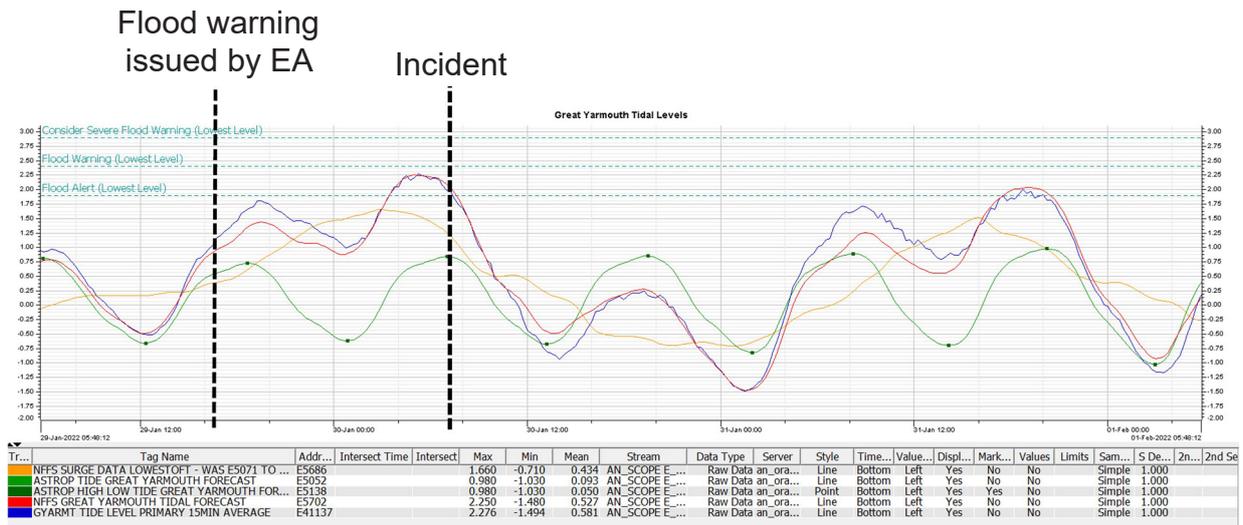
Figure 9: The tide levels at Great Yarmouth.

52 The astronomical high tide prediction for Great Yarmouth on the afternoon of 29 January 2022, the day before the washout at Haddiscoe, was 0.75 m AOD. However, the surge effect meant that the actual level was more than a metre higher than this, at 1.8 m AOD. Surge effects continued so the following low tide, at around 00.50 hrs on 30 January 2022, was about 1.6 m higher than the astronomical prediction. It was also higher than the astronomical prediction for the preceding and following high tides. The next high water occurred at about 07:15 hrs on the morning of the incident, when the water levels reached 2.25 m AOD, around 1.4 m above the astronomical prediction (see figure 9).

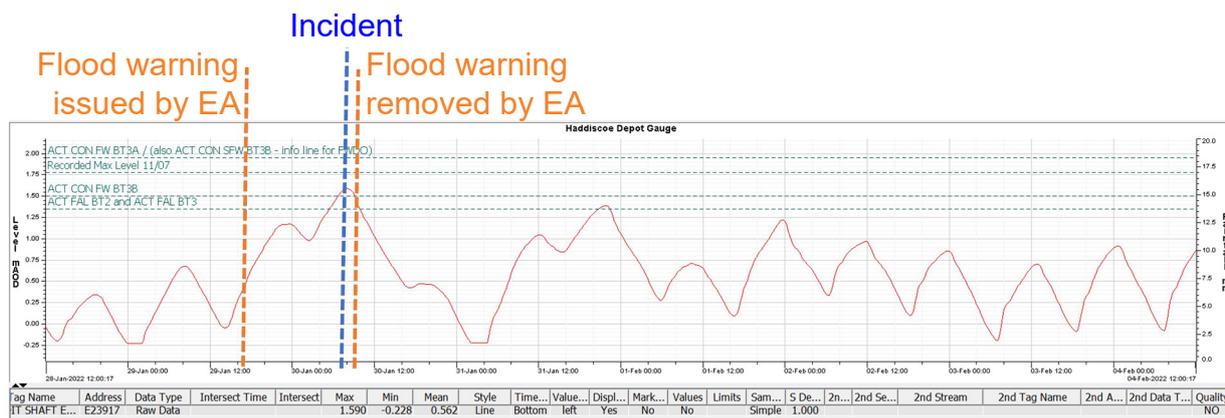
Figure 10: The levels recorded by the gauge at the measuring station at Haddiscoe.

- 54 The time taken for tidal effects to travel upriver from the coast, and the presence of water in the Broads, meant that the maximum water level at Haddiscoe was both higher, and later, than at Great Yarmouth. Water levels at the incident site would have been very similar to those at the EA river monitoring gauge at EA’s Haddiscoe depot, about 700 m from the washout. On the morning of 30 January 2022, this recorded a water level of about 1.58 m AOD as the train approached the washout at 07:45 hrs, and a maximum level of about 1.59 m AOD at around 08:00 hrs (figure 10).
