THE NIMROD REVIEW

An independent review into the broader issues
surrounding the loss of the RAF Nimrod MR2
Aircraft XV230 in Afghanistan in 2006

Charles Haddon-Cave QC

REPORT

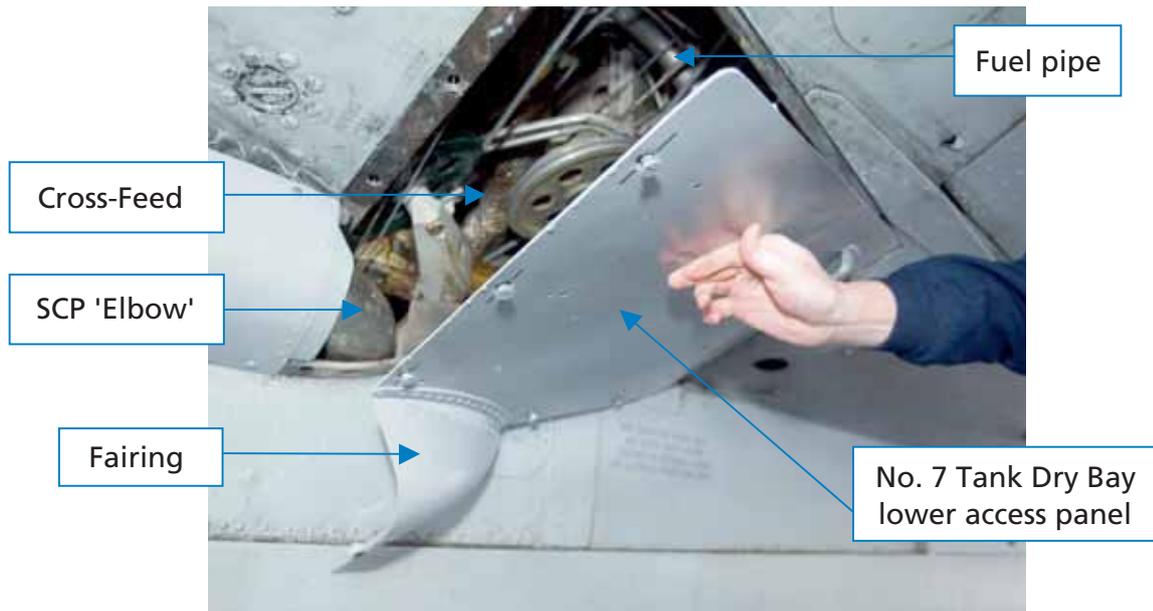
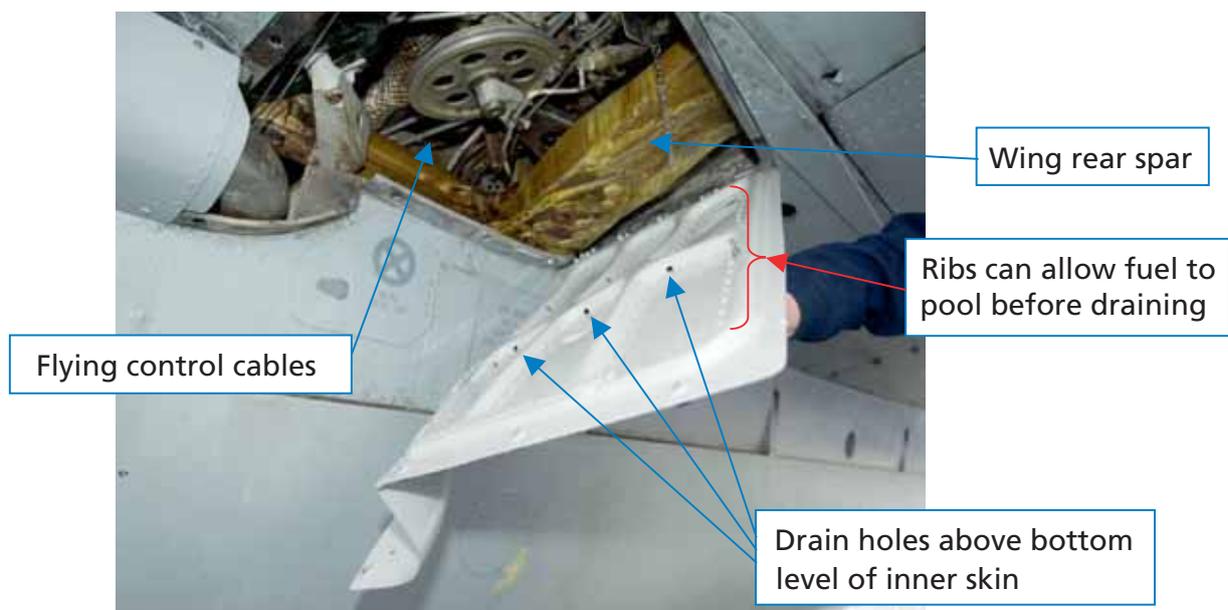
4.15 The starboard No. 7 Tank Dry Bay on all MR1s was modified, on conversion to MR2, to house the SCP bleed-air duct. The SCP duct was routed from the five-way junction on the Cross-Feed duct into and through the bottom of No. 7 Tank Dry Bay and then to an elbow joint outside the existing line of the fuselage. For this purpose, a special fuselage fairing was fashioned, the forward element of which was attached to the internally-ribbed horizontal panel, which formed the lower access panel to the No. 7 Tank Dry Bay (see Figures 4.4 and 4.5).

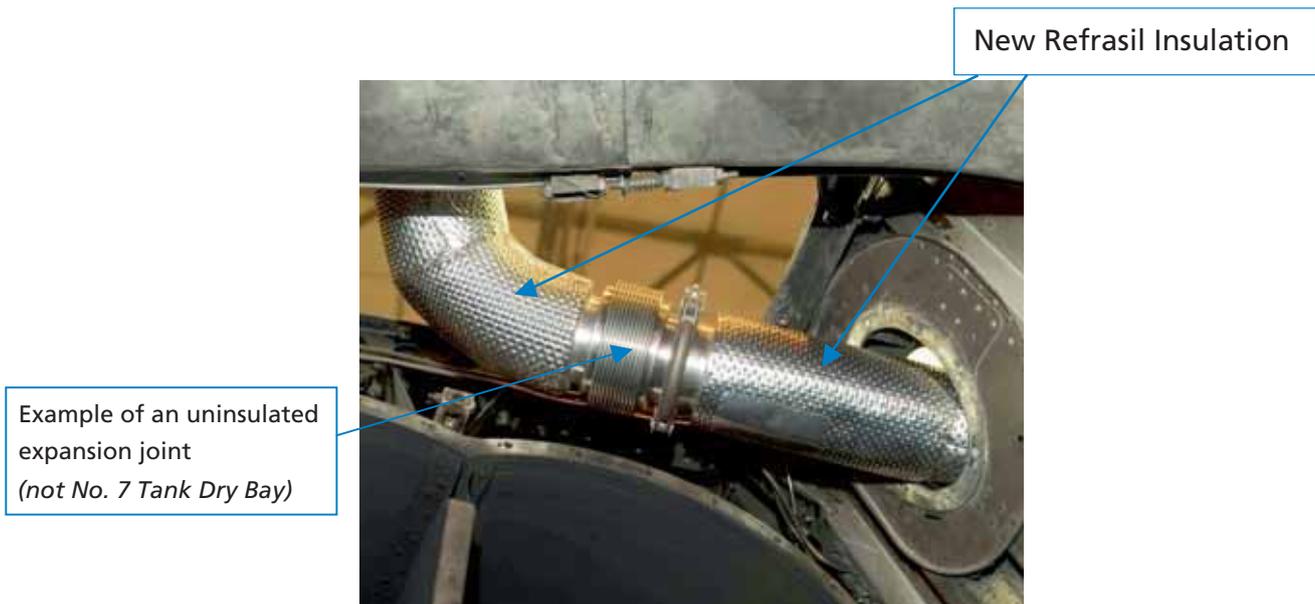
Figure 4.6: Newly Installed Section of Cross Feed Duct

- 4.22 When brand new Refrasil should be as shown in Figure 4.6.

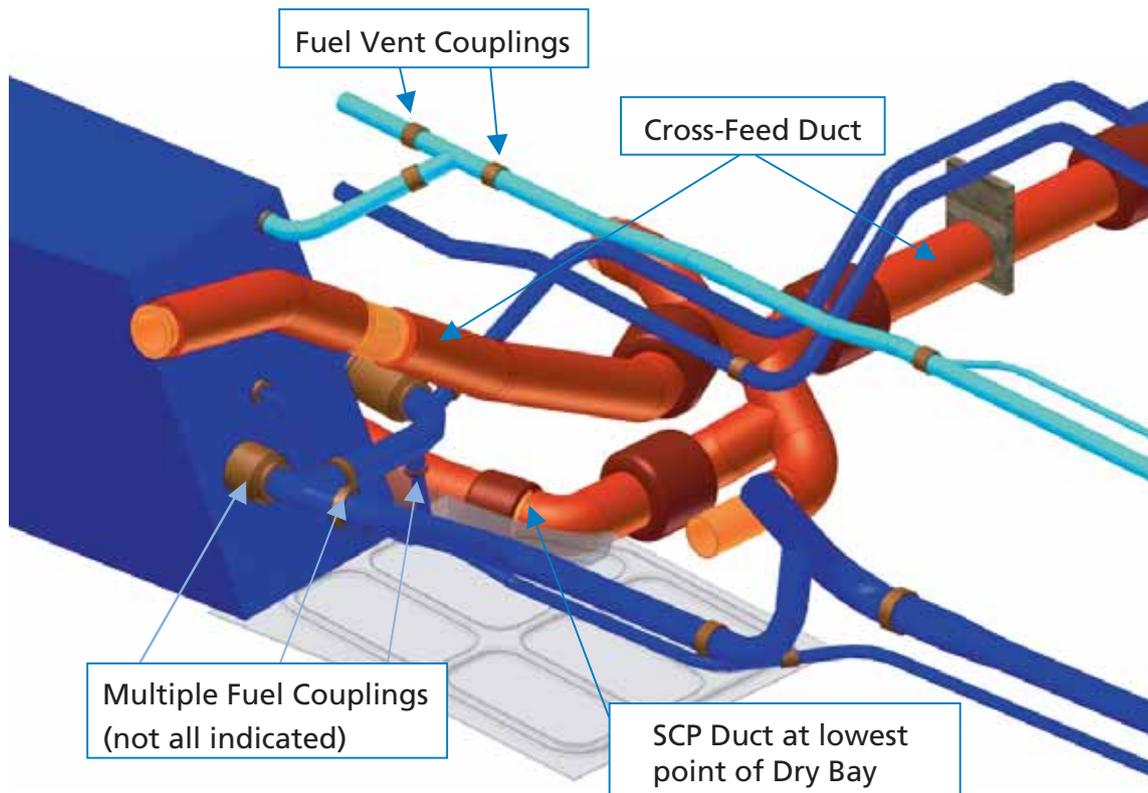
Figure 4.11: No. 7 Tank Dry Bay

- 4.45 The Cross-Feed/SCP duct posed a serious fire risk on the Nimrod MR2 for four reasons: (1) location; (2) design of the No. 7 Tank Dry Bay; (3) inadequate insulation; and (4) lack of fire protection (see Figures 4.11-4.13 below).

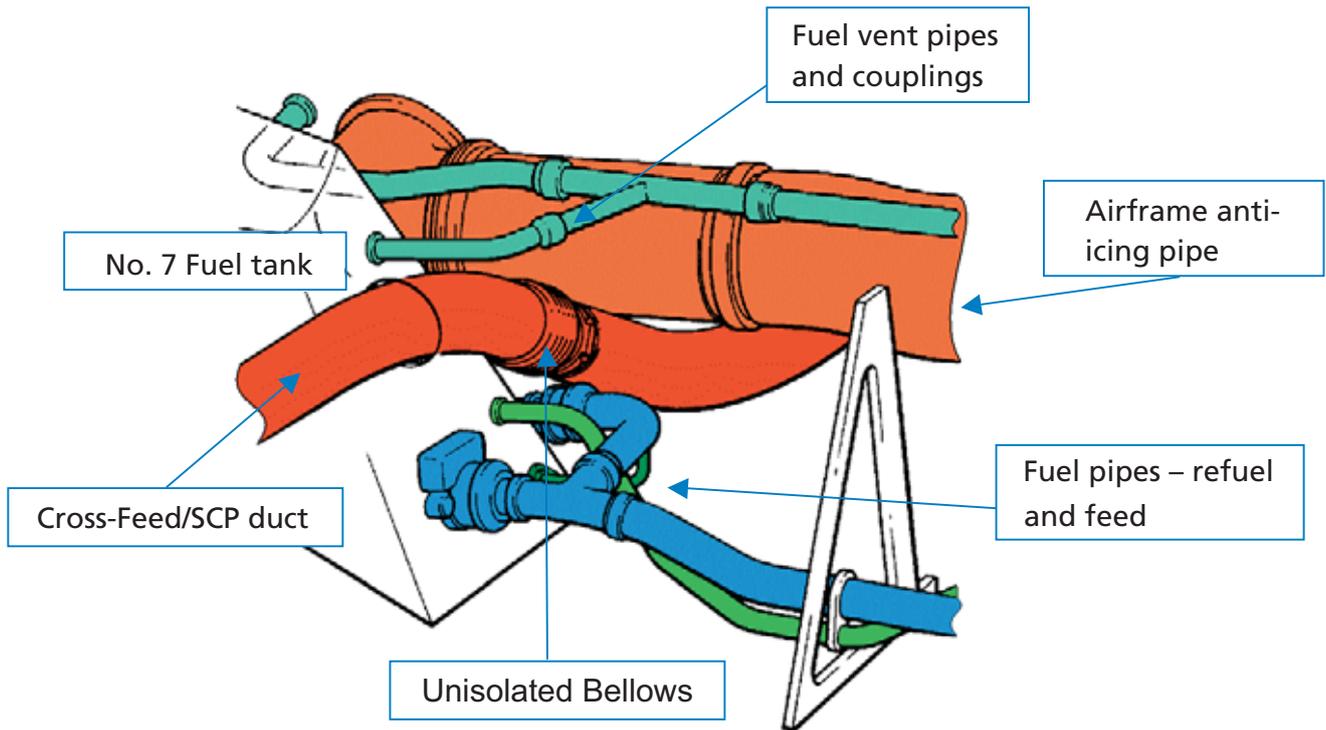
Figure 4.12: No. 7 Tank Dry Bay (Main Components)

- the design of the lower fairing panel was such that it could act as a receptacle for leaking fuel to pool close to the SCP duct elbow. The drain holes are located such that about 300ml of fuel could collect between the ribs of the panel before spilling over to reach the drain holes;⁶² and
- the design of the fairing (covering the SCP duct as it left the No. 7 Tank Dry Bay) was such that any fuel or liquid tracking along the side of the fuselage hull could enter the SCP fairing and, potentially, the bottom of starboard No. 7 Tank Dry Bay.

⁶² Following a BOI recommendation, drainage is now improved.

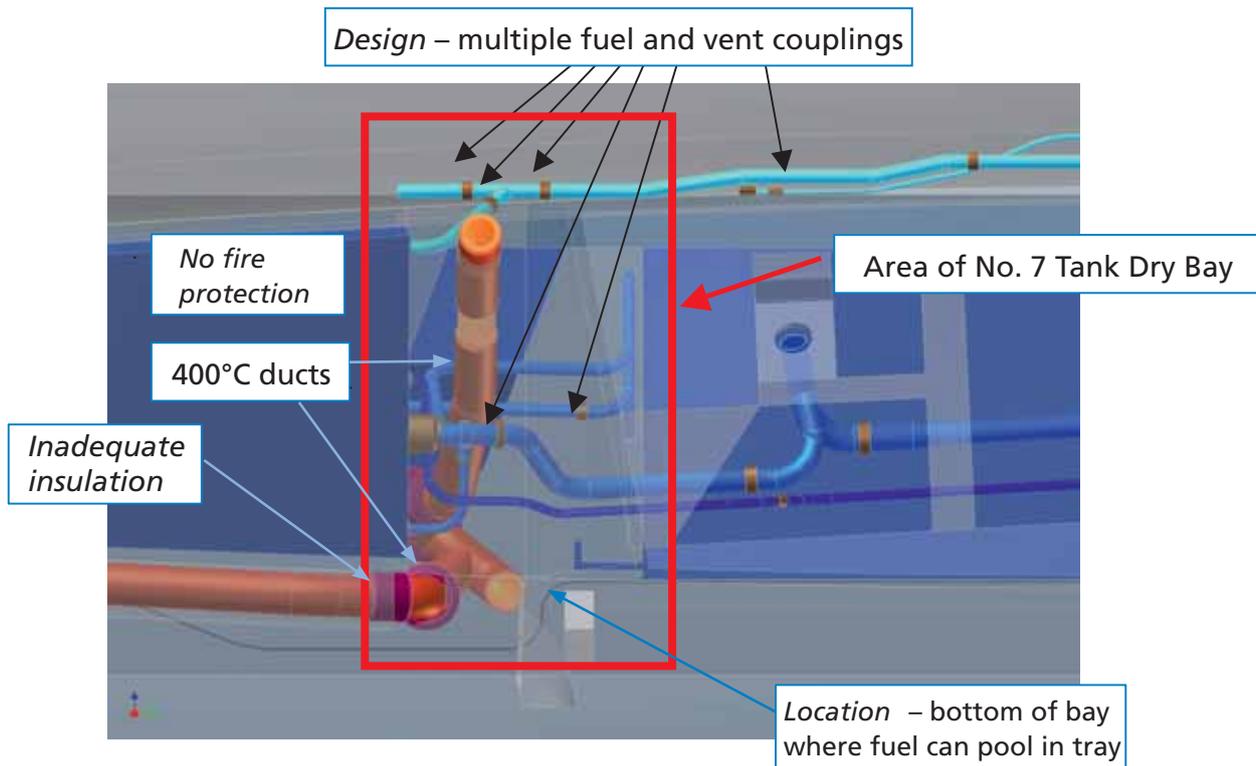
Figure 4.13: No. 7 Tank Dry Bay (Design Features)

- there was no fire detection and suppression system protecting the Cross-Feed/SCP duct;⁶³ and
- there was no fire-wall around it.

⁶³ It would be unlikely that an attempt to introduce a fire detection and suppressant system to an area such as this would be made. It is more likely that the hazard would be removed – as it now has been.

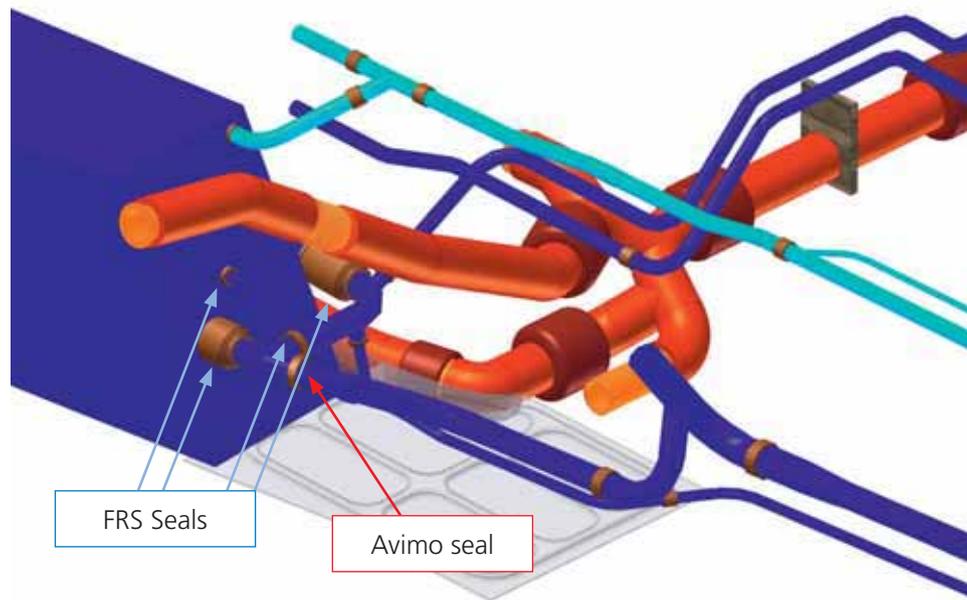
Figure 5.8: Fuel Seals in the No. 7 Tank Dry Bay (NB: not all couplings are visible in this diagram)

- 5.9 There are eight FRS couplings and one Avimo Original coupling in the starboard No. 7 Tank Dry Bay. They are all located higher than the Cross-Feed/Supplementary Cooling Pack (SCP), ducts.

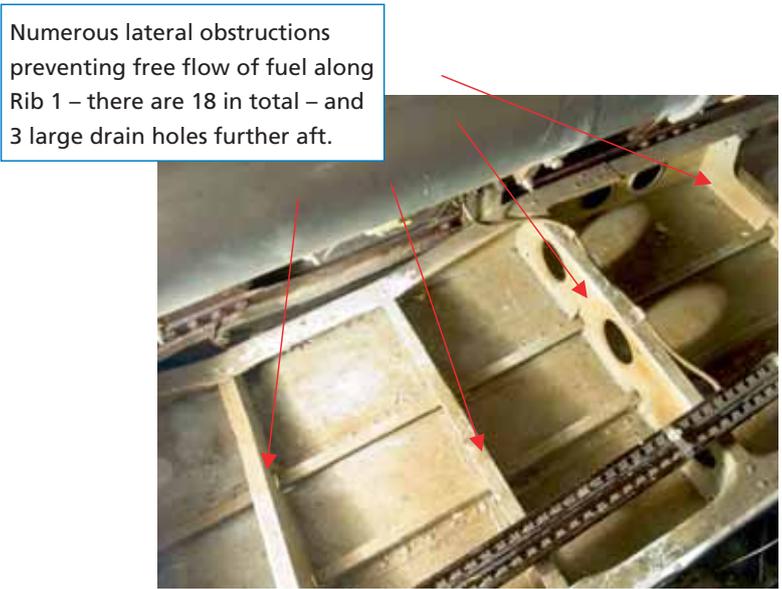
Figure 5.14: Obstructions on the Rib 1 Landing

- 5.155 The pipes for the fuel feed system to engines Nos. 3 and 4 are located at the leading edge of the starboard wing. For fuel to reach the No. 7 Tank Dry Bay from this point, it would have to have: (a) tracked back some 17 feet; (b) crossed at least 18 lateral members; (c) passed through an almost solid dividing wall; and (d) avoided air vent holes in Rib 1, which would also act as fluid drains, before reaching the point of ignition (see Figure 5.14). Furthermore, the fuel pipe at the wing leading edge has no couplings within the vicinity of the most likely route to the No. 7 tank dry bay; thus, any leak would have to originate from a leak within a pipe, which all the technical experts agree is a much less likely event. Whilst not impossible, this proposal was most improbable, as QinetiQ, the BOI and the AAIB found.

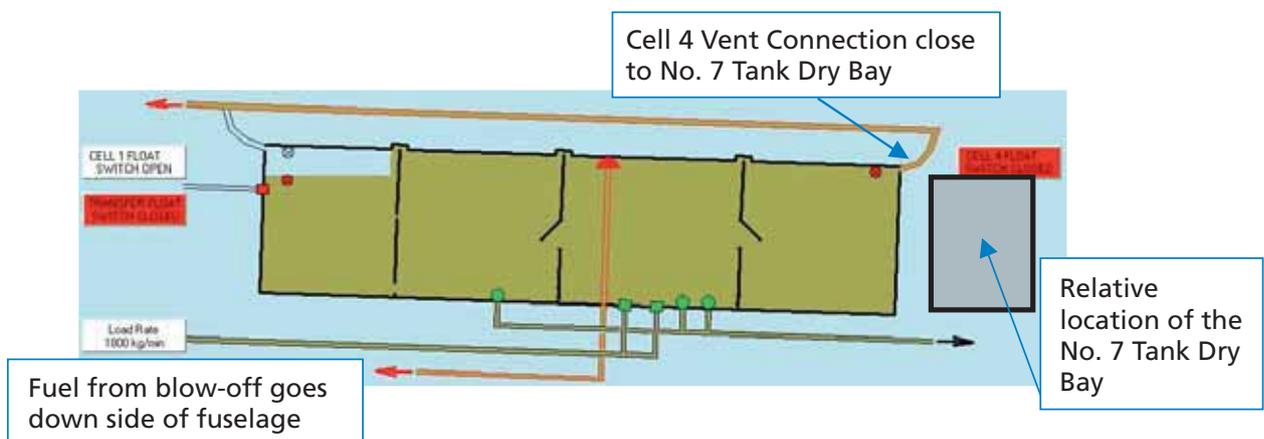
- 6.26 The BOI commissioned Hydraulic Analysis Limited (HAL), a firm experienced in analysis of pipeline system pressures for the oil industry, to construct a computer model of the No. 1 tank.¹⁴ This showed that because of the way in which the individual cells of the tank filled and the relatively high fuel flow rates during AAR,¹⁵ it was likely that, as its contents reached approximately 15,000lbs, the three rear cells would be full, but not the forward Cell 1. Most importantly, the float switch in Cell 1 would not have closed and so fuel would still enter Cell 3. This, in turn, would cause the pressure in Cell 3 to rise and activate the blow-off valve. At this point, fuel would also have entered the vent pipe. It should be noted that the connection to the vent pipe from Cell 4 to the main aircraft vent system is located above and close to the No. 7 Tank Dry Bay; the significance of this is discussed later.

Figure 6.3: Screen Shot of HAL Model

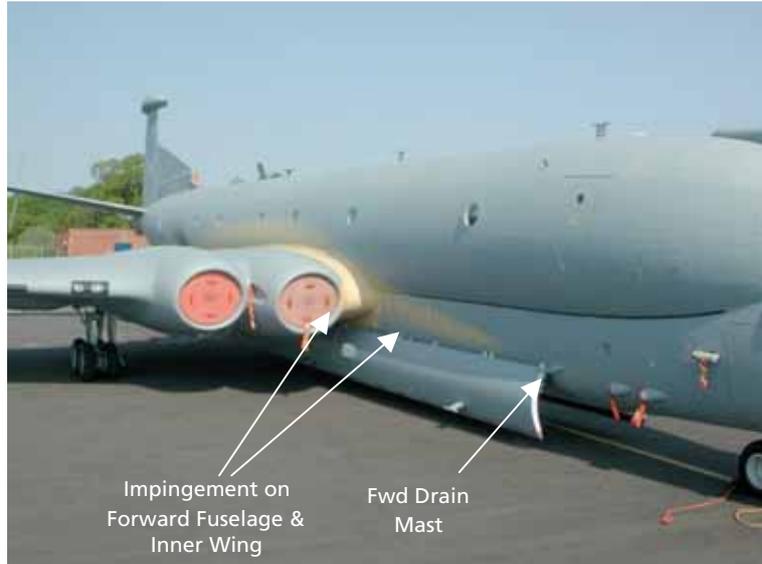
Figure 6.4: MRA4 Showing Dispersal of Dyed Fluid

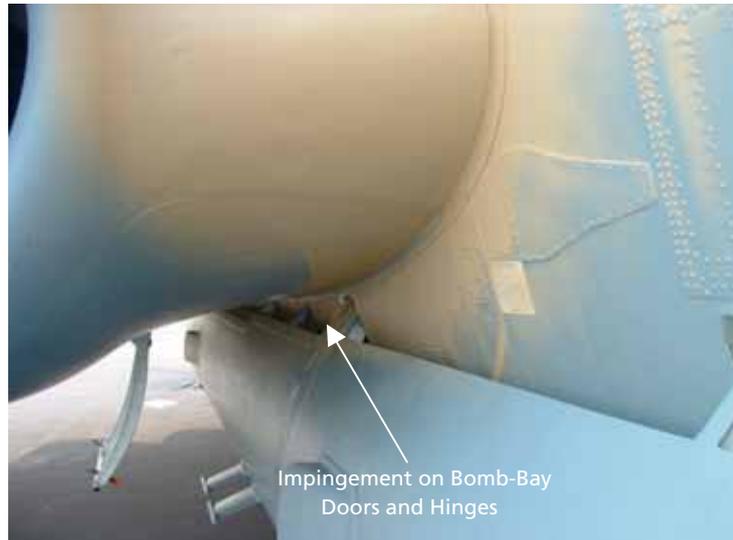
Figure 6.5: MRA4 Showing Dispersal of Dyed Fluid (close-up of wing root)

6.40 If one extrapolates the results of this trial to the No. 1 blow-off valve operating, it is very easy to envisage fuel tracking back only 2.1 metres into the fairing of the SCP elbow and potentially the No. 7 Tank Dry Bay. The prospect becomes even more likely given the fact that if the blow-off valve activated during AAR, the quantities of fuel expelled would be very considerable.

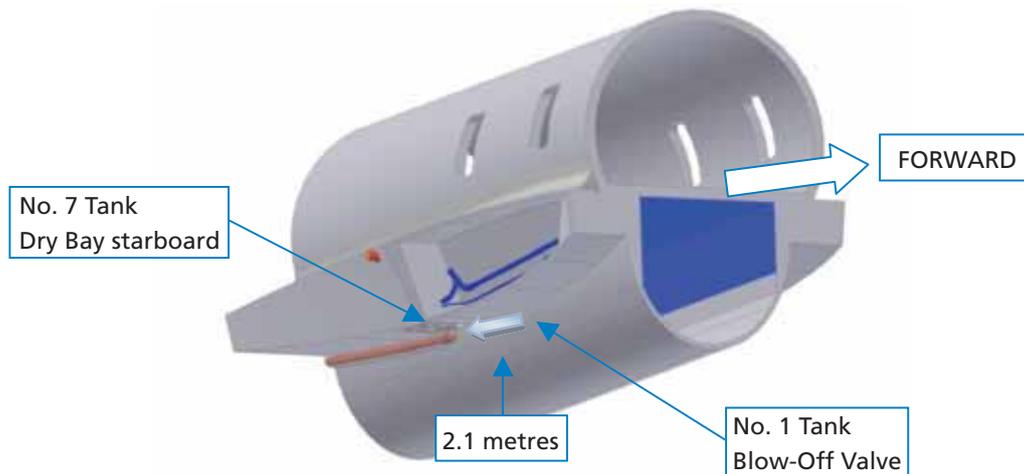
Figure 6.6: Relative Location of SCP External Duct and No. 1 Tank Blow-Off Valve

- 6.51 Is there a credible risk of such expelled fuel penetrating the SCP fairing and the starboard No. 7 Tank Dry Bay? The fairing that covers the SCP pipe attached to the Nimrod's starboard fuselage is 2.1 metres directly aft of the No. 1 tank blow-off valve. It is not sealed to the main fuselage in such a manner that liquid cannot penetrate it (see further below). From my inspection of various Nimrods, and as the BOI noted, there were clear gaps between the fuselage and fairing. It would require very little upwards migration of blown-off fuel for it to impact upon the SCP fairing. In my view, there is no reason to suppose that ejected fuel would not enter this fairing in the same manner that it has been observed to penetrate many other areas of the Nimrod's fuselage in previous incidents and the MRA4 experiments. Once inside the SCP fairing the fuel would have just centimetres to travel before reaching the SCP duct identified as the likely point of ignition.

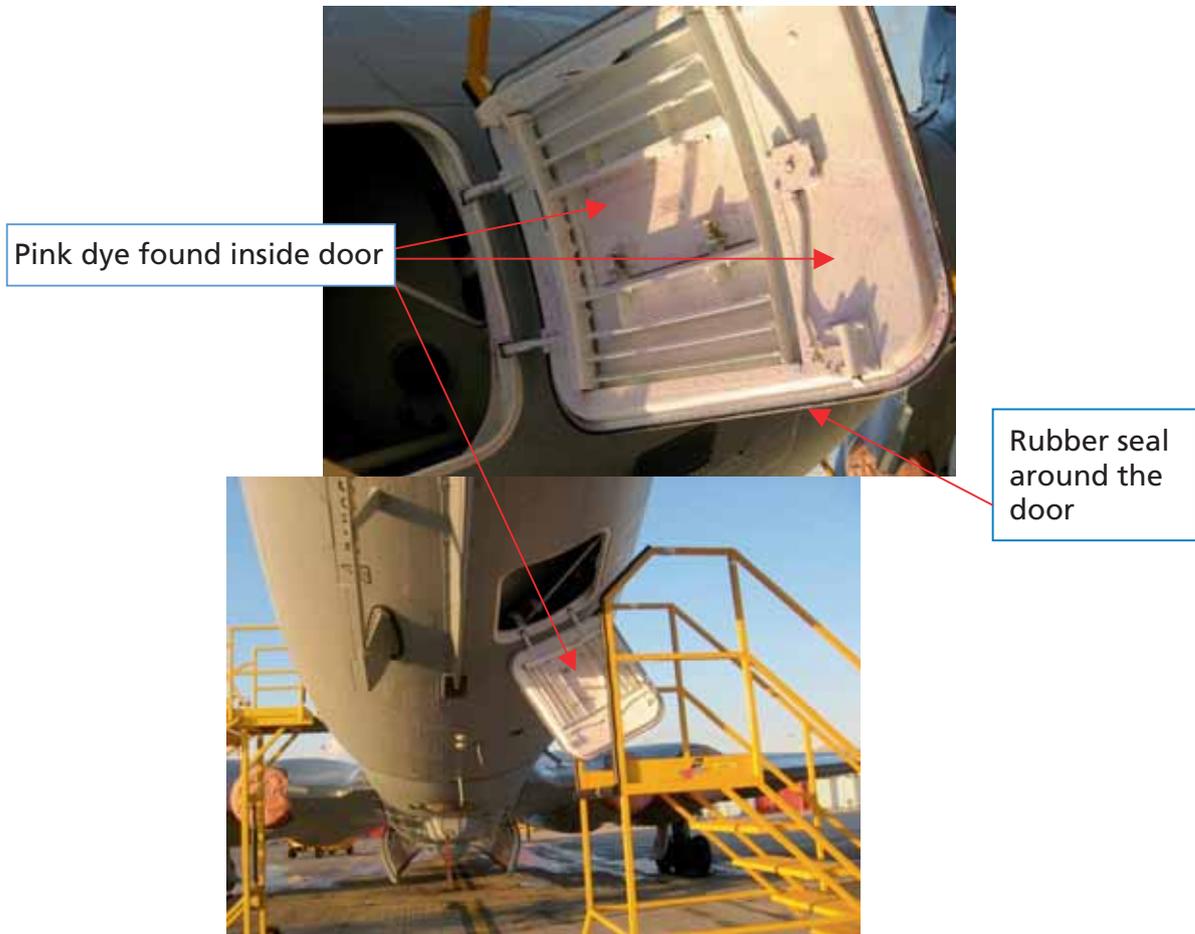
6.44 The dyed water trials from the APU bay and the forward drain of an MRA4 (discussed above) show the manner in which fuel tracking down the aircraft fuselage will enter compartments, despite the fact that the panels are flush with the aircraft fuselage and that, in the case of these trials, the aircraft is recently manufactured and built to modern tolerances. Even 30 minutes after landing, dyed fluid was found “*dripping from the tail-cone bay door*”; and when the door was opened it was noted that the fluid had “*coated an area in the bay within approximately one foot all around the door*” (see the pink dye in the photographs below).

Figure 6.7: MRA4 Dyed Fluid Inside Tail Cone Bay Door

6.45 The report notes that there was no evidence of fluid pooling in the bay. The amount of fluid released into the airflow, however, was very small, only 0.4 litres in total, and the distance it had to travel large, namely several metres from the MRA4 APU bay (in the rear of the wing) to the tail cone bay. By way of contrast, when blow-off occurs during AAR, the flow rate is very large. It has been calculated to be approximately 120 litres every 10 seconds.²⁶ Further, as illustrated above, blown-off fuel would only have to track 2.1 metres along the fuselage skin to reach the SCP fairing. It should be noted that, although the MRA4 is indeed a different aircraft to the MR2, its fuselage is the original MR2 shape.

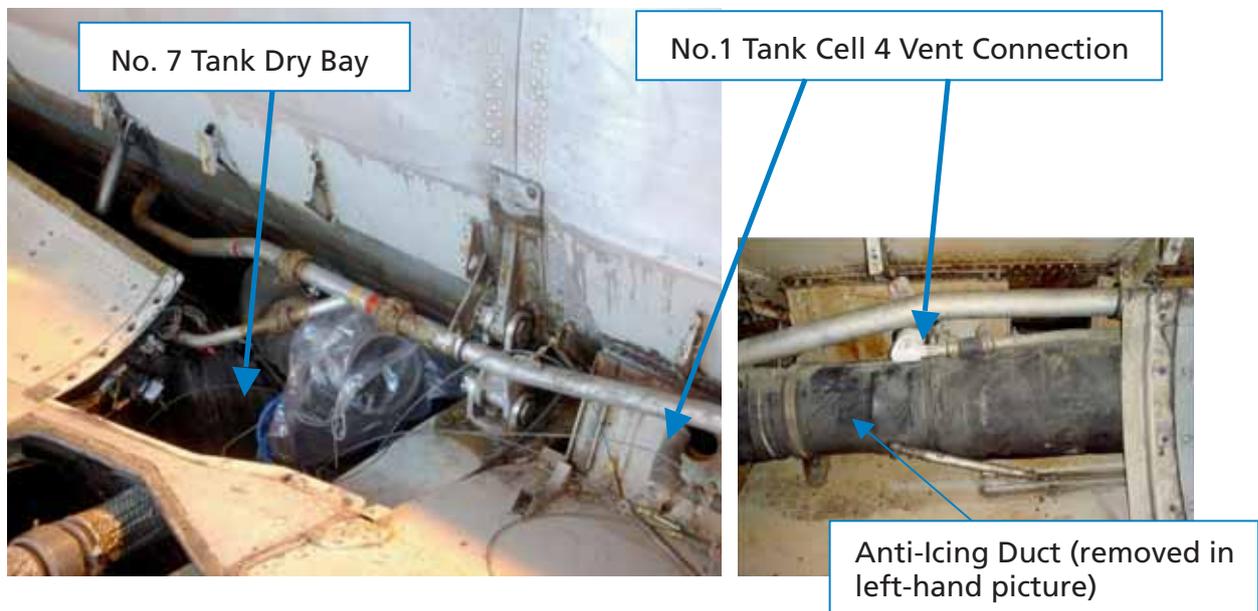
6.69 The Nimrod fuel system had a 'vent' system designed to avoid over-pressurisation of tanks during filling by allowing air to vent to the outside. The adjoining cells within No. 1 tank have vent connections between them. No. 1 tank is connected to the main aircraft vent system through vent pipes exiting Nos. 1 and 4 cells. The outlet pipe for the rear cell (Cell 4) is located above, and just forward of the rear spar, which itself is located in the No. 7 Tank Dry Bays.

Figure 6.8: No. 1 Tank Cell 4 Vent Connection

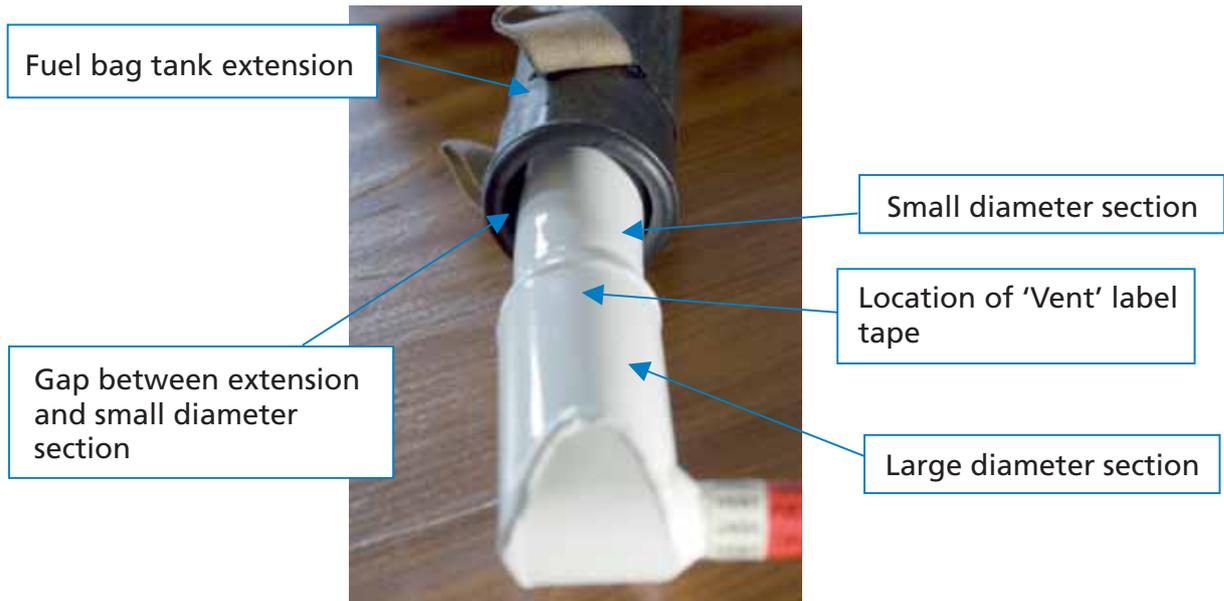
- 6.76 Subsequently, during the teardown conducted by QinetiQ on Nimrod XV236, a fault report was raised concerning the No. 1 Tank Vent Connections (see further **Chapter 15**).³⁶ In order to investigate the matter further, the connection was pressurised and leaked at 0.5psi gauge pressure; well below the blow-off valve setting of 2.7psi. The design features of the connection were described as follows: “The metal vent pipe was fabricated from two diameters of tube: a 1.25” diameter tube, which had both a raised bead to form a seal with a ‘push fit’ rubber pipe and a bonding tag attachment; and a second approximately 1.5” diameter tube. The rubber hose was found to interface with the larger metal pipe section of approximately 1.5” diameter, which had no sealing bead present. Thus the joint was reliant on a single Jubilee clip to both seal and clamp. Due to the lack of a witness mark on this larger pipe, there is a lack of control of the position of the hose clip, which could lead to the hose being clamped only over the welded portion of the pipe assembly or only over part of the surface, which could lead to complete detachment.”

Figure 6.9: No. 1 Tank Cell 4 Vent Connection

- 6.78 In order to assist the Review, a trial³⁷ was carried out at RAF Kinloss to investigate where fluid would track if released in the area of the No. 1 Tank rear vent connection (see Figure 6.8 and 6.9). Although unable to replicate the exact pitch attitude of XV230, the results showed that fluid would track back into the No. 7 Tank Dry Bay and some would pool on the lower panel. Larger quantities of fuel (several litres) were required in order to cause the fuel to disperse widely over the panel. In addition to the 'on aircraft' trial tracking the movement of the fluid, the connection was also subjected to a bench test under pressure. Leaks were not apparent up to 5psi on the test specimen with the jubilee clip on the wider part of the vent pipe. However, as noted above by QinetiQ, the jubilee clip had potential to slip rearwards over the narrower section if located over the weld. Given the difference in the two diameters this would result in a large leak, as can be seen from the photograph above.

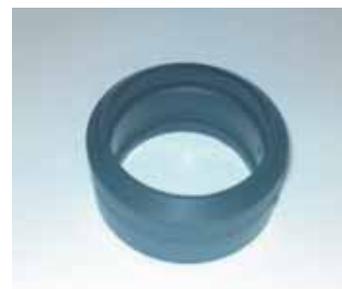
Figure 7.2: Normal Fuel Seal

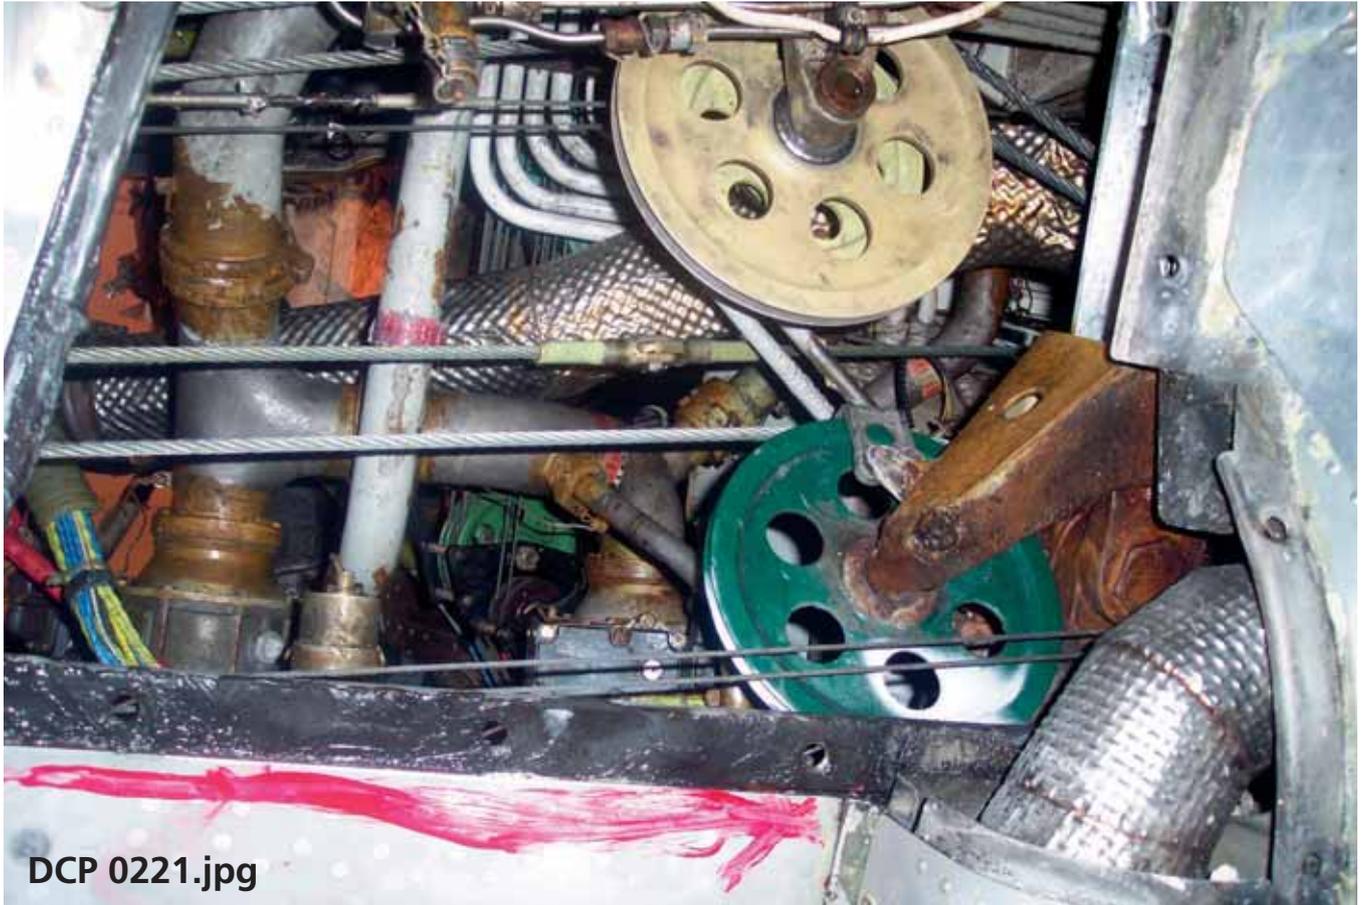
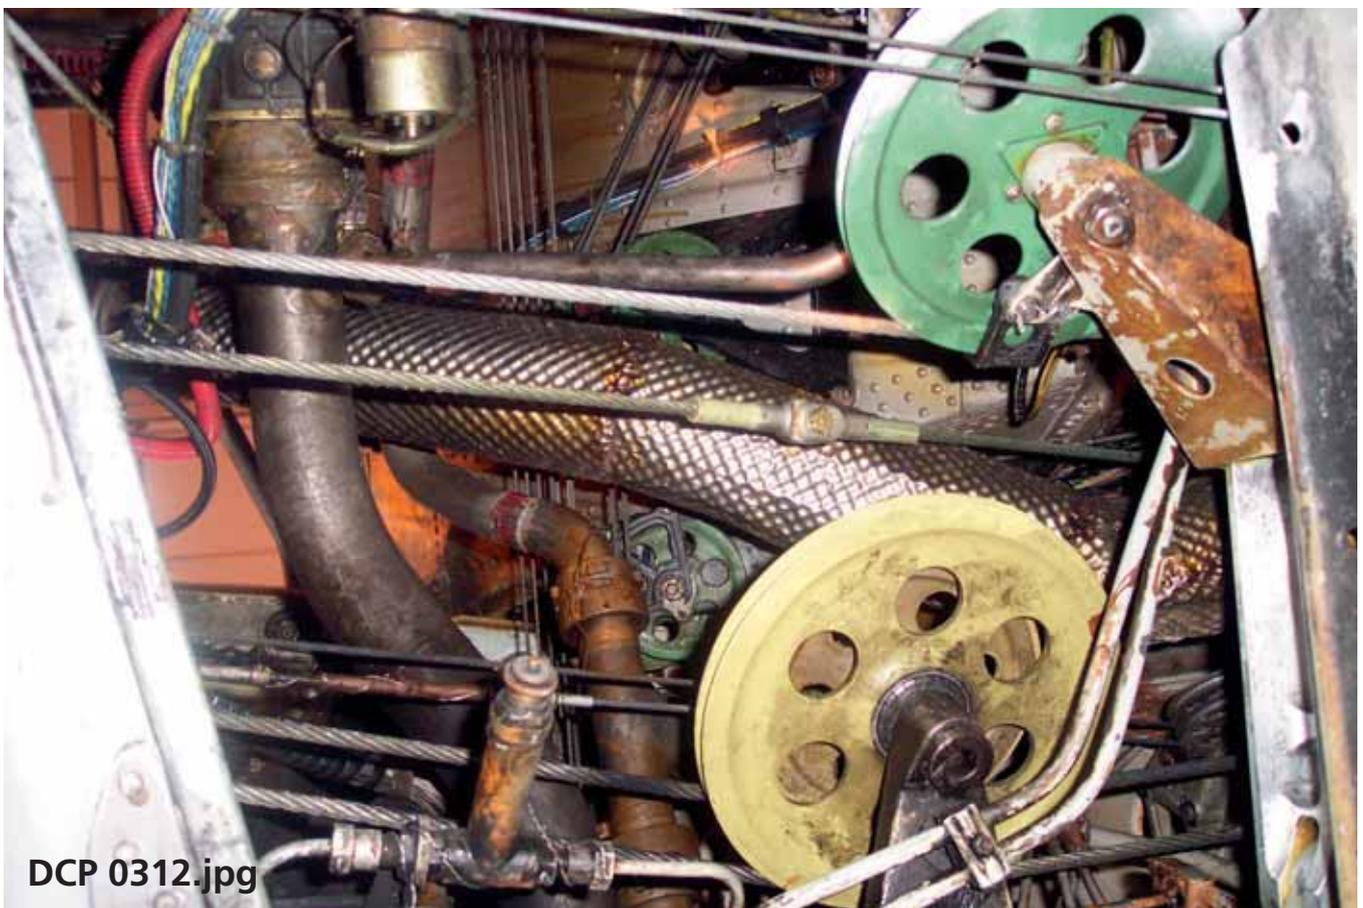
³¹ Further, if the PRC mastic is used as a weather-proof seal, it will be used on the top surfaces of the panels only, in order to prevent rainwater ingress.

- 10A.77 The jpg photographs for hazards H367 and H498 were incorrectly labelled in the CASSANDRA log entries: photo Dcp0221.jpg related to Zone 614 (*i.e.* the starboard No. 7 Tank Dry Bay) not 514; and photo Dcp0312.jpg related to Zone 514 only (*i.e.* the port No. 7 Tank Dry Bay) not both Zones 514 and 614. This meant that a person looking at the photographs later was going to have considerable difficulty in understanding which was which, let alone appreciating that there was a significant difference between the port and starboard No. 7 Tank Dry Bays. Furthermore, the gaps in the insulation and the deterioration in the condition of the insulation are not apparent from the photographs. Indeed, both photographs give the impression that the condition of the insulation of the Cross-Feed pipe and SCP pipe was good. As I explain in **Chapter 4**, however, that was not the case: much of the Refrasil insulation was old and deteriorated throughout much of the Nimrod fleet.

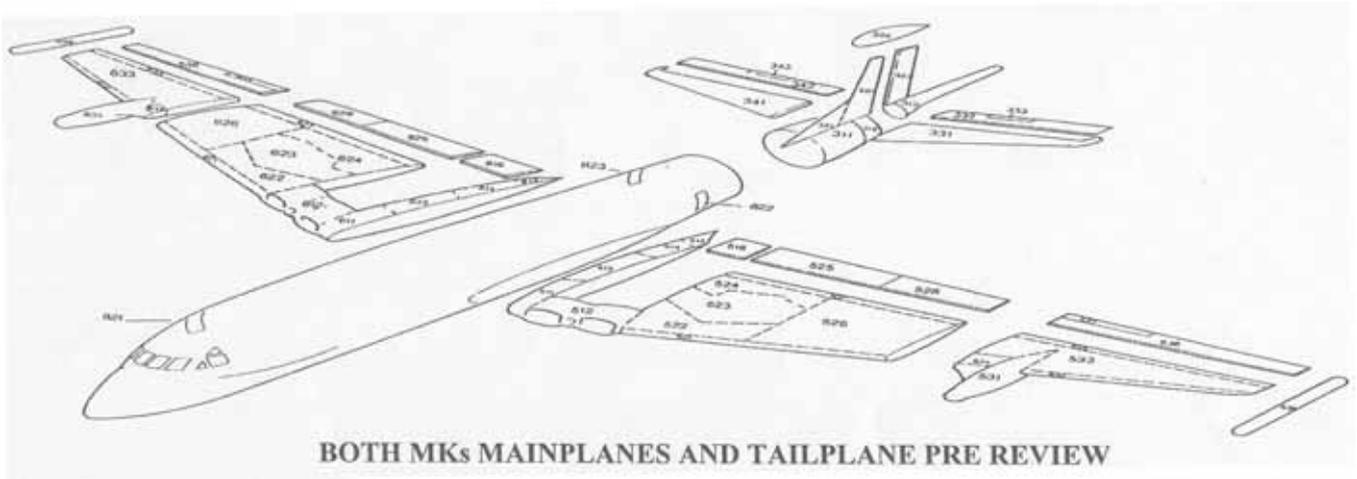
Figure 10B.1: Master Maintenance Schedule diagram showing location of Zone 614

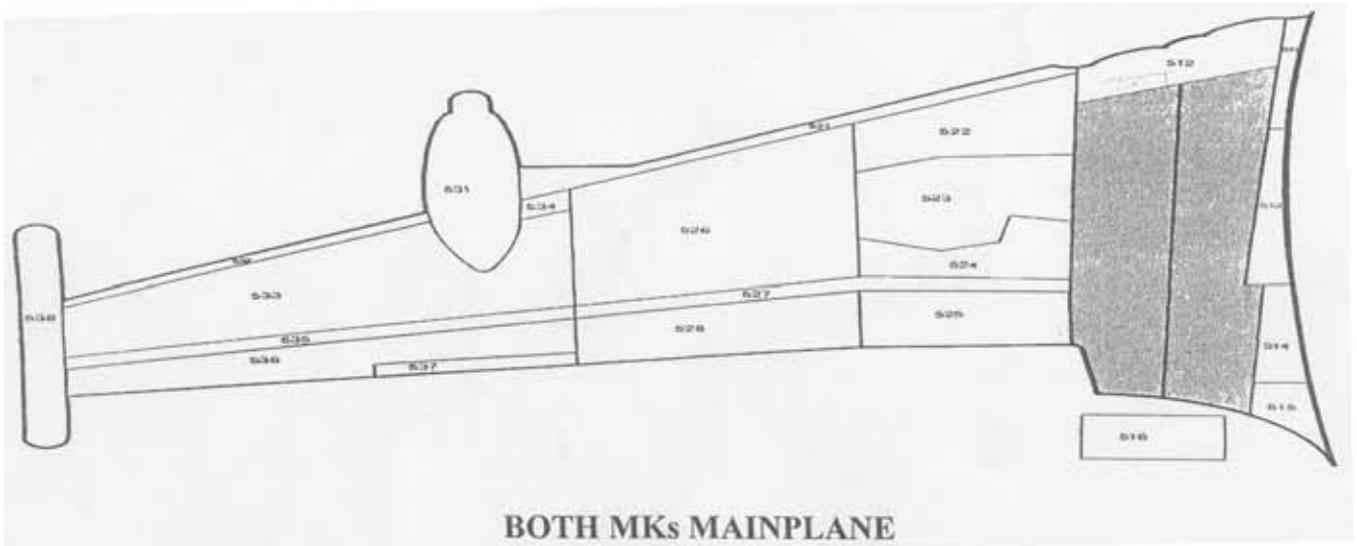
Figure 10B.2: Master Maintenance Schedule diagram showing location of Zone 514

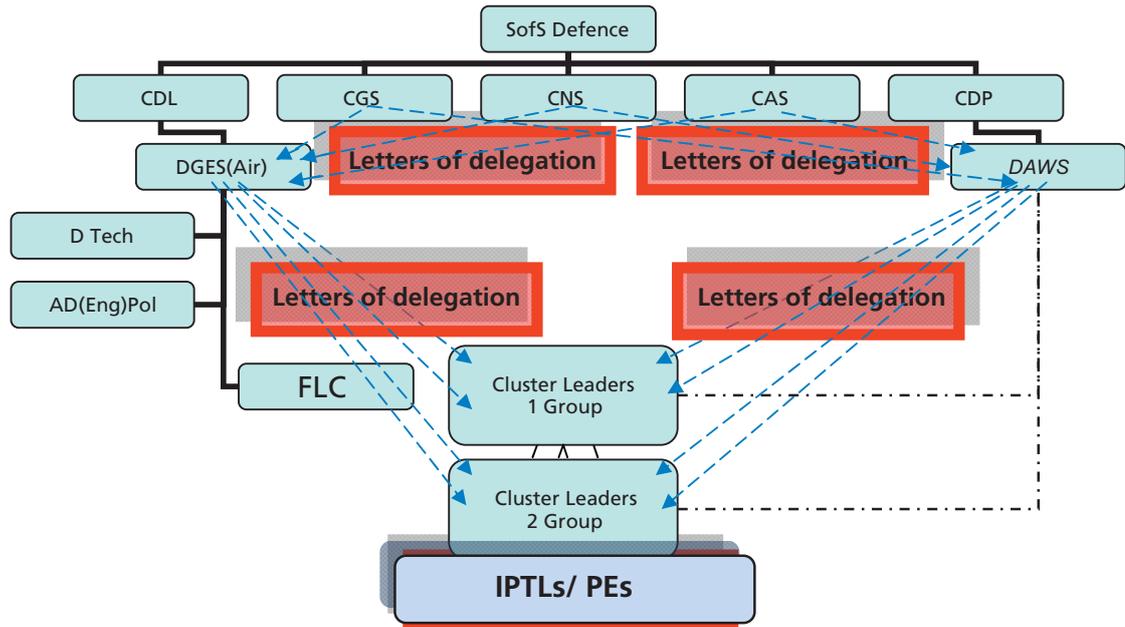
Figure. 13.5: Letters of Delegation Chain(s) in DLO

13.133 The lines of airworthiness delegation were no longer clear following the creation of the DLO. At one stage, DG ES(Air) had LODs from the three Service Chiefs to delegate that authority from them to him to set the policy and regulations across all military aircraft. Figure 13.5 is a rough diagrammatic estimation of the position as it is recalled to have been.

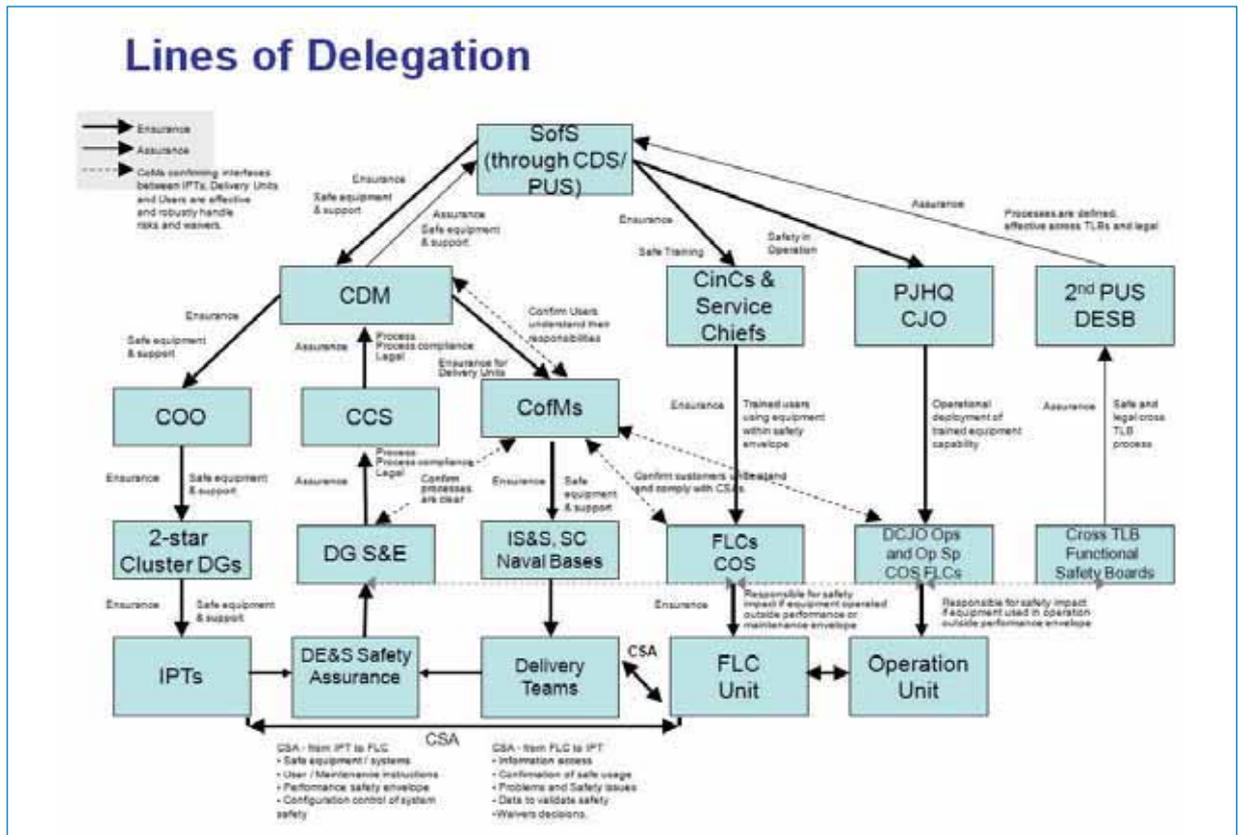
Fig. 13.6: Present MOD/ DE&S Lines of Delegation

13.138 By 2007, the airworthiness regime within the new DE&S had become even more Byzantine, complex and confused. In the DE&S, responsibility for airworthiness was moved to a separate organisation within “Corporate Services”. Today, Airworthiness policy is ‘brigaded’ alongside the other Safety and Environmental disciplines and ‘linkage’ with the three Front Line Commands achieved through the tri-Service forum inherited from the DLO structure. The primary interface with the single-Services at DE&S Main Board level is through the Chiefs of Material (CoM), with CoM(Air) being a member of the AFB. It still continues to confuse many for reasons which will be apparent from the following diagrams.

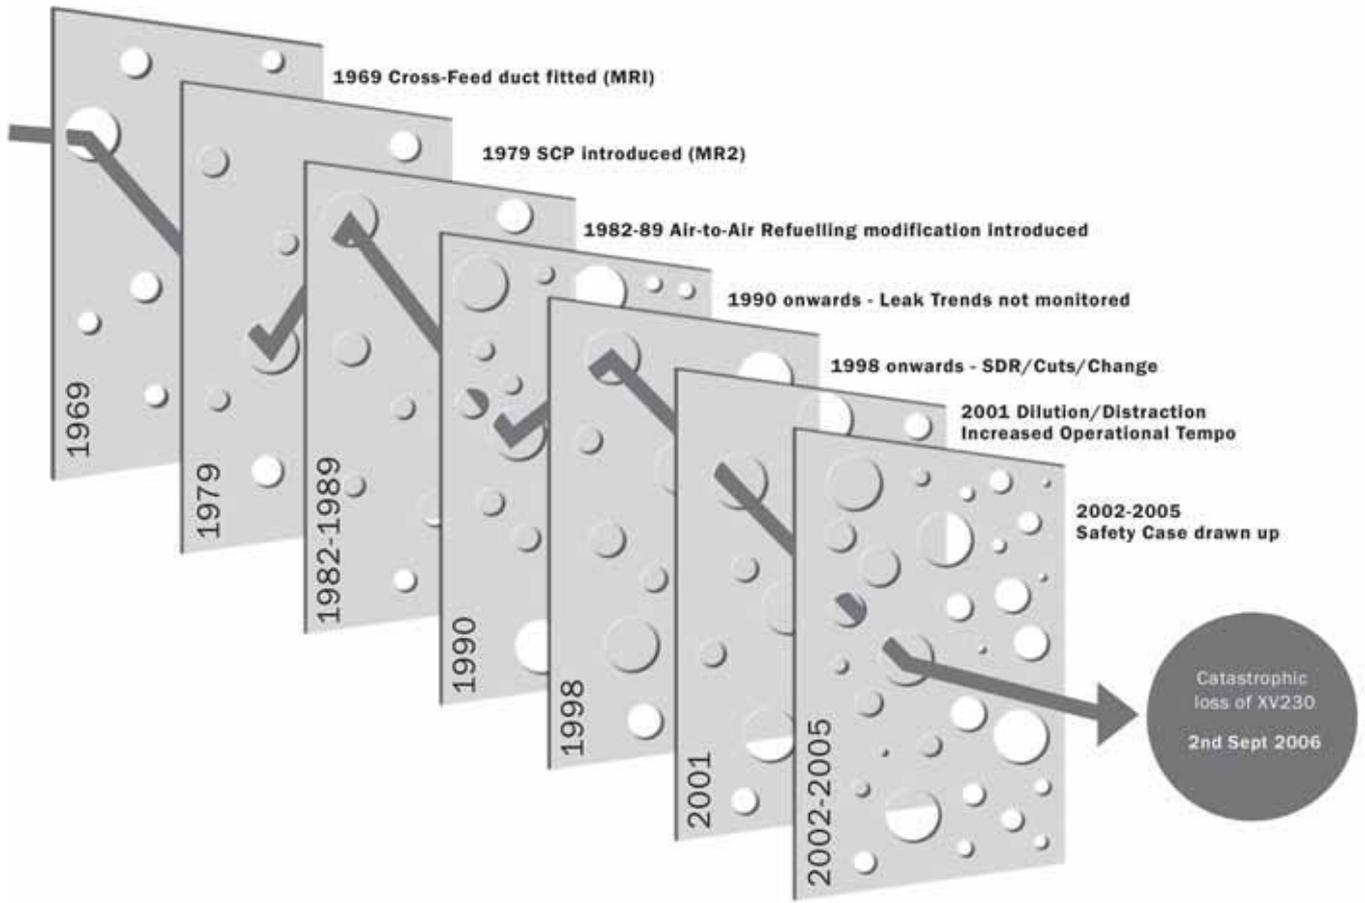
Figure 18.2: ‘Swiss Cheese’ Model as applied to XV230

- 18.26 In Figure 18.2 below I have used the 'Swiss Cheese' model to illustrate how the various defences were penetrated over the period 1969-2006 and led to the loss of XV230. The drawing uses a zig-zag arrow trajectory in order to emphasise the eccentric and unexpected nature of accident paths over lengthy periods:
