THE NIMROD REVIEW

An independent review into the broader issues
surrounding the loss of the RAF Nimrod MR2
Aircraft XV230 in Afghanistan in 2006

Charles Haddon-Cave QC

REPORT

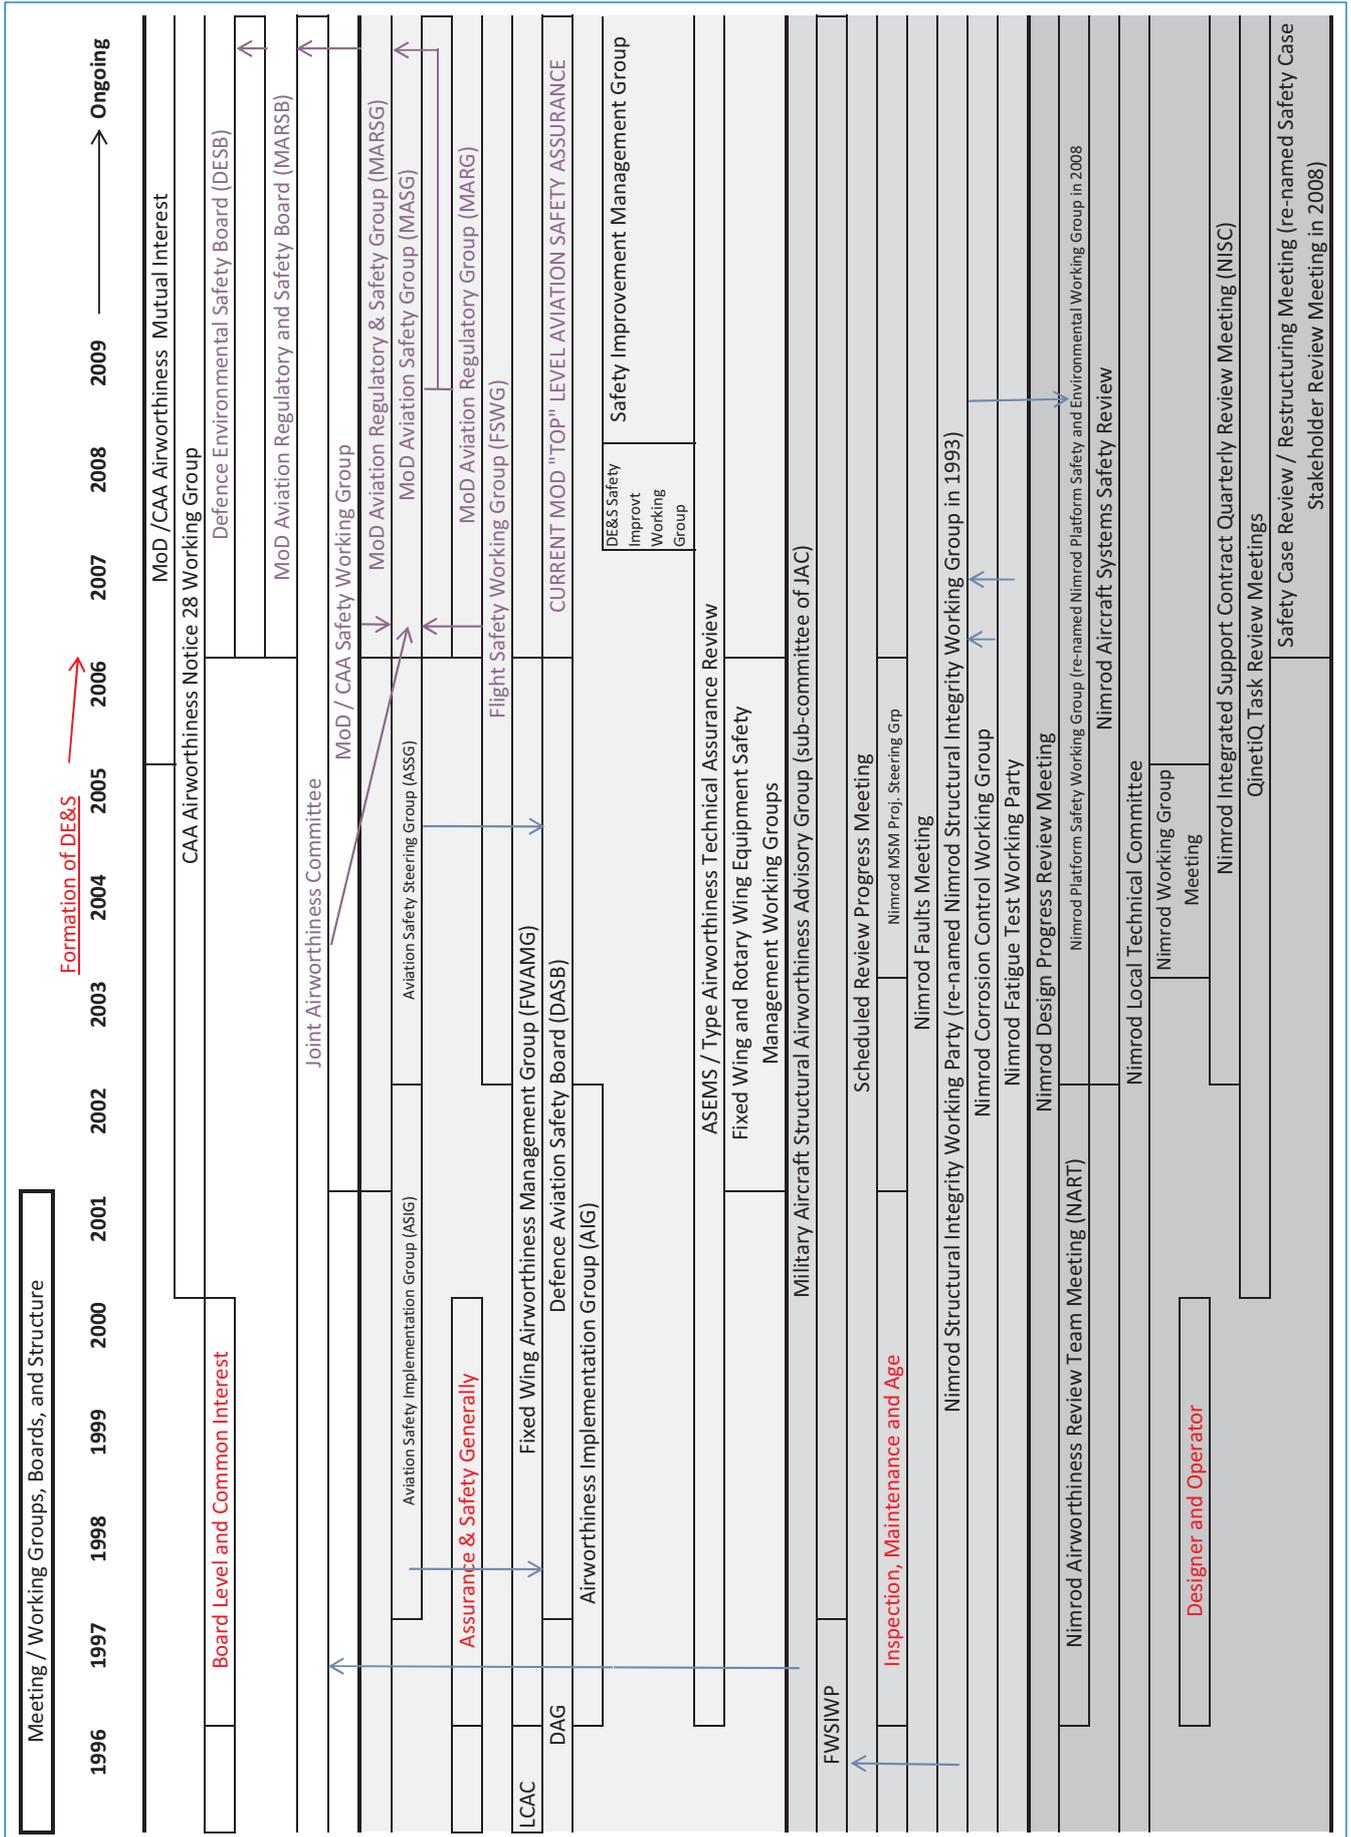
Figure 19.1: MOD Safety and Airworthiness committees etc (1996-2009)

- 19.30 The culture of change and complexity fed the MOD safety and Airworthiness structure. The Review carried out a historical analysis of the number and layers of safety and Airworthiness 'boards', 'meeting groups', 'committees', 'sub-committees' and 'working groups' etc. which were already in existence or have come into existence in the past decade or so. As far as the Review was able to ascertain these numbered at least 37 in total and formed the 'patchwork' shown below for the period 1996-2009 (see Figure 19.1). It is obviously highly unsatisfactory and confusing to have such a myriad of different safety and airworthiness-related bodies, leaving aside the major question marks over cost, their ability (where necessary) to communicate with each other properly, and their overall effectiveness. Many are the result of the growth of 'bolted-on' process in reaction to problems, rather than any strategic foresight or planning.
