PART 1.4 - FINDINGS

1. Given the technical nature of the accident involving ZG792, the Panel elected to present a chronological description of its findings. A modified version of the James Reason model is then subsequently used to categorise the various factors identified by the Panel.

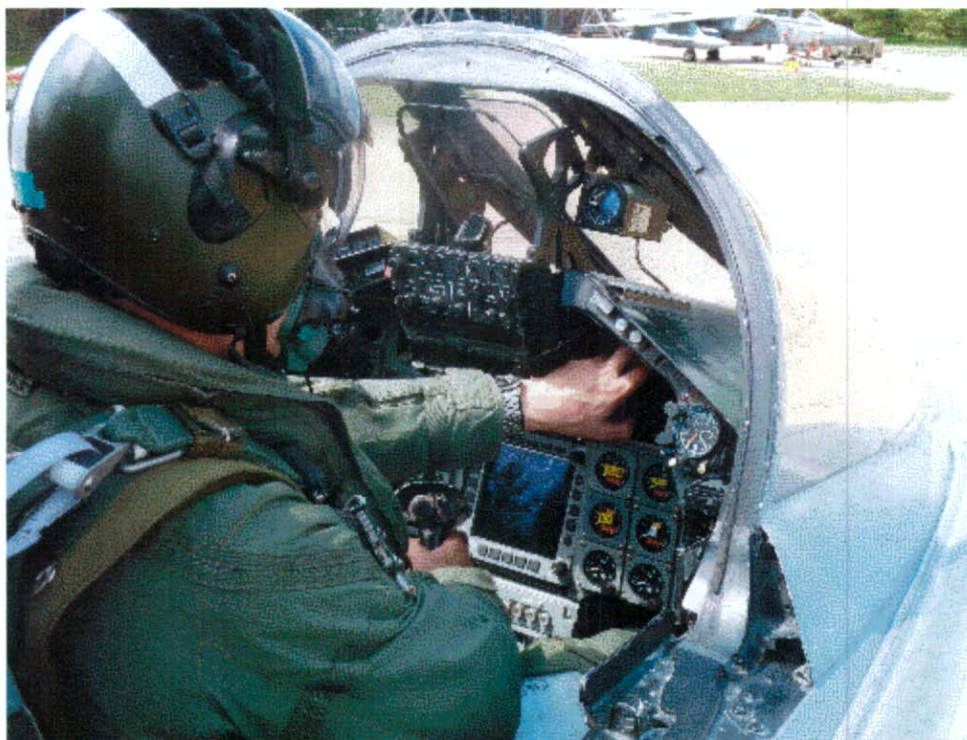
Figure 10 - Using right hand to push fire buttons

17. **GR4 cockpit ergonomics.** In his formal interview the pilot stated that he had pushed both fire buttons with his left hand. Given the position of the fire buttons (see Figure 7) this would have been an unnatural hand to have used. The LP cocks are positioned on the left side coaming of the cockpit, just below eye-level but both easily accessible and obvious (Figure 8). Had the pilot only operated the fire buttons the Panel believed it would have been more natural to have used his right hand (Figure 10). However, if his left hand was already available from having just closed the LP cock, the Panel reasoned that it would be understandable to use the same left hand to reach across and push the fire buttons (Figure 11, Figure 12). This would speed the process up and avoid the pilot having to swap hands on the control column. The fact that the pilot used his left hand to activate the fire buttons suggested that he may have previously used it to close the LP cock. Just prior to receiving the L FIRE caption, the pilot initiates a right hand turn. This action would have required a positive control input from him. Given that the Panel believe the pilot actioned the fire button press during the turn, it is also possible that he failed to close the LP cock but used his left hand as his right hand was occupied flying the ac. The HF report also alludes to the fact that this unnatural use of his left hand could have made the omission of the LP cock more likely, as his use of the left hand may have convinced him that the action was done. The Panel was unable to determine which of these sequences was correct.

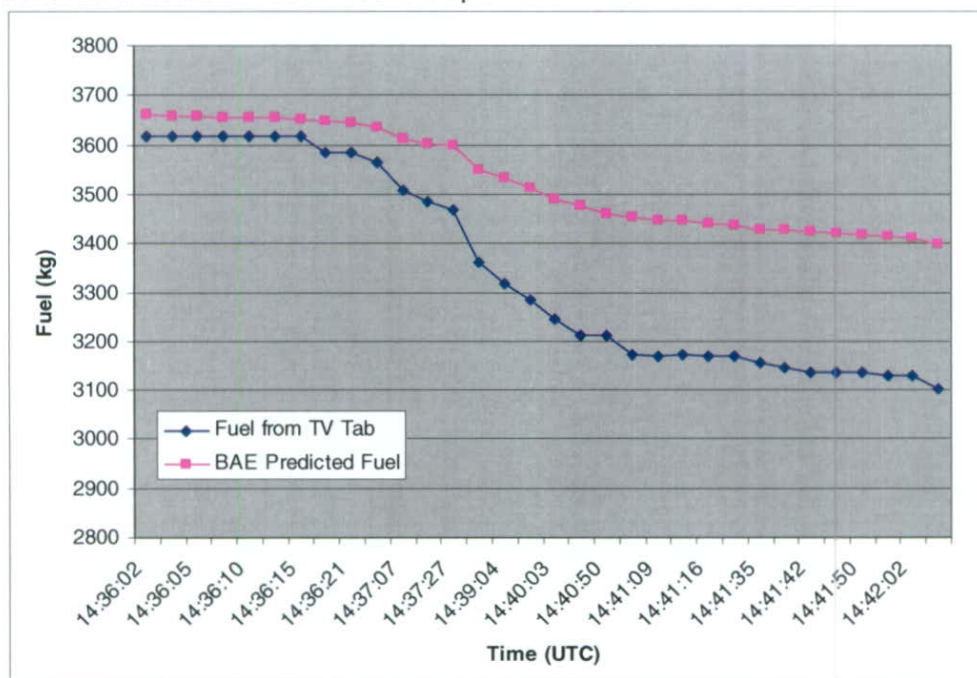
Figure 14 - BAE Systems Fuel Flow Rates

data, and provide their opinion as to the most likely sequence of events in order to determine when the LP cock was closed. Initially all the JPEG photos from the WSO's TV/Tab were re-checked by personnel not involved with the original collection of data. Again, data was only used if both a time and fuel figure could be derived from the snap shot; no interpolation was used. This check confirmed that the original figures used were correct. This information was provided to BAE Systems propulsion who spent 2 weeks independently reviewing the data. The department were provided with the fuel level figures and asked to plot them against BAE Systems predicted fuel flow rates. BAE Systems used their own models to calculate the predicted burn rates which are detailed in Annex J. These models allow for a greater degree of accuracy than the ODM as the models allow more specifics to be entered in calculating the exact fuel burn rate (of note the BAE Systems fuel flow rates closely matched the Panel's ODM rates). Figure 14 shows the BAE Systems plotted fuel flow rates. The Pink lines show the BAE Systems modelling of the fuel level and the blue line shows the actual fuel quantity as displayed on the WSOs TV/Tab. What can clearly be seen is a consistent divergence from the predicted fuel quantity set against the actual fuel quantity implying a leak. The lines become more parallel at approx T4:37, implying that at this stage the leak had reduced (and/or stopped) and as such the fuel to the engine had been isolated. This graph supports the theory that the fuel was not isolated until much later on in the emergency. After the graph had been produced BAE Systems were asked to comment on the likely cause of this leak and the conclusions from MilAAIB. BAE Systems concurred with the analysis from MilAAIB and stated that they believed that the LP cock was left open until T4:37.
