PART 1.3
NARRATIVE OF EVENTS

1. RAF Tutor aircraft G-BYUT and G-BYVN of the University of Wales Air Squadron (UWAS) No 1 Elementary Flying Training School (EFTS) departed MOD St Athan on the morning of 11 Feb 09 to conduct Air Experience Flights (AEF) for 2 Air Training Corps (ATC) cadets. An earlier sortie corroborated that the weather forecast and conditions in the local flying area were good, with visibility in excess of 10 km and very little cloud. The Volunteer Reserve (VR) pilot of G-BYUT was an experienced ex RAF Fast Jet (FJ) pilot and he sat in the primary (right hand) seat with the cadet in the left hand seat. The pilot of G-BYVN was awarded his wings upon graduation from RAF Linton-on-Ouse in Nov 08 and was waiting to commence FJ trg at RAF Valley; he also occupied the right hand seat with the cadet in the left hand seat. The aircraft took off at 1037Z and 1038Z with G-BYUT ahead and maintained a separation of approximately 1 min during a standard visual departure to the west. Radar trace recordings confirm that both aircraft adhered to the published procedure, making radio calls at Nash Point, a local visual reporting point, and then continuing west until clear of the

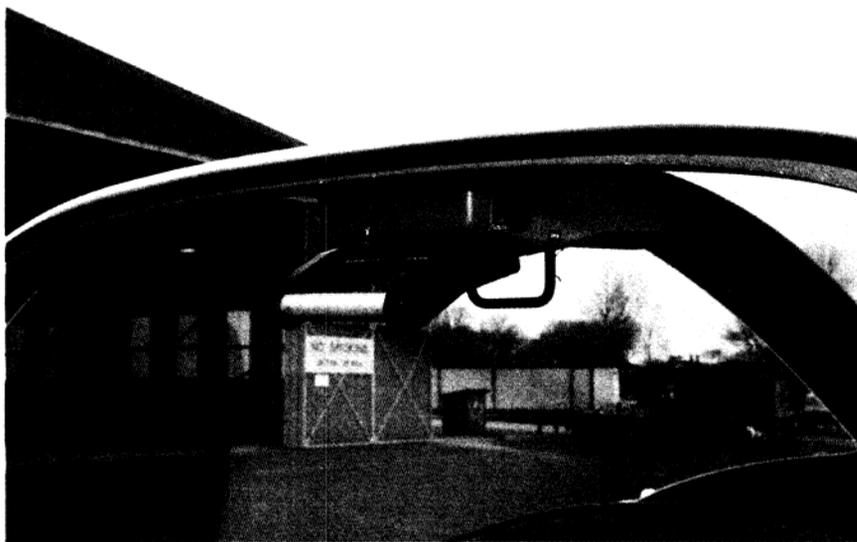
Figure 5. RAF Tutor canopy opening and jettison handle mechanism.

a. **G-BYUT.** Remnants of the aircraft canopy structure, main canopy handle mechanism and red emergency jettison handle were all found within or adjacent to the main impact point. The emergency jettison handle comprises a red handle attached to 2 hinged detent bolts; one of these bolts was still in situ within the main operating handle mechanism. The emergency jettison handle and the second detent bolt were found, still intact, within the impact wreckage but separate from the main operating handle mechanism where it normally resides. However, following detailed analysis by Fleet FS (Air) Materials Integrity Group (MIG), there is evidence that the jettison handle became separated during the accident sequence, most likely at ground impact, and had not been pulled by the cockpit occupants. Additionally, the analysis concluded that the canopy operating

b. **G-BYVN.** Although the pilot's body was found 23m away from the main impact point of the aircraft, witness marks on the normal canopy release mechanism indicate that the canopy was likely to have been in the closed position and the canopy locked upon impact with the ground. The MIG analysis concluded that it was likely that the emergency jettison handle had not been operated. The pilot's seat harness buckle had been released but the harness release buckle of the cadet was still secured. The parachute operating handles of the pilot and the cadet had not been pulled.

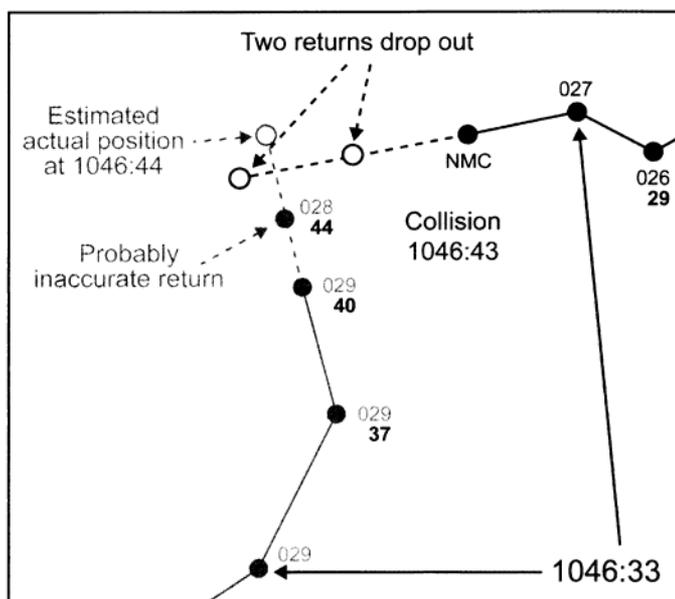
41. Modern displays are also subject to software based interpretation of the raw radar returns; the ARP and resolution limitations can lead to returns being incorrectly ascribed to aircraft that are in close proximity, leading to erroneous data. The returns for G-BYUT appear closer together immediately prior to collision but the aircraft could not have slowed appreciably without extreme aerodynamic manoeuvre. It is more likely that G-BYUT continued to progress at a similar rate to the preceding returns until the collision and the actual position at 1046:44 would have been further north, as illustrated in Figure 8. This revised position matches the estimated time of collision at 1046:43.

42. Overall, the radar trace data provided a clear picture of the flight paths of both aircraft leading up to the collision. As the aircraft come together, and in the immediate aftermath, some of the data is missing or inconsistent, as should be expected due to radar resolution limitations, and must therefore be interpreted with caution.
