Lessons from historical dam incidents

Project: SC080046/R1

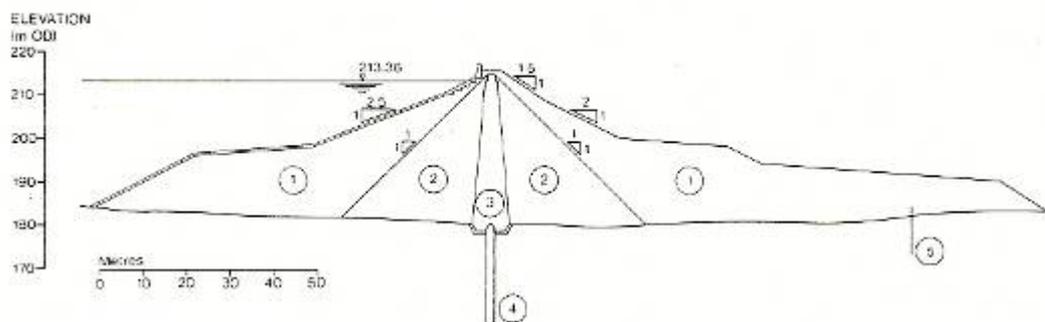
Figure 5-9 Cross-section of Greenbooth dam (after Flemming and Rossington, 1985)

1 – Sandstone fill; 2 – Shale fill; 3 – Puddle clay core; 4 – Concrete; 5 – Sheet piling.

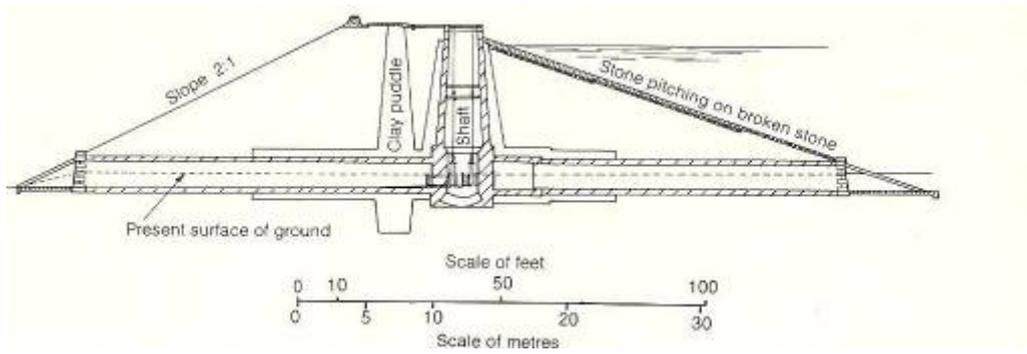
Figure 5-10 Section of Lower Rivington embankment (assumed to be as Yarrow embankment, after Binnie, 1981, p139)

Culverts constructed through dam embankments are potential hazards leading to internal erosion, and this incident reinforces the need for vigilant surveillance of such structures. Similar incidents have occurred at other dams including Holmestyes, March

Haigh and Carno Lower. It is likely that this type of incident will occur at other dams in the future.

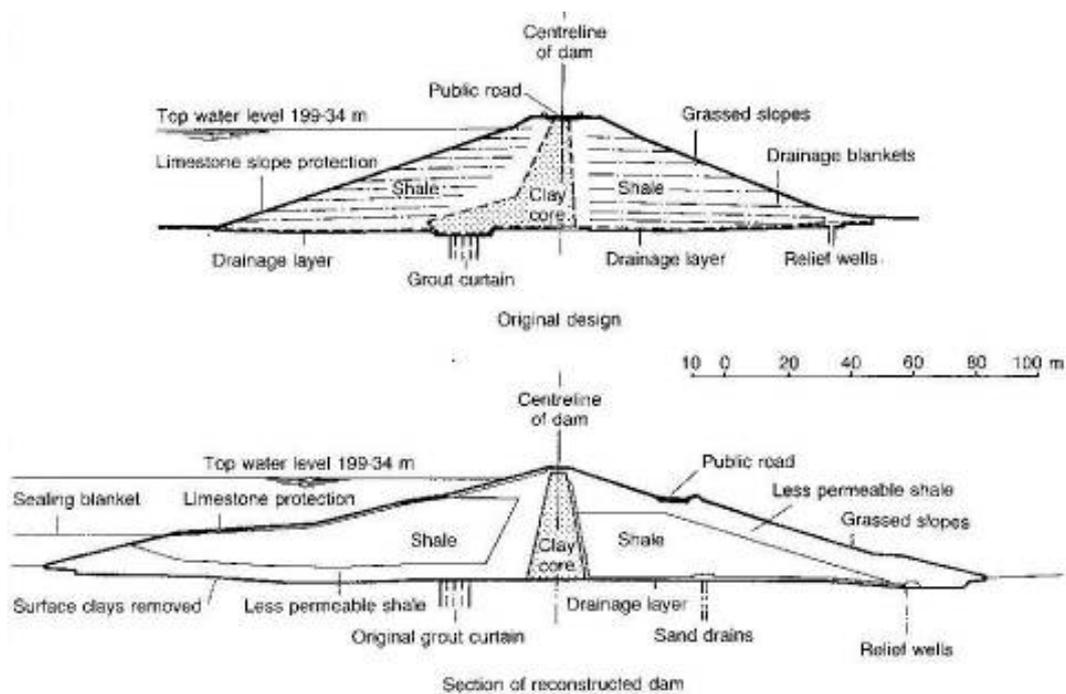
Figure 5-14 Cross-section of the original and reconstructed Carsington dams (after Banyard *et al.*, 1992)

The investigation of the failure by Professor Peter Vaughan led to a better appreciation of the significance of progressive failure, and overestimation of stability by limit equilibrium analysis (Vaughan *et al.*, 1989; Potts *et al.*, 1990). The factor of safety based on peak strengths was about 1.4. Pre-existing shears lowered the safety factor to about 1.2 and progressive failure reduced it to 1.0.

A similar rotational failure occurred at Acu dam, Brazil in 1981 during construction which was due in part to the core shape.

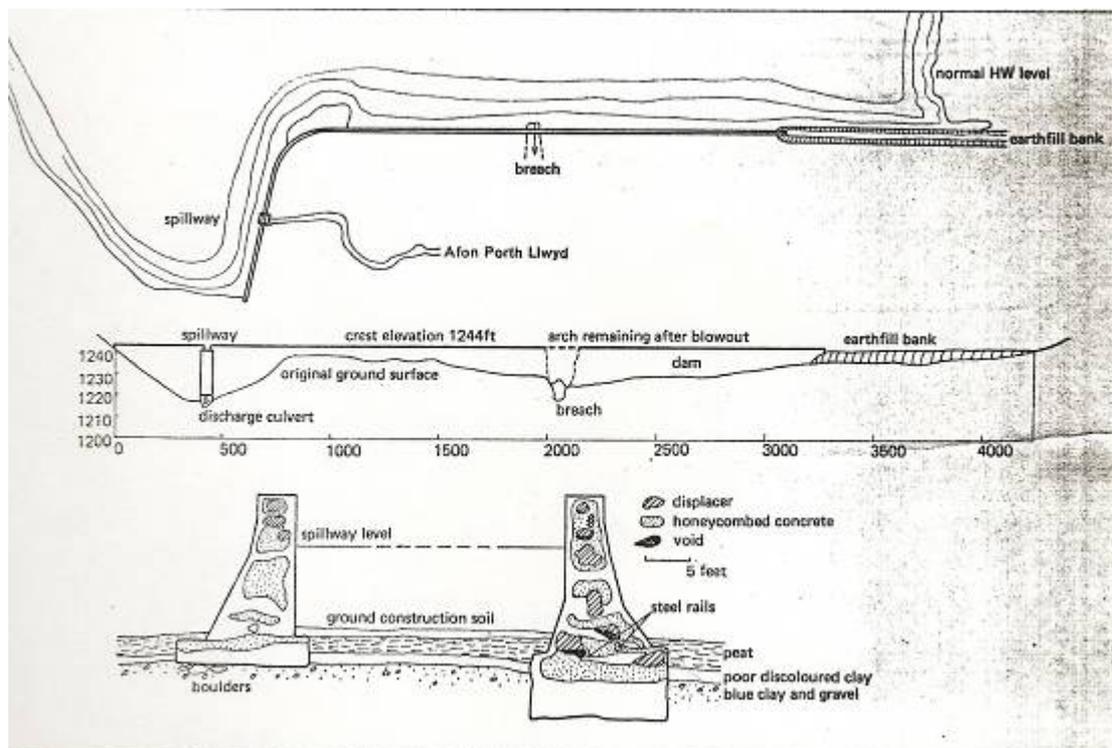
Figure 5-23 Plan and longitudinal sections of Eigiau dam and cross-sections of each side of the breach (after Evans and Walsh, 1973)

The incident showed the need for a competent engineer to supervise the construction of dams.

As a direct consequence of the failure, the Reservoirs (Safety Provisions) Act 1930 was passed by Parliament.

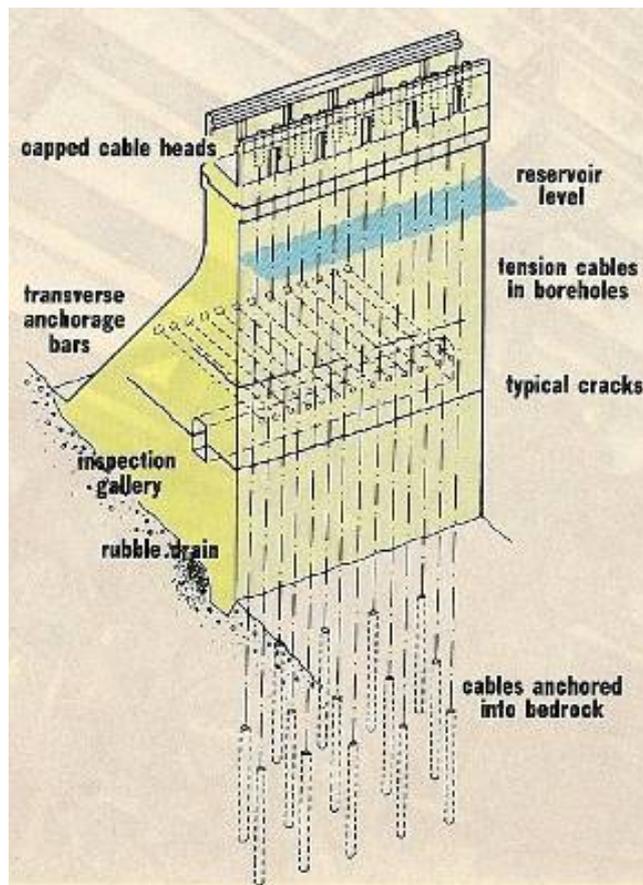
Figure 5-27 Layout of post-tensioning (after Hayward,1990)

Experiences at Mullardoch dam and elsewhere (Abraham and Sloan, 1978) suggest that sharp changes of alignment should be avoided.

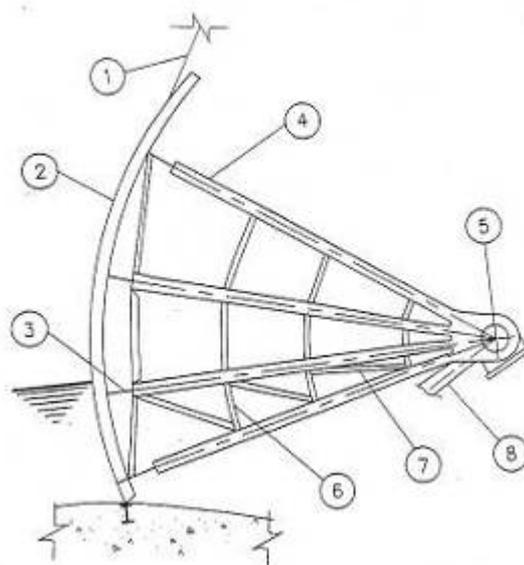
Figure 5-29 Side view arm forming radial gate at Folsom dam prior to failure (after Todd, 1997)

The failure was due to inadequate structural design aggravated by corrosion on the loaded side of the steel trunnion pins and vibration. As a result of the incident the following recommendations were made:

- All radial spillway gates that could involve loss of human life in the event of failure should be inspected thoroughly and design calculations reviewed to ensure the gates meet current design standards.
- Trunnion moments were not considered in many gate designs prior to the mid-1960s and therefore reinforcement may have to be added where trunnion moment was overlooked.
- To prevent possible self-excited vibrations which can cause fatigue damage and damage to the hoisting system, gates should be made adequately stiff.
- Monitoring of a gate's condition over time should be undertaken every five years and could include loading on the hoist, changing geometry of the arms and strain gauge data to check changes in the trunnion moment caused by corrosion.

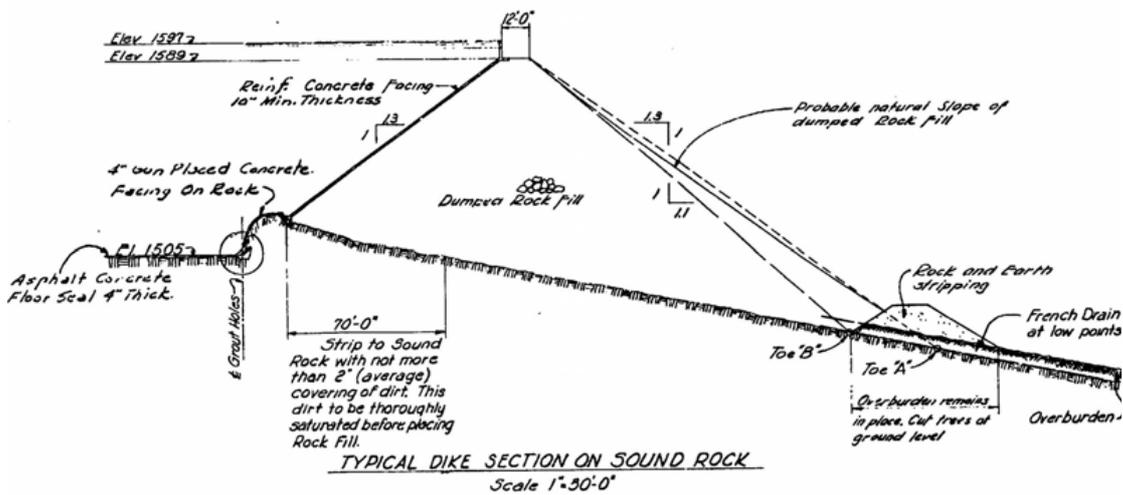
Figure 5-31 Typical section through Taum Sauk embankment

Although failure of the dam was primarily due to overtopping resulting from the failure of the reservoir-level instrumentation to stop pumping, other contributory factors include the absence of a spillway, poor quality of rockfill that was not free-draining and was readily erodible, weak foundation conditions, steep angle of the slope and sudden failure of the three-metre high parapet wall. No regular visual surveillance of the reservoir was made to prove the reliability of the water-level telemetry readings.

Construction of any dam without an adequate spillway is a potential hazard to the safety of the dam, even when the reservoir is non-impounding.
