SS RICHARD MONTGOMERY SURVEY REPORT 2011

Maritime and Coastguard Agency
October 2012

1. EXECUTIVE SUMMARY

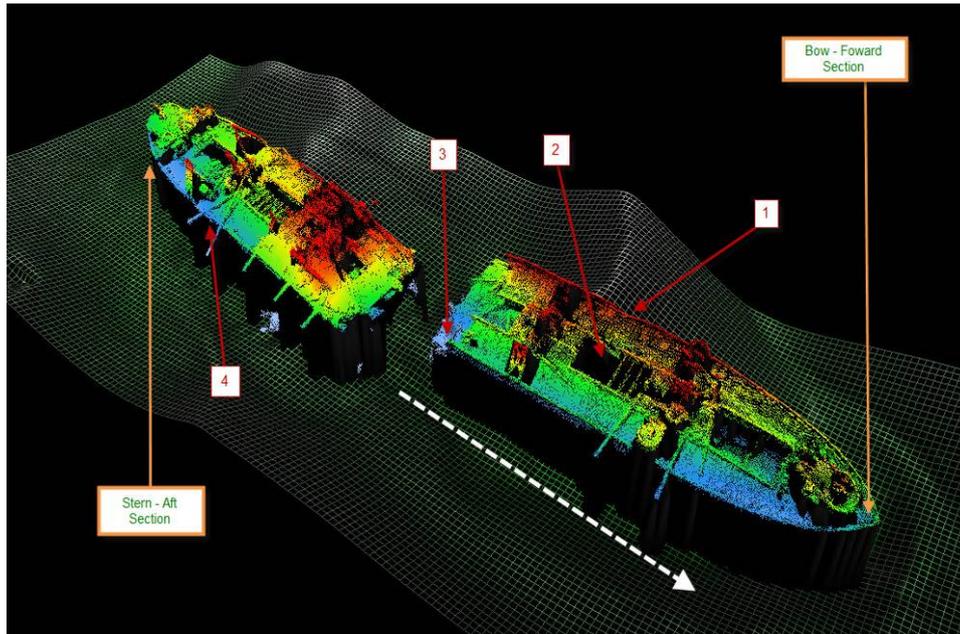
Fig. 2 - SS Richard Montgomery Overview with location of key areas

- Area 1) Crack and split in hull plating at Hold 2
- Area 2) Partial collapse of deck plating above Hold 2
- Area 3) Aperture in the bulkhead aft of the forward section
- Area 4) Vertical split in hull plating in the stern section
