Maritime &
Coastguard
Agency

SS RICHARD MONTGOMERY SURVEY REPORT 2012

Maritime and Coastguard Agency
October 2013

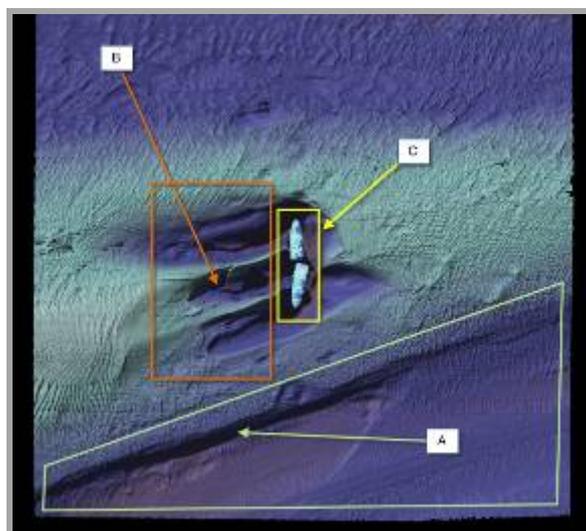
Fig. 15 Seabed areas A, B & C

5.2 For the purpose of evaluating the 2012 survey data, the seabed that surrounds the wreck was split into three distinct areas. These are areas A, B and C. Area A is the dredged channel to the south which has remained apparently unaffected by the wreck structure. Area B is the scours that have developed to the west of the wreck structure. These have been shown in this and previous surveys to change over time, mainly due to the relatively shallow depths of the water and strong tidal streams that pass around the wreck. Area C is the immediate area of the wreck site itself which surveys suggest is subject to changes in sediment levels.

5.3 Area A - Survey data from the edge of the dredged channel indicates that there has been a small reduction in sediment deposits. There is no evidence to suggest that the wreck is having an influence on this area and the channel is surveyed and dredged by the port authority.
