Maritime &
Coastguard
Agency

SS RICHARD MONTGOMERY SURVEY REPORT 2012

Maritime and Coastguard Agency
October 2013

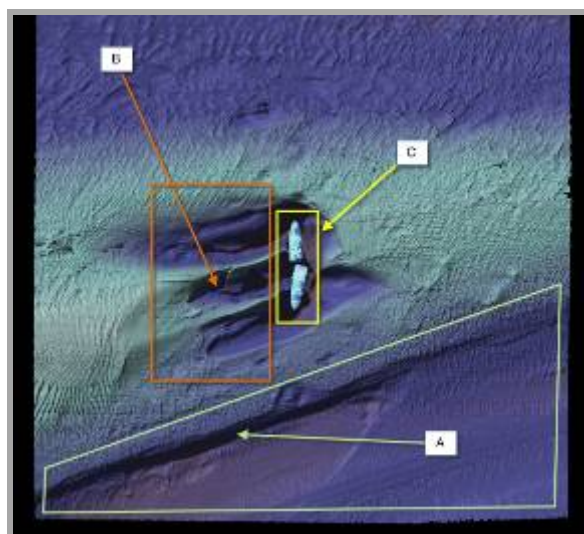
Fig. 15 Seabed areas A, B & C

5.3 Area A - Survey data from the edge of the dredged channel indicates that there has been a small reduction in sediment deposits. There is no evidence to suggest that the wreck is having an influence on this area and the channel is surveyed and dredged by the port authority.
