MARINE ACCIDENT
INVESTIGATION BRANCH

SAFETY DIGEST

**Lessons from Marine
Accident Reports
3/2004**

No 3/2004

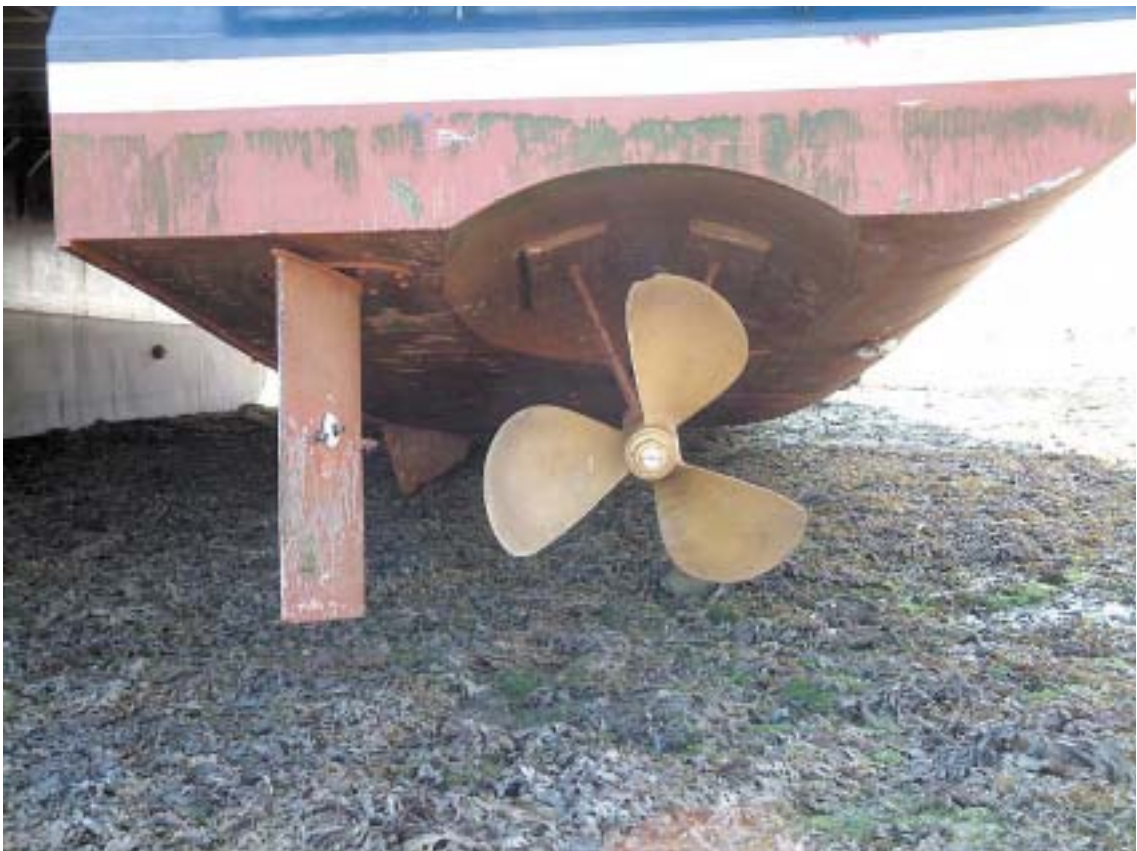
Photographs of hull showing position of propeller and offset rudder

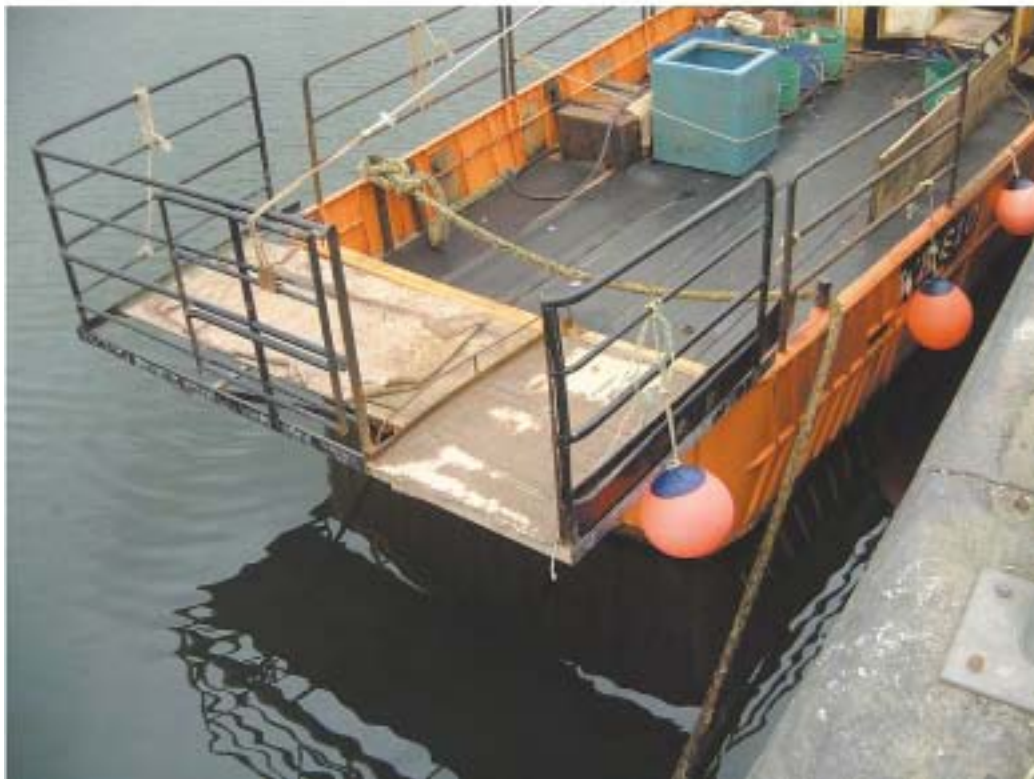
Working deck area showing pound board arrangement

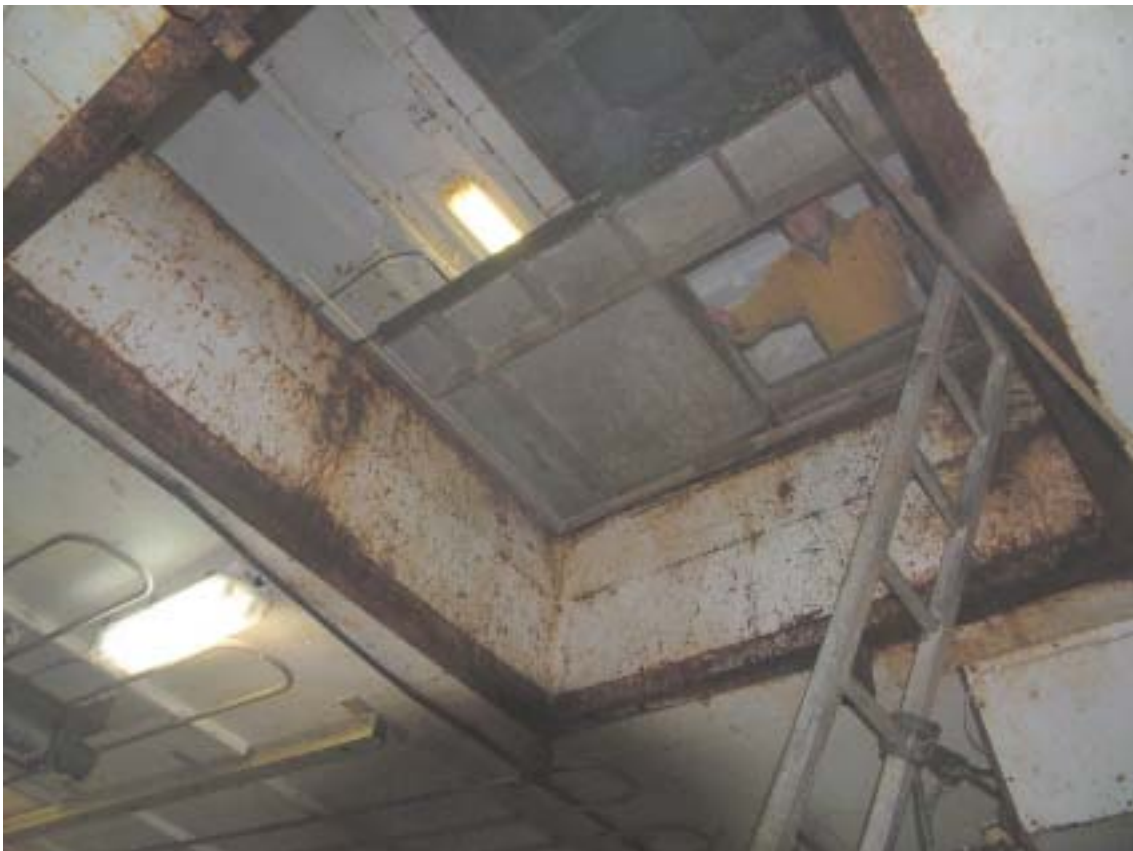
A 34m vessel was trawling when one of her crew fell down into the fish room through the open hatch from the deck above.

Views into and out of the fish hold indicating the distance the casualty fell

1. Whenever working close to open hatches, always ensure safety measures are in place, such as portable guard rails. If that is not possible, use a safety harness attached to a point which will prevent a person working close to an open hatch from falling down. It's also a good idea to wear a hard hat with a chinstrap, just in case.
2. Contrary to popular belief, the assessment of risk is not a complicated exercise. It requires all concerned in any operation to stand back, for a few minutes only, and consider the risks associated with that particular operation. If hazards are identified, often, simple control measures can be put in place to prevent accidents from happening.
3. The best people to carry out risk assessments are the skipper and his crew. It is they who know their vessel better than anyone else, and it is they, therefore, who are able to more readily identify risks.

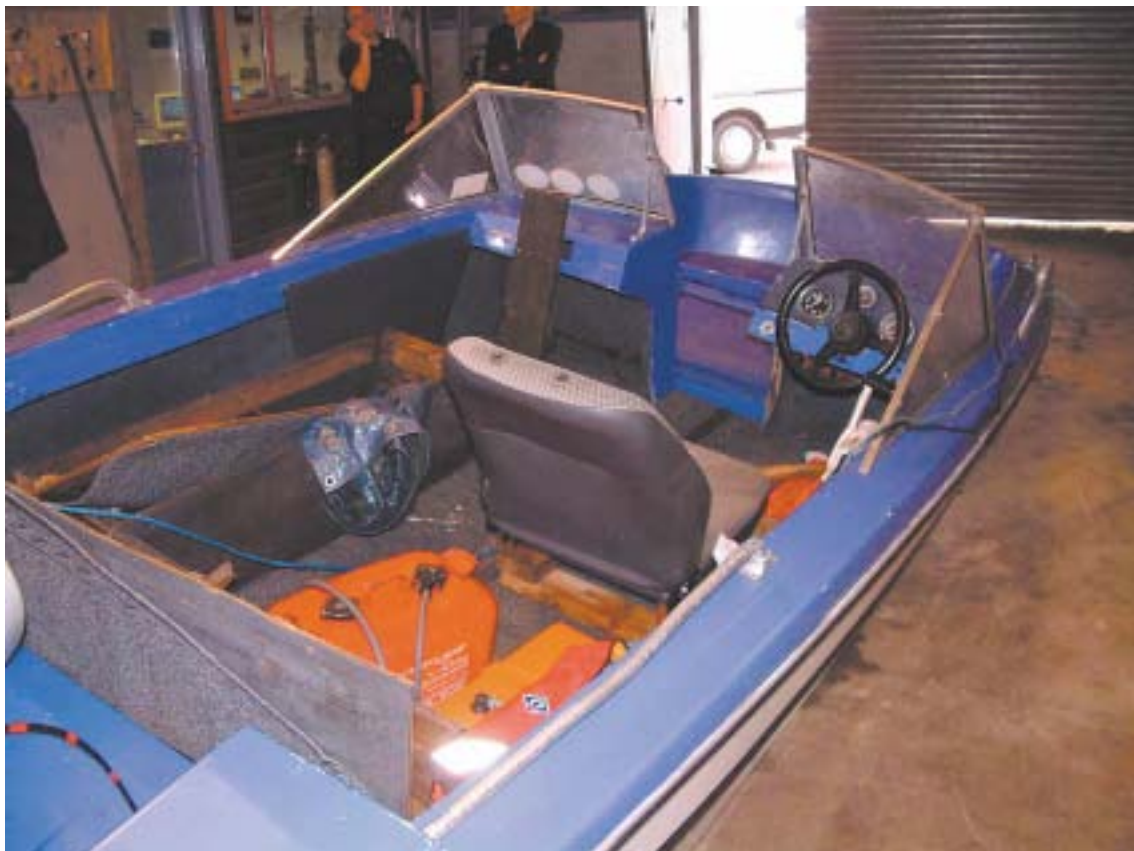
Photographs of the boat

1. The boat, which was nearly 30 years old, had had multiple owners and had been modified and poorly repaired such that it no longer met the original design criteria. Many boats like this are for sale on the second-hand market, and their condition is not regulated. A boat can inadvertently become a death trap when modifications are carried out inexpertly. Before buying a second-hand boat make sure you know:
