MAIB
MARINE ACCIDENT INVESTIGATION BRANCH

SAFETY DIGEST

Lessons from Marine Accident Reports

No 2/2003

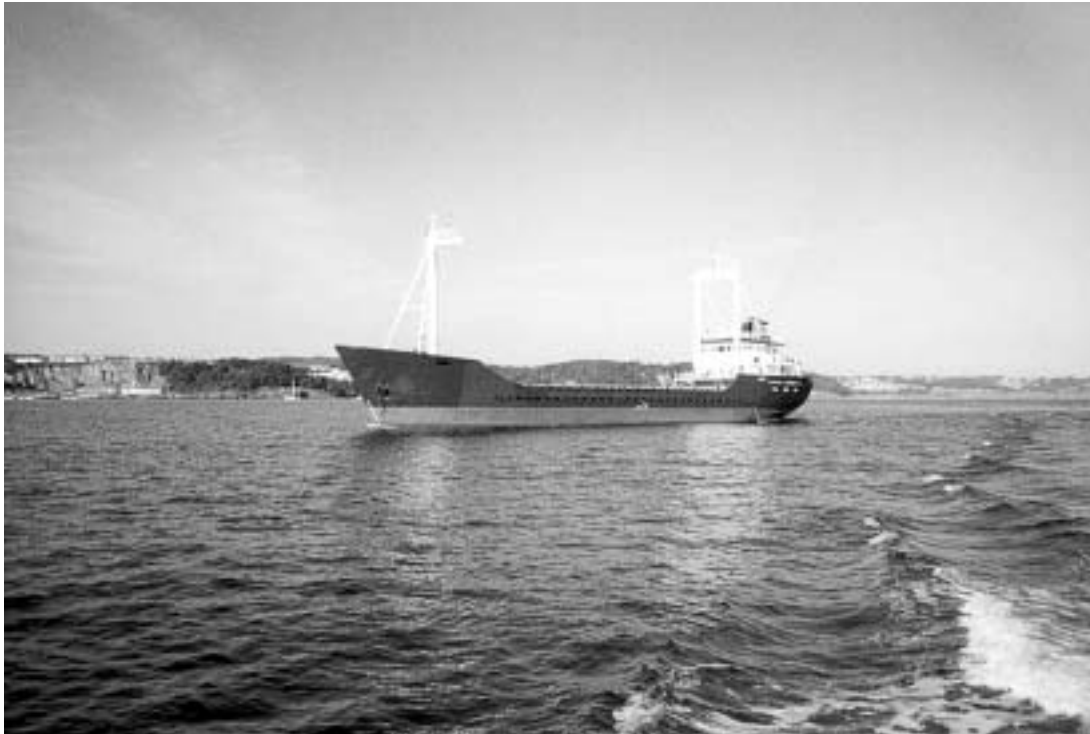
Cargo vessel

In the preceding 13 months, three other very similar collisions occurred in the same area. However, this one was made particularly notable because the cargo vessel was holed below the waterline and quickly listed to starboard and sank.

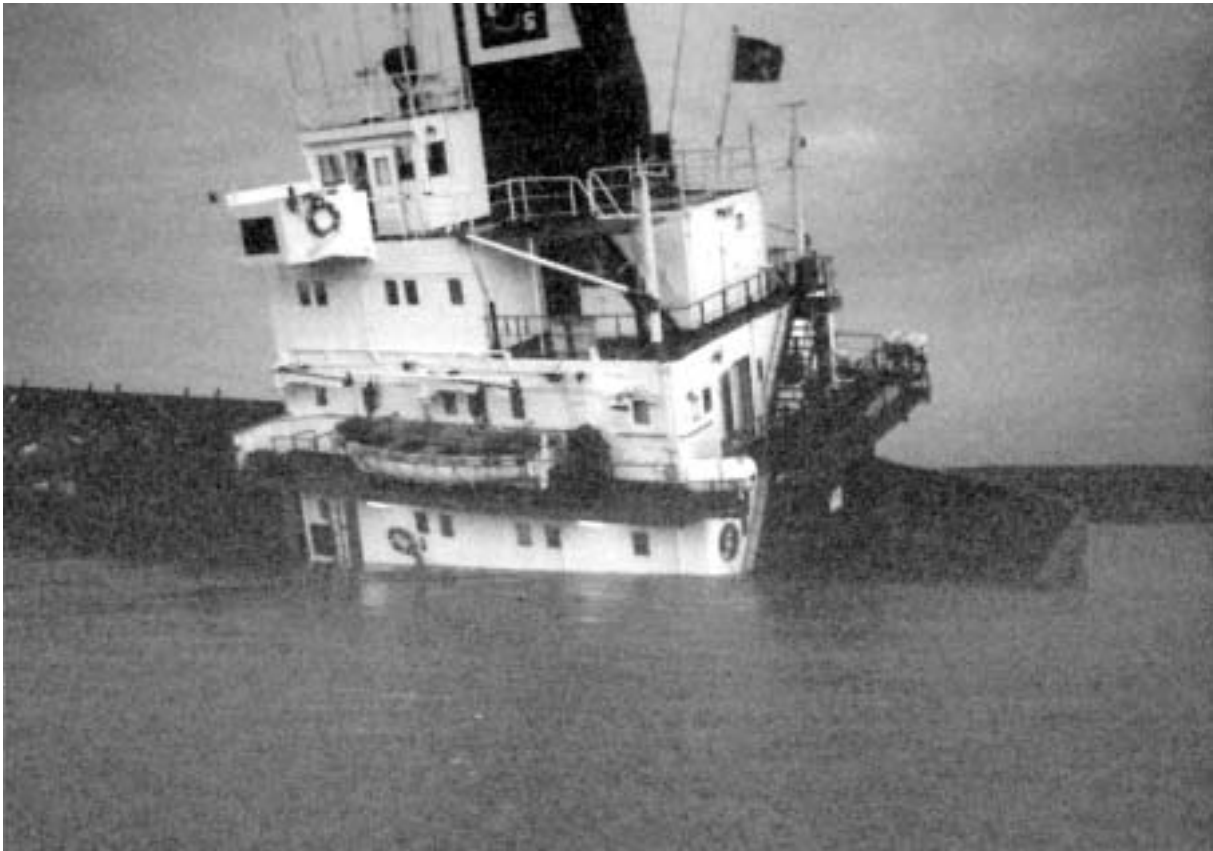
Fortunately, the vessel floated to an even keel before floodwater was able to reach the open cargo hatches.

Eventually, the vessel was towed to safety. Apart from superficial flood damage to her engine room, she was virtually unscathed.

1. Even though the departure deadline had passed, the pilot still elected to sail. The passage plan deadlines were introduced by the competent harbour authority, and served a purpose. They should not have been exceeded. Had the pilot not found it necessary to proceed at full speed downriver, when making the turn, he would have had reserve engine power at his disposal. This might have prevented the vessel grounding.
2. The master had assured the pilot that the hatches would be closed immediately after letting go. They were not. This left his vessel dangerously exposed to floodwater entering. Never, ever sail with open hatches.

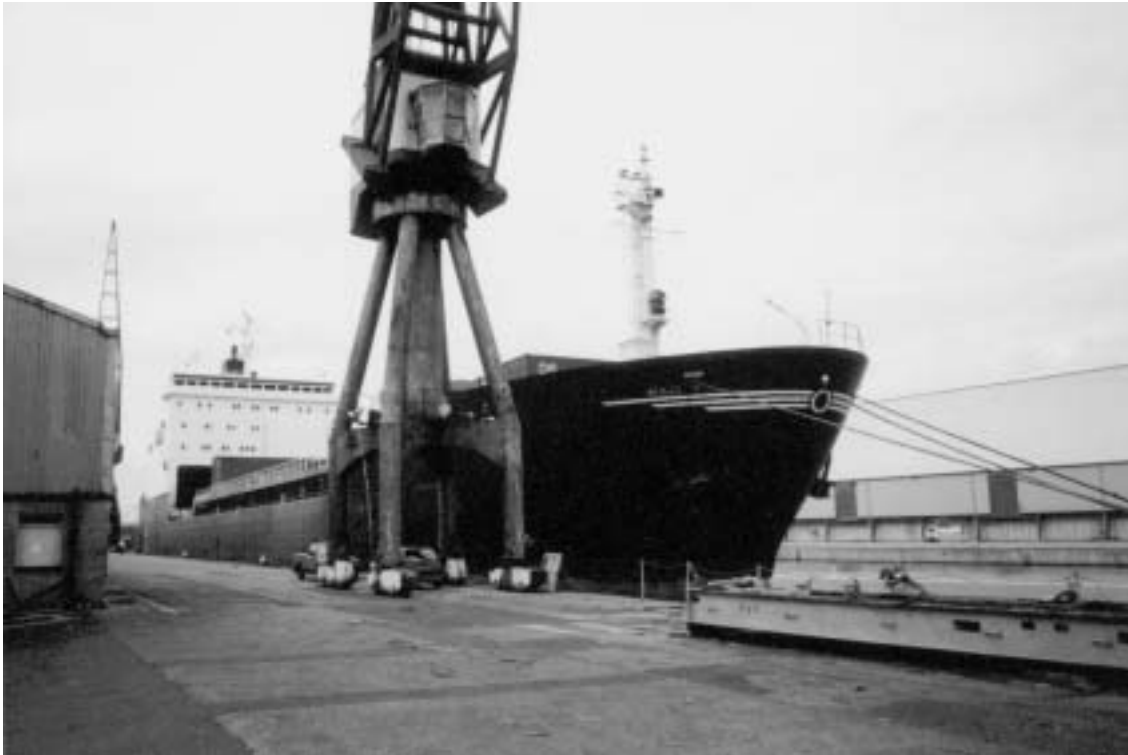
Ro-ro cargo vessel

Only when the ro-ro cargo vessel was virtually alongside the fishing vessel, was the pilot able to detect her trawl wires leading astern, and her port navigation light. Realising a collision was imminent, he altered course hard to port, but failed to prevent the ro-ro's starboard quarter colliding with the fishing vessel's port side.

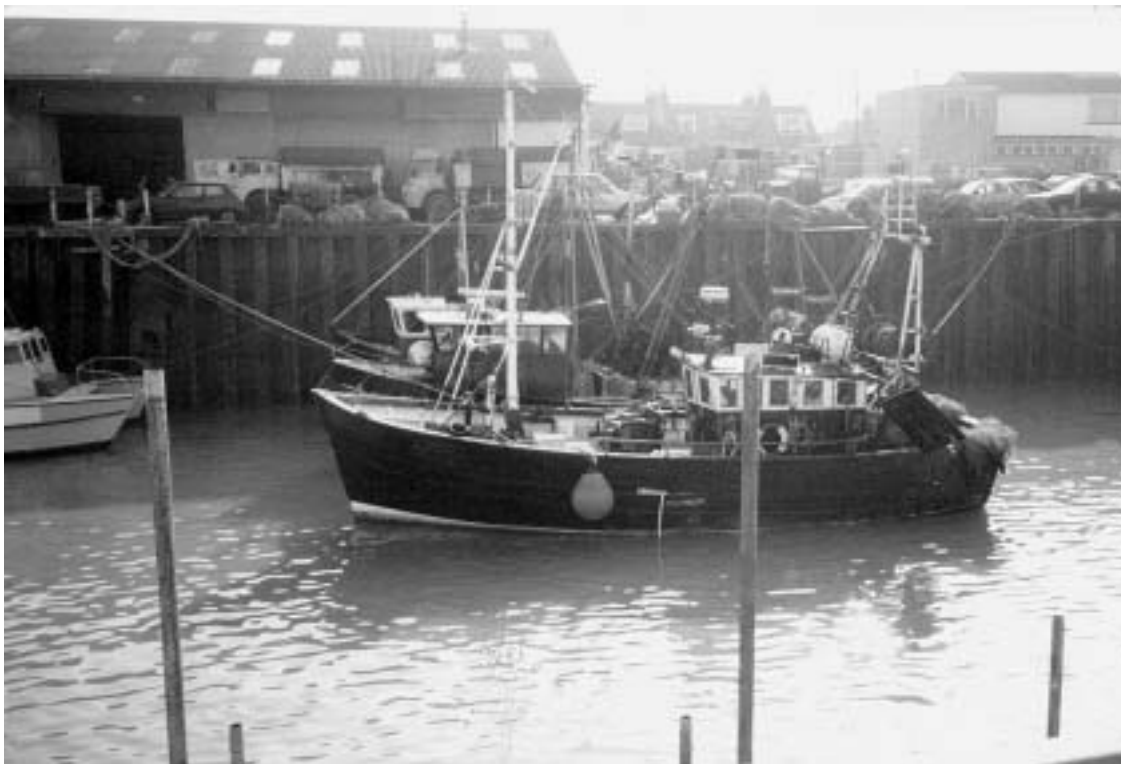
Fishing vessel

As a result of the collision, the fishing vessel flooded and foundered very quickly. Fortunately a pilot cutter rescued the single-handed fisherman.

1. The immediate causes of the collision were the pilot failing to take avoiding action in sufficient time, and the fisherman failing to keep a proper lookout. The pilot had previously regularly used VHF radio for collision avoidance and, on this occasion, used it instead of altering course as required by the Rule of the Road. He had made the assumption that once contacted, the other vessel would alter course at his request, irrespective of her status. Making assumptions can lead to disaster.

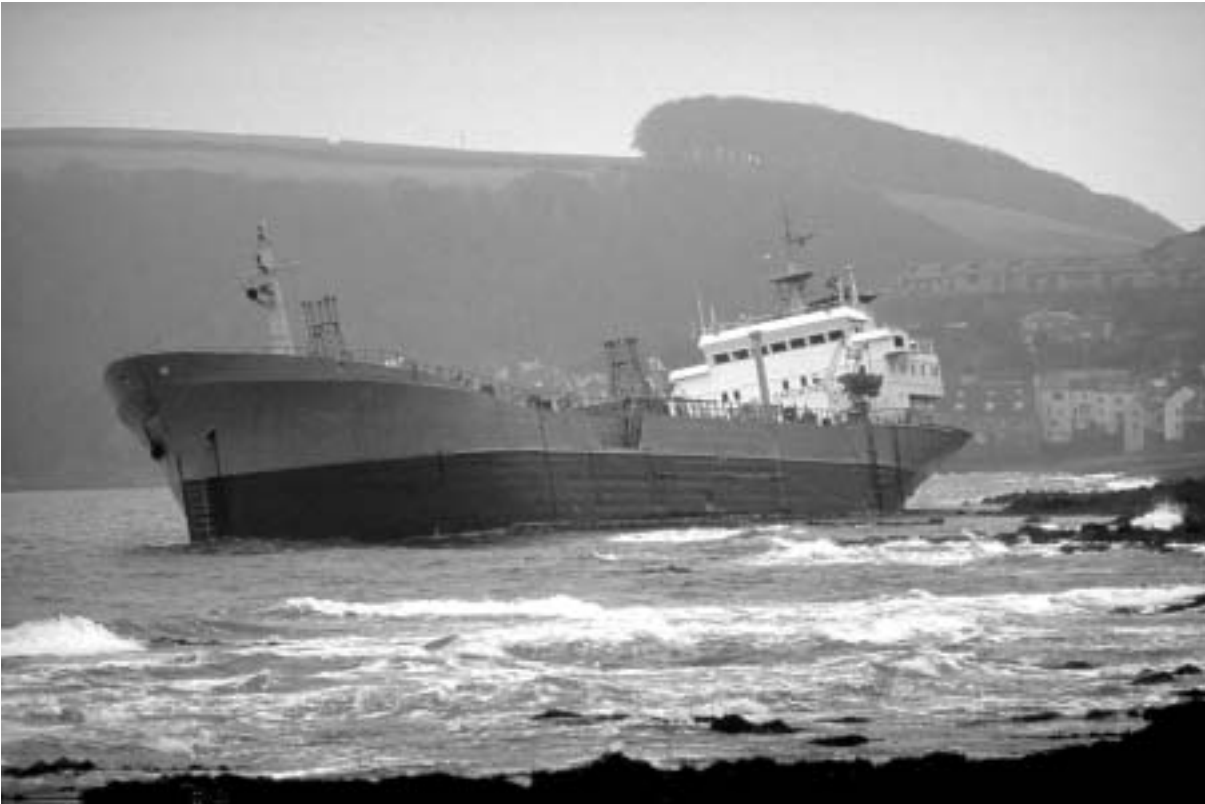
Having discharged her cargo at Cattewater, in Plymouth Sound, a 3,070gt product tanker shifted to a designated anchorage in Cawsand Bay to await orders. She anchored in a position nominated by the harbour authority, in a depth of 9.6m. She used her port anchor with 4 shackles in the water, and this gave a stern swinging circle of 1.25 cables.

The vessel remained hard aground for 10 days. She was very badly damaged and was declared a constructive total loss.

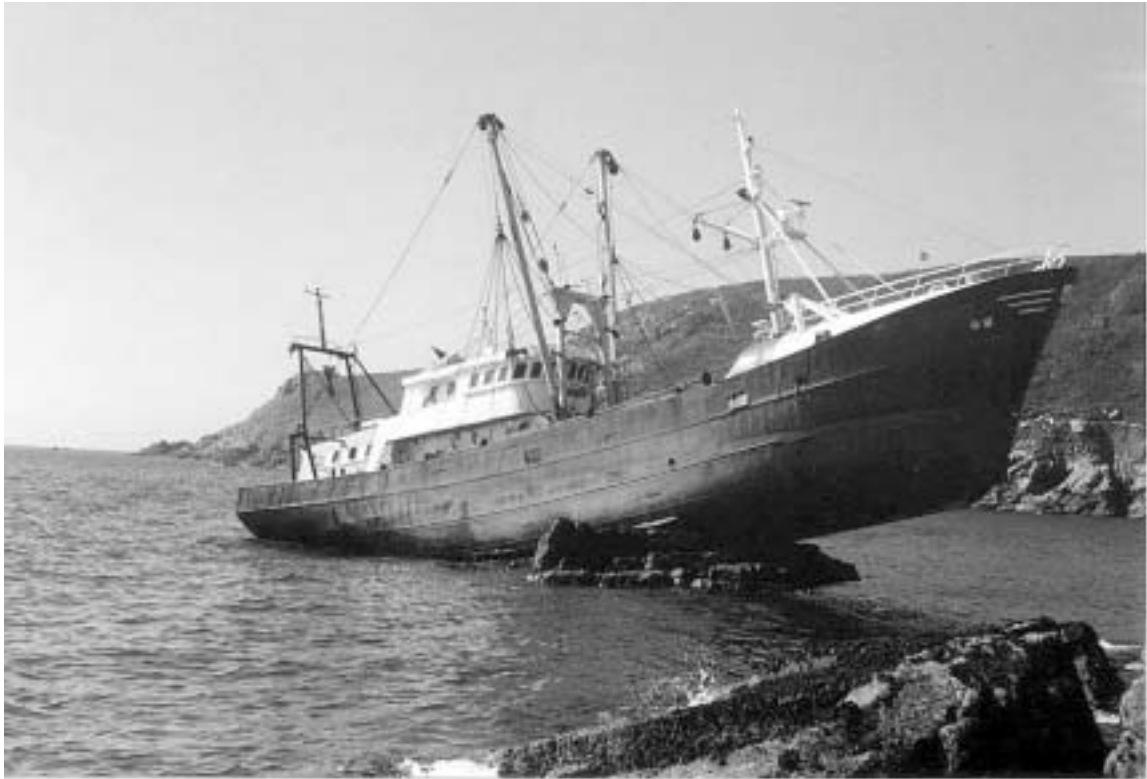
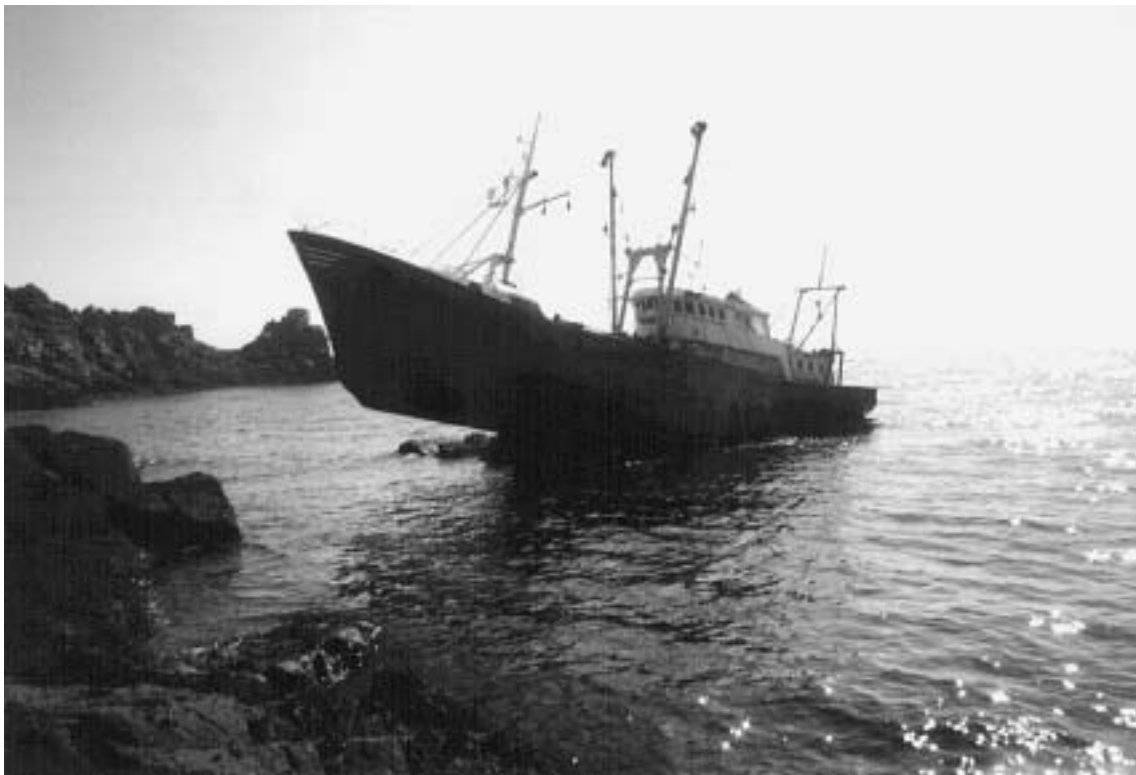
Watchkeepers, too, must take responsibility to ensure they are fit for duty, and should take every possible opportunity to catch up on lost sleep. The watchkeeper concerned in this case could have 'put his head down' for a few hours before his watch, but chose not to do so. The dramatic photographs illustrate only too well the consequences of this ill-fated decision.

2. Although not a mandatory requirement, fitting a watch alarm can be a very effective safety measure. However, if you are a fishing vessel owner or skipper, you are recommended to ensure that if one is fitted on board your vessel, it is loud enough to alert the watchkeeper, and is connected to a secondary back-up system that will alert the remaining crew should the watchkeeper, for whatever reason, fail to cancel the initial alarm.
