# Safety digest 1/2003

## **MARINE ACCIDENT INVESTIGATION BRANCH**

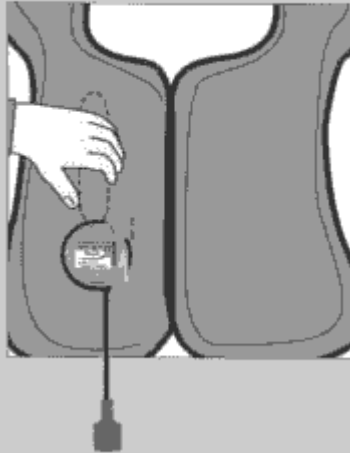
The tests revealed that the lifejackets which had failed to inflate, had probably done so because the gas cylinders had become detached from the Hammar release units.

**1. Fishermen and mariners who routinely wear inflatable lifejackets should ensure that the gas cylinders are firmly tightened into the release units. Owners of lifejackets fitted with Hammar release units are particularly urged to make this check, and should also carry out the safety checks listed in the booklet issued with every lifejacket:**

**Check that the gas cylinder is firmly tightened by holding it through the lifejacket fabric.**

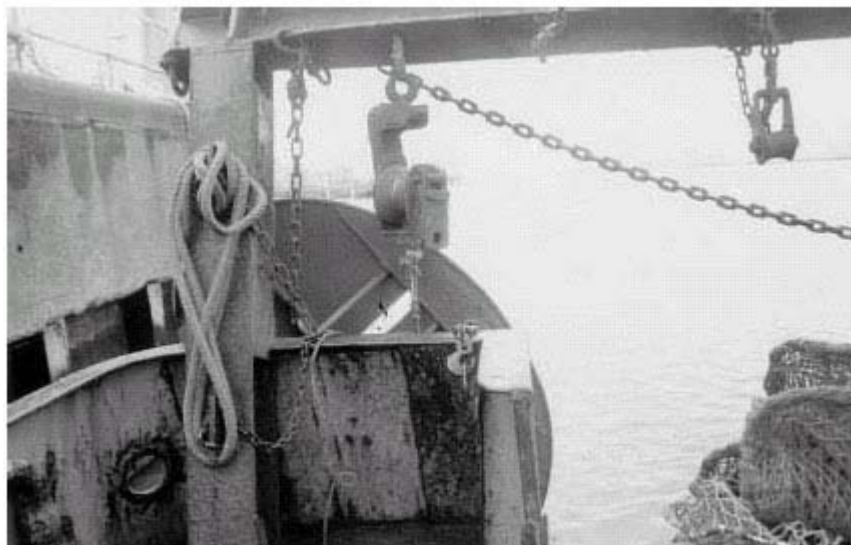
Aft deck starboard

The snatch blocks being used on the aft gantry to lead the trawl wires over the stern, were being used in the open condition. Because of the general condition of the blocks, and the lack of any locking pins, they were unable to be used in the correct manner anyway.

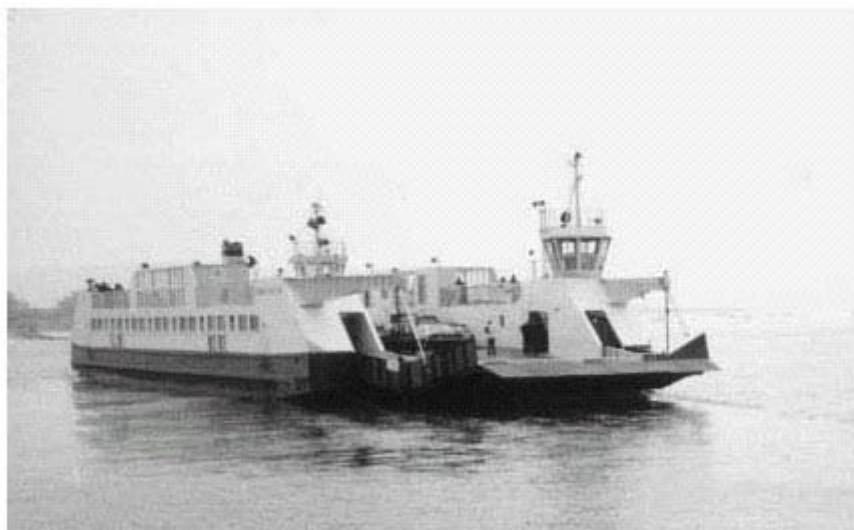
The chain ferry

Under an obligation to keep out of the way of all traffic, the skipper reversed the chain ferry to allow the leading group to pass to the south of it. However, a strong ebb tide swept the next four XODs into the side of the ferry.

Two of the yacht clubs safety/rescue boats attempted to rescue them but one damaged her propeller, and the crew of the other boat felt that the tide was too strong. Fortunately, RNLI lifeboats were nearby and were able to quickly tow away three of the XODs from the side of the chain ferry. One yacht remained, pinned to the side of the ferry. Its owner, his 72 year old wife, and one other crew member were on board.

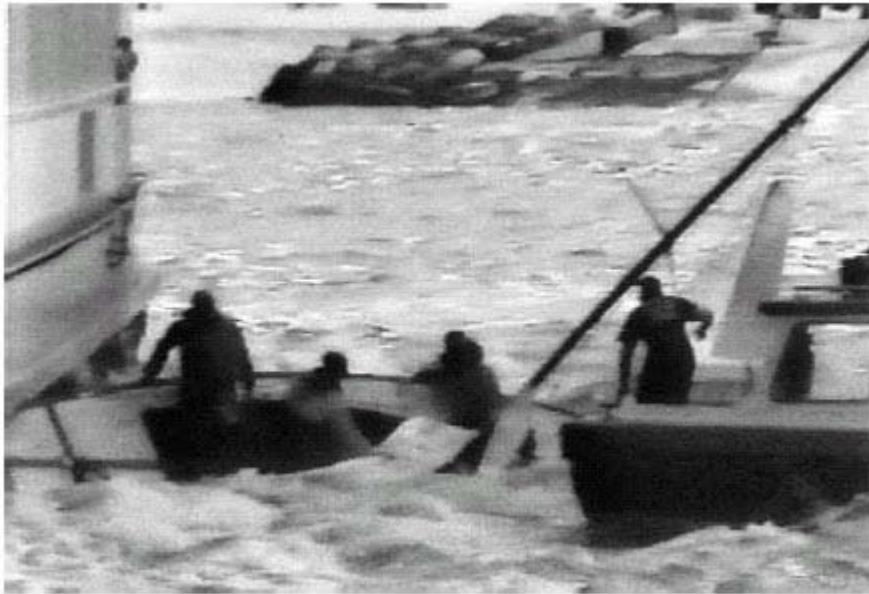
The yacht was buffeted and pounded into the ferry. She was in danger of capsizing. Water was quickly being taken on board, there was a great deal of turbulence and a very strong ebb tide. Within minutes, the boat was drawn under the chain ferry, together with the owners wife.

Image from a video recording taken at the time of the accident

**5. Safety/rescue boats should be adequately designed and equipped, and should be manned by properly trained crew.**
