Safety digest 1/2003

MARINE ACCIDENT INVESTIGATION BRANCH

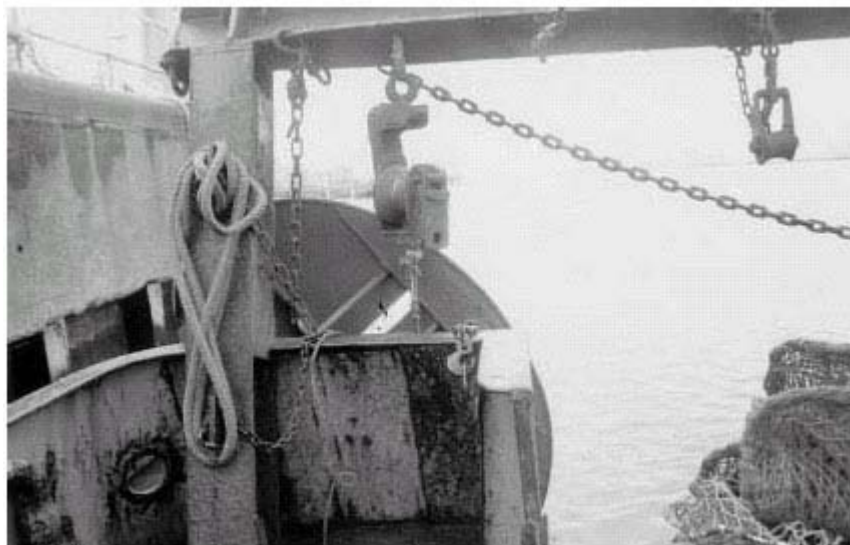
Aft deck starboard

The snatch blocks being used on the aft gantry to lead the trawl wires over the stern, were being used in the open condition. Because of the general condition of the blocks, and the lack of any locking pins, they were unable to be used in the correct manner anyway.

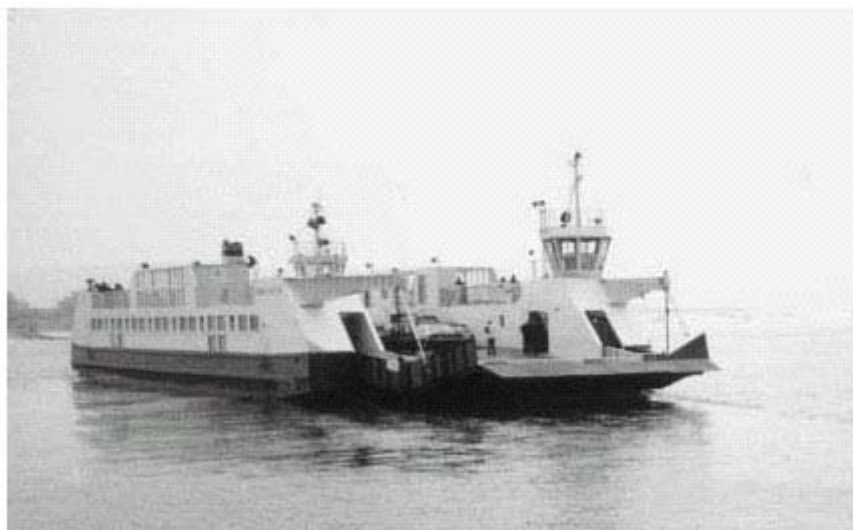
The chain ferry

Under an obligation to keep out of the way of all traffic, the skipper reversed the chain ferry to allow the leading group to pass to the south of it. However, a strong ebb tide swept the next four XODs into the side of the ferry.

Two of the yacht clubs safety/rescue boats attempted to rescue them but one damaged her propeller, and the crew of the other boat felt that the tide was too strong. Fortunately, RNLI lifeboats were nearby and were able to quickly tow away three of the XODs from the side of the chain ferry. One yacht remained, pinned to the side of the ferry. Its owner, his 72 year old wife, and one other crew member were on board.

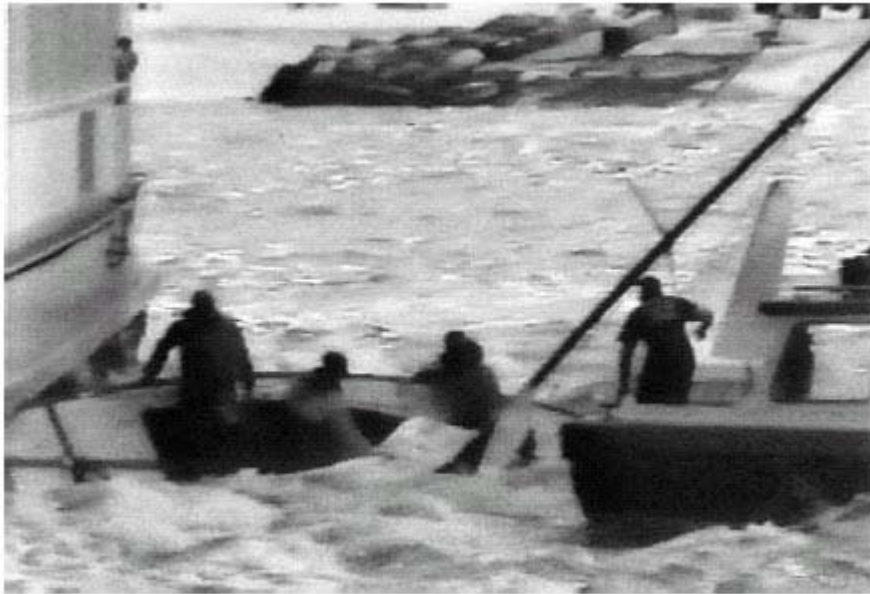
The yacht was buffeted and pounded into the ferry. She was in danger of capsizing. Water was quickly being taken on board, there was a great deal of turbulence and a very strong ebb tide. Within minutes, the boat was drawn under the chain ferry, together with the owners wife.

Image from a video recording taken at the time of the accident
