Marine Accident Investigation Branch (MAIB) - Safety Digest 3/2002

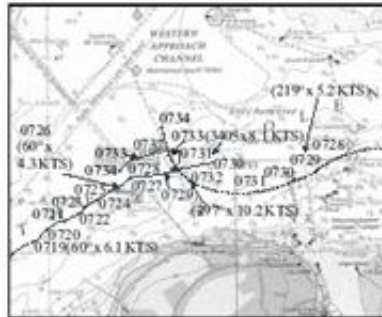
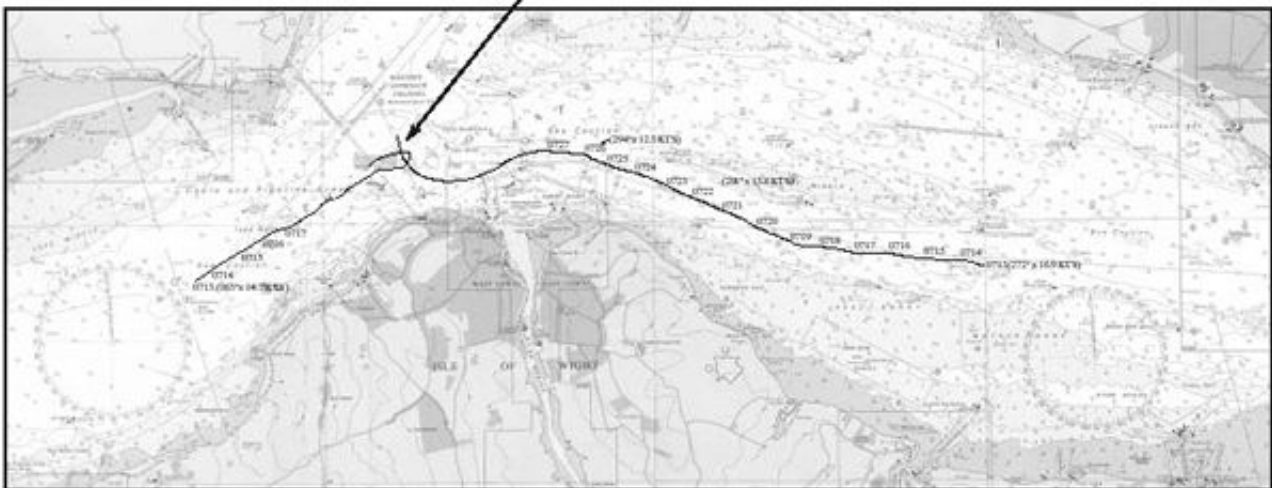
At 0729, the Cowes pilot told VTS that he was altering course to port, and asked if the container vessel would be passing astern. At that point, the container vessels pilot intervened and instructed the passenger vessel to turn around and get out of the way. The passenger vessel had, by then, crossed the south-west limit of the port of Southampton and was entering the Western Approach Channel. She started to alter her course to port and increased her speed rapidly.

At 0730, the Cowes pilot asked the container vessel which side she was going to pass. Her pilot replied to the effect that he was about to turn to starboard into the Thorn Channel.

As the passenger vessel turned on to a westerly heading, the container vessel turned to starboard and passed astern at a distance of about 1 cable.
