Marine Accident Investigation Branch (MAIB) - Safety Digest 02/1997

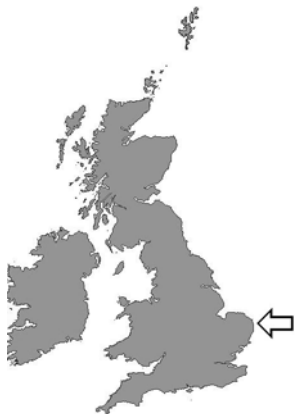
Reproduced from Admiralty Chart 1536 by permission of the Controller of HMSO and the Hydrographic Office.

A general cargo vessel of 1,960 GT loaded with potash was approaching Great Yarmouth from the south-east via Holm Channel (see chart extract). The Master had the con and was the only person on the bridge. The vessel was being steered by auto-pilot. The wind was westerly Force 2 with good visibility and there was a southerly tidal stream of about one knot. The time was about 0530 and it was dark.

After leaving Cort on buoy to port, the speed of the vessel was reduced to Half Ahead. The auto-pilot was set to steer a course of 300° but due to the effect of the tidal stream the vessel made good a course of 297°. In order to leave NE Holmbuoy to port, the auto-pilot setting was altered to 330° and the vessel initially made good a course of 325°. However, the Master then observed Holm Sand buoy on the starboard bow and altered the auto-pilot setting to starboard in order to counter what he considered to be the increased effect of the southerly set.

Shortly afterwards the Master realised that both the auto-pilot and gyro compass had failed and attempted to prevent the vessel from running aground on Holm Sand by changing over to hand steering and applying full starboard helm. His action was too late to prevent the vessel from grounding. The vessel remained aground for a day but was not seriously damaged.

3. The cause of the electrical failure which led to the failure of both auto-pilot and gyro compass was never discovered, but four fuses were reported to have failed. Whatever the reason, it happened at an awkward moment and could happen again.

1. The good seaman knows that when navigating in shoal waters, and especially in a narrow channel, a vessel should be in manual steering with a dedicated helmsman. This Master did not comply and found himself unable to take sufficiently early corrective action when something went wrong. The steering failed, the Master was slow to notice it and the vessel grounded. This accident highlights the real risks arising from one man bridge operation in confined waters. The lesson is to

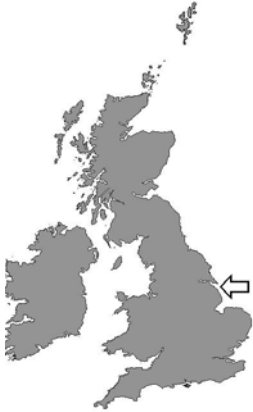
The cargo vessel was slightly to the north and the fishing vessel was slightly to the south of the channel between the north-east extremity of Bull Anchorage and the Chequer Shoal (see chart extract). When the range had closed to one mile, the Master of the cargo vessel noticed the fishing vessel's echo on his radar and assumed that he would pass starboard to starboard. The Skipper of the fishing vessel on the other hand, having also detected the cargo vessel on his radar at short range, altered course to starboard to pass port to port. Despite the poor visibility both vessels were proceeding at their full service speeds.

Spurn Pilot Station watch keepers, who were monitoring the developing situation on radar, contacted the cargo vessel on VHF and informed the Master of the presence of the fishing vessel. Although both vessels realised that a close quarters situation was developing, neither slowed down. The Master of the cargo vessel attempted to contact the fishing vessel on VHF Channel 14 (Spurn Pilot Station) to confirm a starboard to starboard passing but failed. The fishing vessel was, correctly, monitoring the VTS VHF Channel 12.

The two vessels collided. Both vessels were damaged but were able to continue under their own power. There was no pollution and nobody was injured.

2. There was nothing new in the causes of this accident. Following the late detection of each other on radar, those in charge of both vessels made the classic error of taking action on the basis of insufficient information. Both assumed the other would take a particular course of action. Both were wrong. They collided.

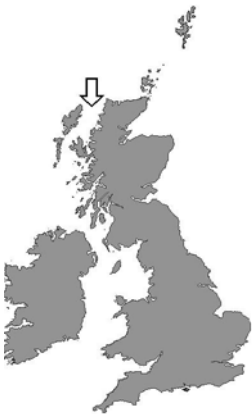
The incident occurred when en route between the Republic of Ireland and the Baltic on a north-about passage through The Minches. The weather was fine and the visibility clear. The Master had an uneventful watch between 1800 and 2400. Towards the end of his watch the Master called the Chief Officer, who had been asleep in his cabin, to relieve him on the bridge. While waiting for his relief the Master sat in the watch keeper's chair and fell asleep. The vessel was not fitted with a bridge watch alarm nor had a lookout been posted. The vessel continued on auto-pilot past a planned alteration of course position. The Chief Officer meanwhile, had gone back to sleep. The Master, and everybody else on board, was woken when the vessel grounded at 0150. Attempts to refloat her failed and, in deteriorating weather, the crew were airlifted to Stornoway. The twenty year old vessel was later declared a constructive total loss.

- a) There is a growing tendency for short sea traders to adopt one-man bridge operation at night in contravention of International Maritime Organization (IMO) Regulations.
- b) Although encouraged, or required by owners to do so, Masters regularly fail to post a lookout.
- c) Bridge watch alarms, when fitted, are often defective, are deliberately switched off or are not remoted to another part of the ship where they can be heard by either the Master or another officer not on watch.

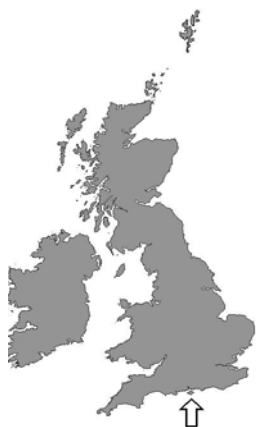
The passage necessitated making a tight turn to port to follow the main channel around a sand bank. As part of the passage planning, the pilot and the port VTS officer had fully discussed the proposed manoeuvre. When the vessel was in the appropriate wheel over position the pilot ordered "hard to port" and automatically checked the rudder indicator. He noted that only 30° of helm had been applied but as this was not unusual, he was not unduly concerned. The actual rate of turn (ROT) of the vessel could not be determined as her ROT indicator was inoperative. Half way through the turn the pilot realised that the ROT had decreased to an extent where he felt it was prudent to assist the turn by applying more wheel and ordered "fullhard to port". The indicator reflected 37° of port rudder, the ROT increased and the turn continued in the normal manner.

With full port rudder and a speed of about 8 knots, the VLCC continued to turn. The pilot informed the escort tug that the VLCC had suffered a system failure and ordered the tug to pull on the port quarter with full weight. Almost simultaneously he ordered "stop engine" and "full astern". The anchor party was told to lower both anchors to the water.

Using a combination of the VLCC's engines and the escort tug, the pilot managed to stop the turn and arrest headway within four minutes of the initial failure. There was no requirement to use the anchors and the VLCC ended up only 1.5 cables from the edge of the sandbank.

The cause of the "steering failure" was never determined and, as it did not result in an accident, there was no obligation to report it to the MAIB. The Branch often hears of steering failures, usually long after the event, involving vessels in pilotage waters but which do not lead to an accident. Masters, Pilots and Port Authorities are urged to inform the MAIB of any such incidents so that any designed effects, material factors or inadequate operating procedures can be identified and the appropriate recommendations made.

- 4 Although not a specific recommendation arising from this "near miss", the value of thinking through such an occurrence in advance, and planning a range of corrective measures, cannot be overemphasised. Simulator training for such eventualities is highly recommended when propulsion failures or steering breakdowns in pilotage waters can be introduced for pilots (and ship's officers) to handle without suffering any of the consequences. Simulators can also aid harbour authorities in assessing risk.

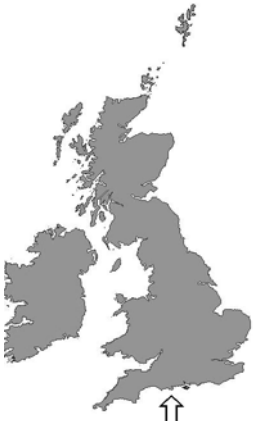
upper deck and normally took day trippers from Poole around the large extensive natural harbour. Occasionally the vessel was chartered for evening cruises during which the on-board bar was stocked and staffed by additional crew.

On the night of the accident the vessel was booked for a local club's annual function for a harbour cruise and a passage up the adjoining river to Wareham. It was a fine summer's night, with light winds and clear visibility, but fog was forecast. 112 passengers, two crew and three bar staff were embarked. The launch was not fitted with radar.

In this instance no harm came to the vessel, passengers or crew but the lessons learned should prevent a more serious situation arising next time.

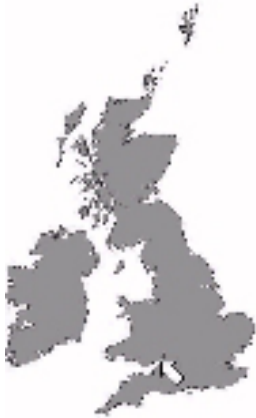
A UK registered sail training vessel was outbound in the River Severn on passage from Sharpness to Barry at the time of the incident. She was carrying twelve crew and twenty trainees. The weather was favourable with good visibility and the tide was ebbing. A pilot was on board and the vessel was making a speed of about 7 knots under power (the sails had not been set).

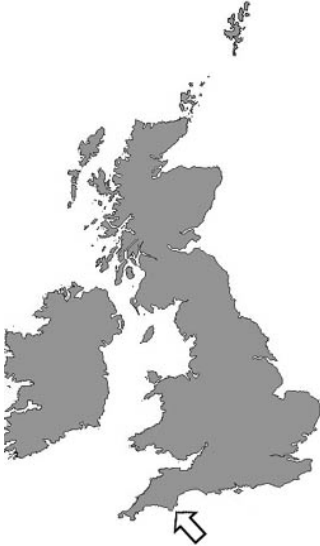
A fishing vessel was on passage from Cherbourg to Kings wear, Devon, making good about 8 knots. It was night and the Skipper was alone on watch in the wheelhouse. There was a slight south-westerly sea and the range of visibility was between 6 and 8 miles.

The auto-pilot was steering a magnetic course of approximately 290°, the VHF radio was monitoring Channel 16 and the radar was operating on the 3-miles range scale. The vessel was exhibiting appropriate navigation lights for a power-driven vessel underway.

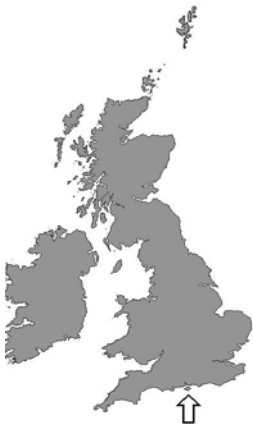
A small sailing yacht was chartered for a weekend in early April by a group of three men who intended sailing from Portsmouth to Hythe, near Southampton. The weather forecast was for westerly winds of Force 5 to 6 increasing to 7 later in the Western Solent. The yacht was a small fractional rigged sloop with a lifting keel and a length overall of 6.4 metres. The charter company had a fleet of these craft and used them for individual "bareboat" charter and for group activities which included racing. In the winter months the craft were confined to sailing within Portsmouth Harbour.

The passage through the harbour passed without incident but the wind strength increased as they emerged into the Solent and continued to sail close-hauled towards the Isle of Wight. The land provided some shelter as they began to tack westwards. Despite the poor conditions, the crew chose not to don life-jackets until they started a longer tack to the north to enter Southampton Water.

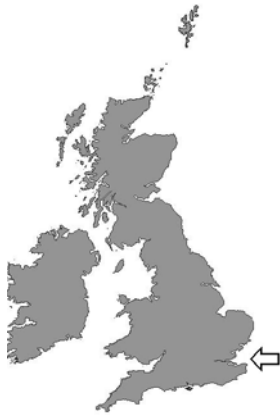
A 9 metre long fully decked motor cruiser was purchased by a private individual with the intention of using it for pleasure purposes on the upper, non tidal, reaches of the River Thames. Before setting out on her final voyage, the vessel was moored in another river which flows into the Thames

The new owner wished to sail the vessel to its intended area of operation but, due to his lack of experience, employed a certificated delivery Skipper to undertake the passage. The Skipper, the owner and a friend arranged to be on board during the 50 mile passage.
