Marine Accident Investigation Branch (MAIB) - Safety Digest - Fishing 2000

This *Safety Digest* draws the attention of the fishing community to some of the lessons arising from investigations into recent accidents. It contains facts which have been determined up to the time of issue.

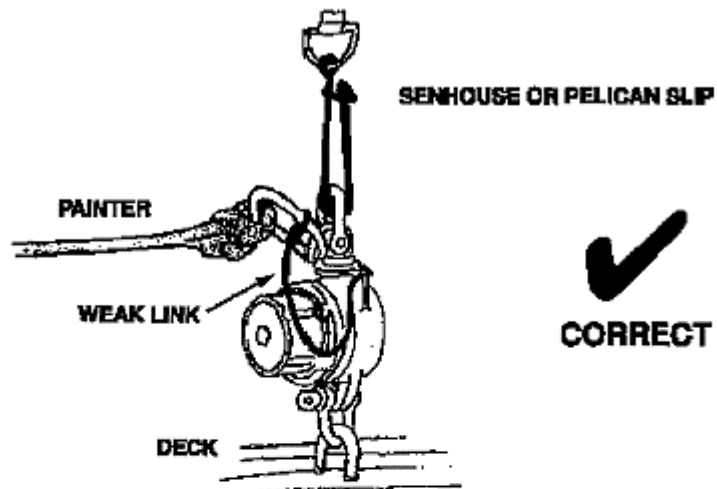
BERWYN MK 7 TYPE HRU

LIFERAFT WILL NOT RELEASE FROM CRADLE IF THE SHIP SINKS

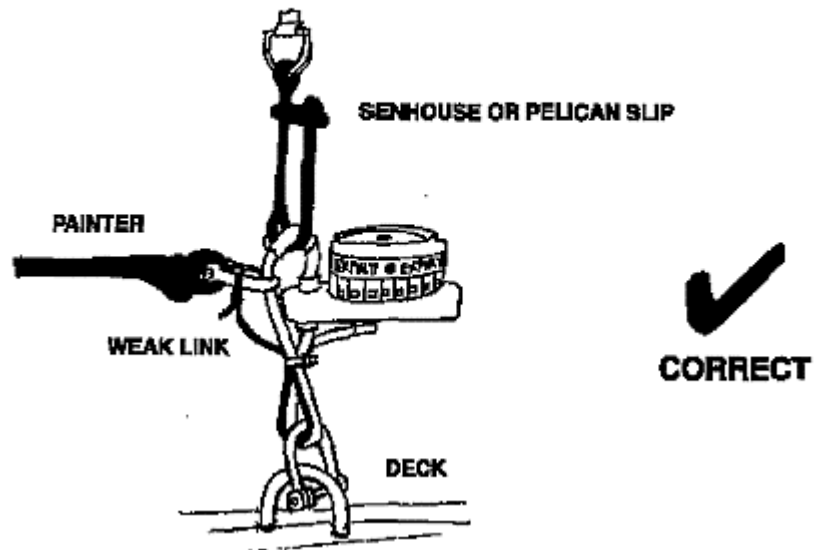
HAMMAR DISPOSABLE TYPE HRU

WILL WORK CORRECTLY ON AUTOMATIC RELEASE BUT THE LIFERAFT WILL ONLY BE SECURED BY THE WEAK LINK IF THROWN OVERBOARD - WEAK LINK MAY BREAK AND LIFERAFT WILL BE LOST
