MARINE ACCIDENT INVESTIGATION BRANCH

TIMBER DECK CARGO STUDY

Safety Study No 1/2003
August 2003

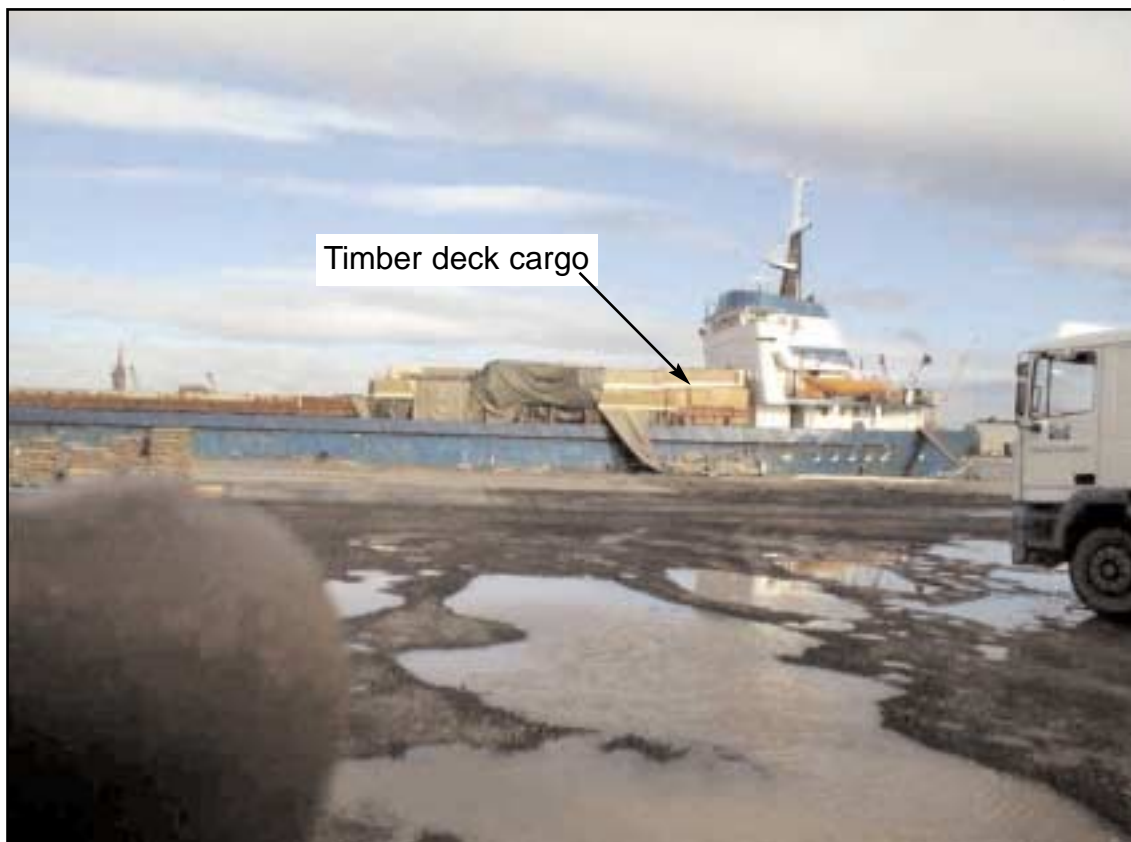
Figure 2

The vessel eventually reached a Scottish port and berthed port side to (**Figure 2**). In the early hours of the morning, the crew began preparing the cargo for unloading. All the lashings had been removed (**Figure 3**) and, while the tarpaulins were being taken off, a section of cargo at the aft end on the port side collapsed (**Figure 4**). While rolling up a tarpaulin at this position, a crew member fell over the side, along with the planks from the broken packages. He hit his head on the dockside, before falling into the water.

Looking forward on port side

2. If a timber deck cargo shifts at sea, it should be unloaded with extreme caution when in port. If possible, the crew should avoid standing on the stow, and the use of cherrypickers should be considered for releasing the lashings and removing the tarpaulins. If crew are sent out on top of the cargo they should wear lifelines.

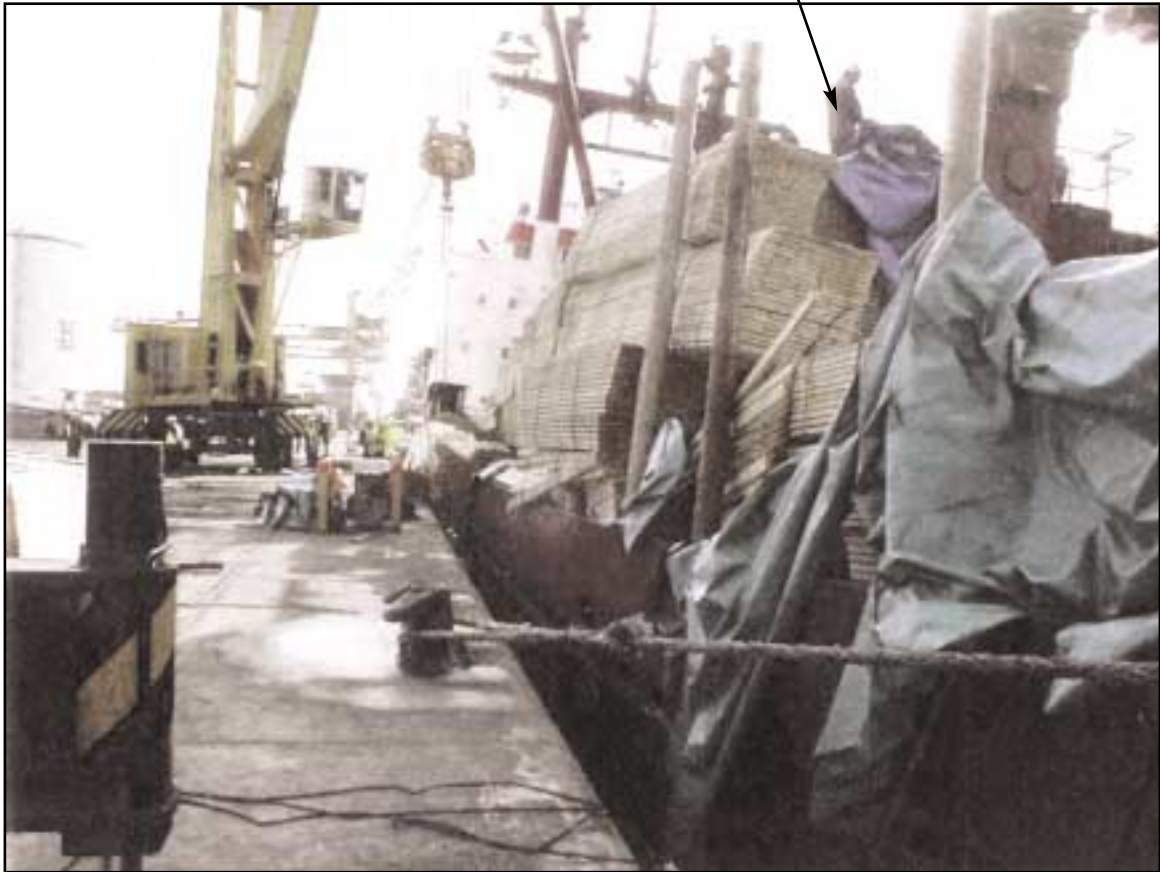
Figure 13

Height of deck cargo can be judged against this stevedore

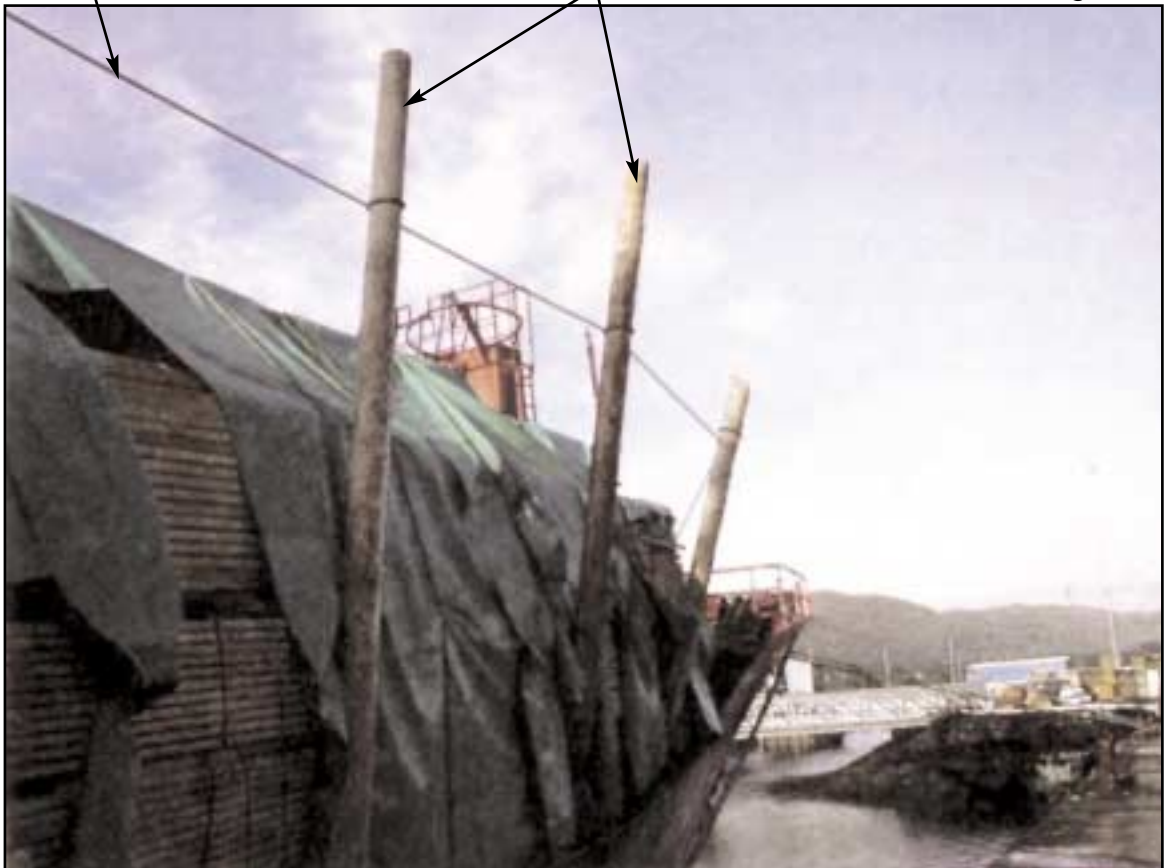
Figure 14

A vessel, 97m in length, loaded a cargo of sawn timber in Russia. The planks were bundled into packages which were stacked in tiers on top of the hatch covers. When all the packages were on board, the deck cargo was covered with tarpaulins and lashed down. Turnbuckles were used to tension the lashings, and senhouse slips were incorporated in the system (**Figure 12**). The deck cargo was stacked relatively high (**Figure 13**), and uprights, consisting of logs held in position by ropes tied around and between their tops, were used to help secure the stow (**Figure 14 & 15**).

Rope tie

Uprights

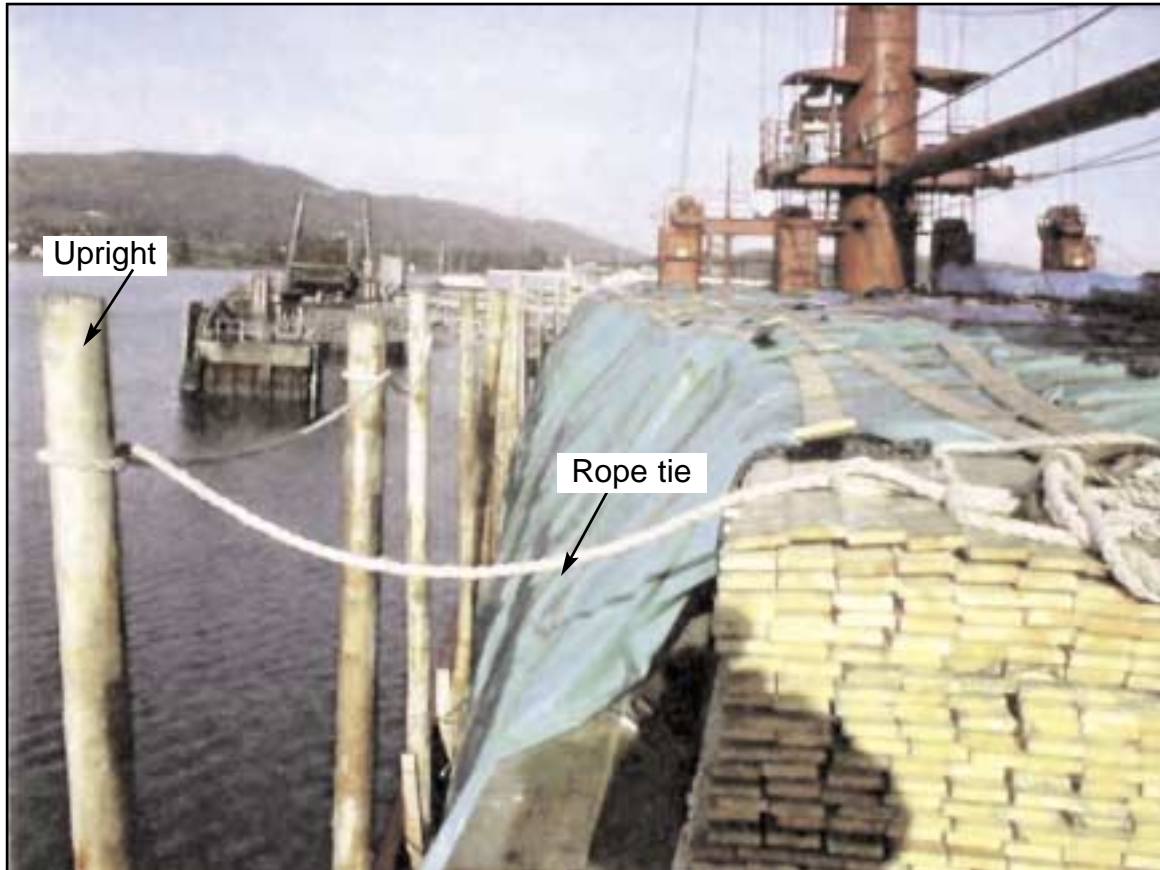
Figure 15

Looking forward on starboard side

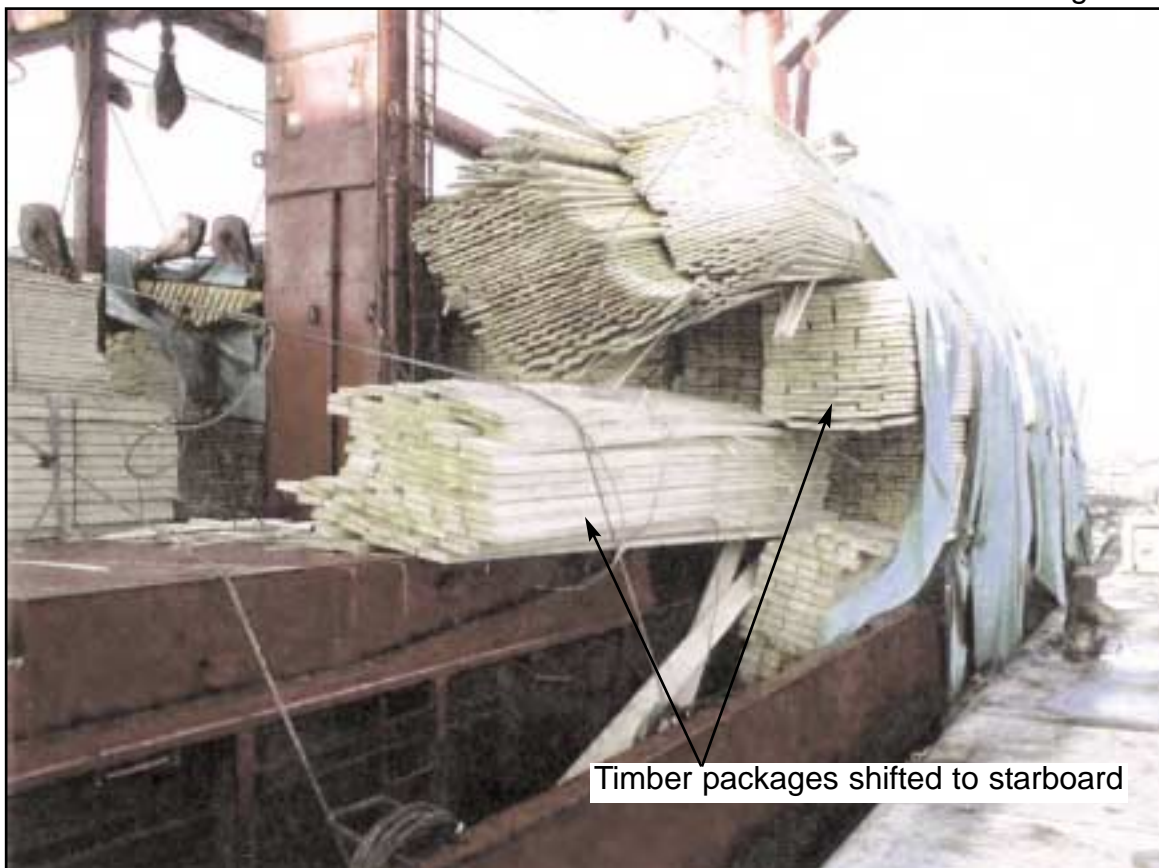
Figure 16

While on passage to Northern Ireland during the autumn, the vessel encountered heavy weather to the west of the Orkneys. A large wave hit the vessel on the port side and shifted the deck cargo on Nos. 2 & 3 hatch covers (**Figure 16**), causing a starboard list of about 35°. To save the vessel, the crew released the senhouse slips (**Figure 17**) in the lashings over No. 3 hatch. Most of the timber on this hatch cover then fell over the side, as the vessel rolled, and the uprights on the starboard side aft went over with it (**Figure 18**).

Looking forward on port side

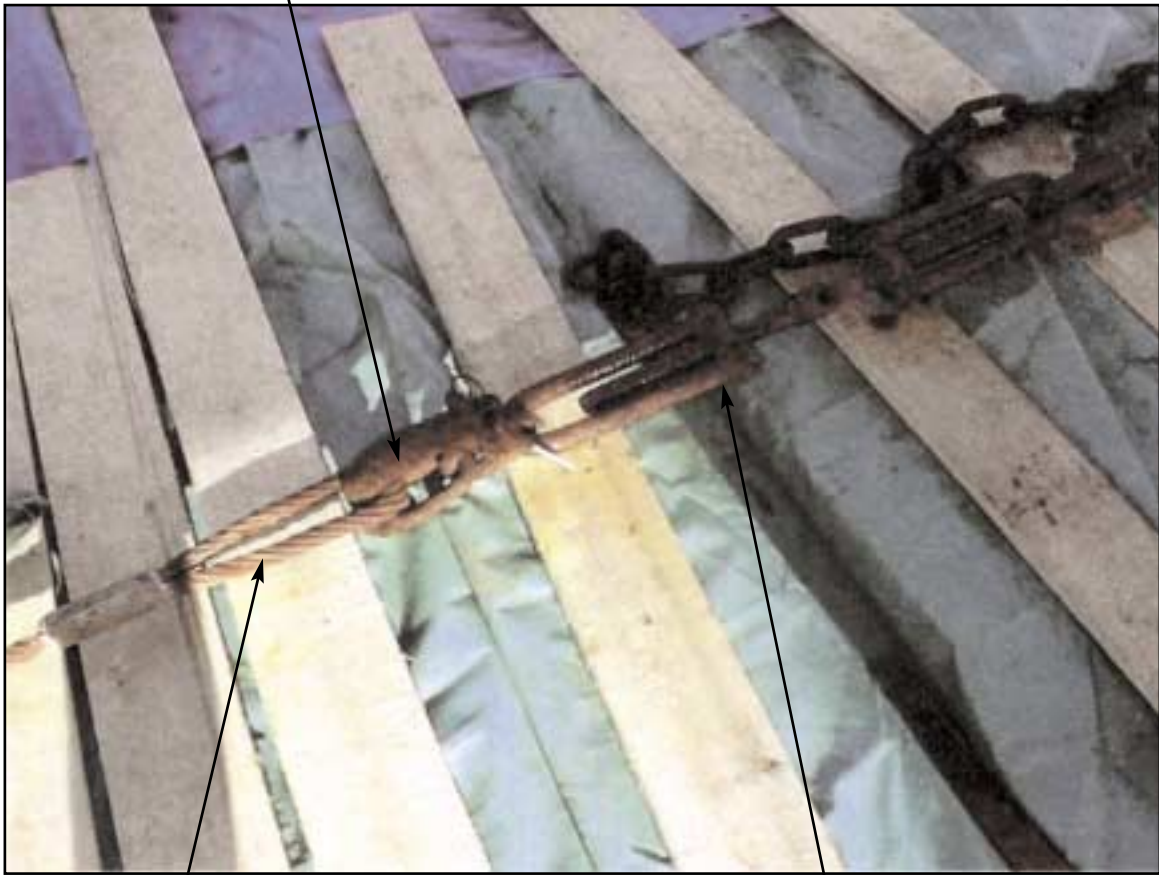
Figure 17

Looking forward on starboard side

Senhouse slip

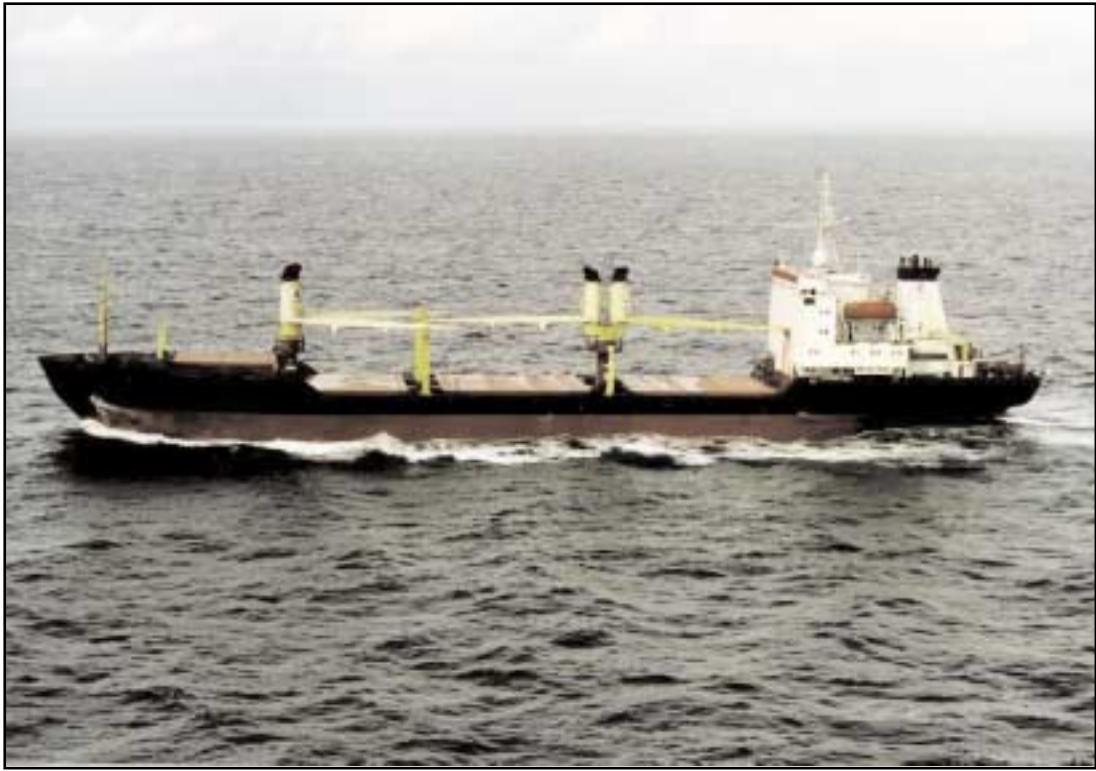
Figure 20

Although speed was reduced from 12 knots to 8 knots, large quantities of water were shipped on to the deck cargo. About 2 hours after darkness had fallen, loud bangs were heard from the cargo deck as two of the wooden uprights (**Figure 20**), used to help secure the stow, were broken. The master realised the deck cargo had started to shift, and altered course to port to close the French coast; the nearest place of safety. Speed was also increased to 12 knots. On the new course, the sea was about 35° on the starboard bow, and the vessel started to roll more heavily. About 20 minutes later, the vessel rolled heavily to port, which caused the deck cargo to shift about 0.5m across the deck and break all of the remaining uprights on the port side. The vessel immediately listed to between 10° and 15° to port.

Vessel shown without deck cargo

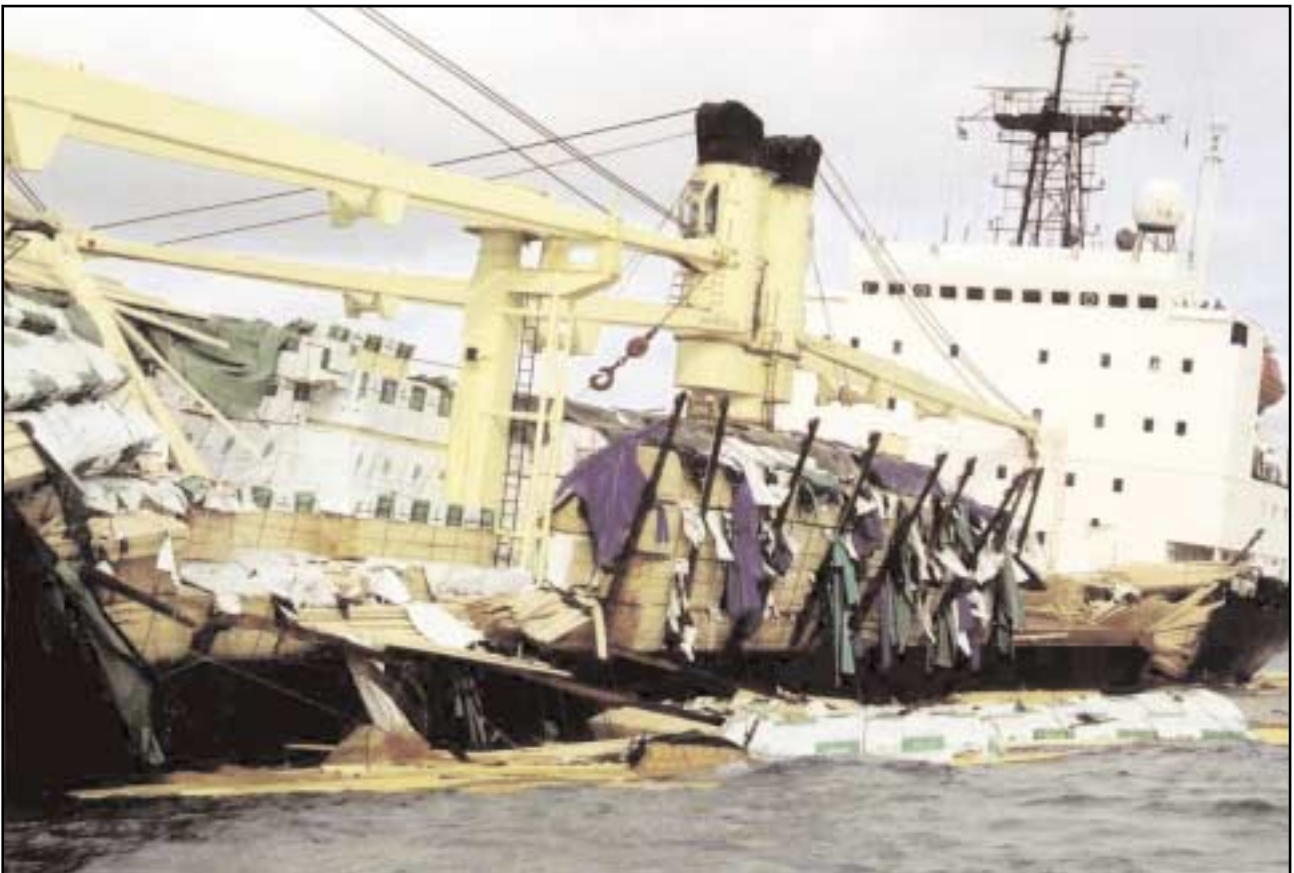
Figure 22

Jettisoned timber packages

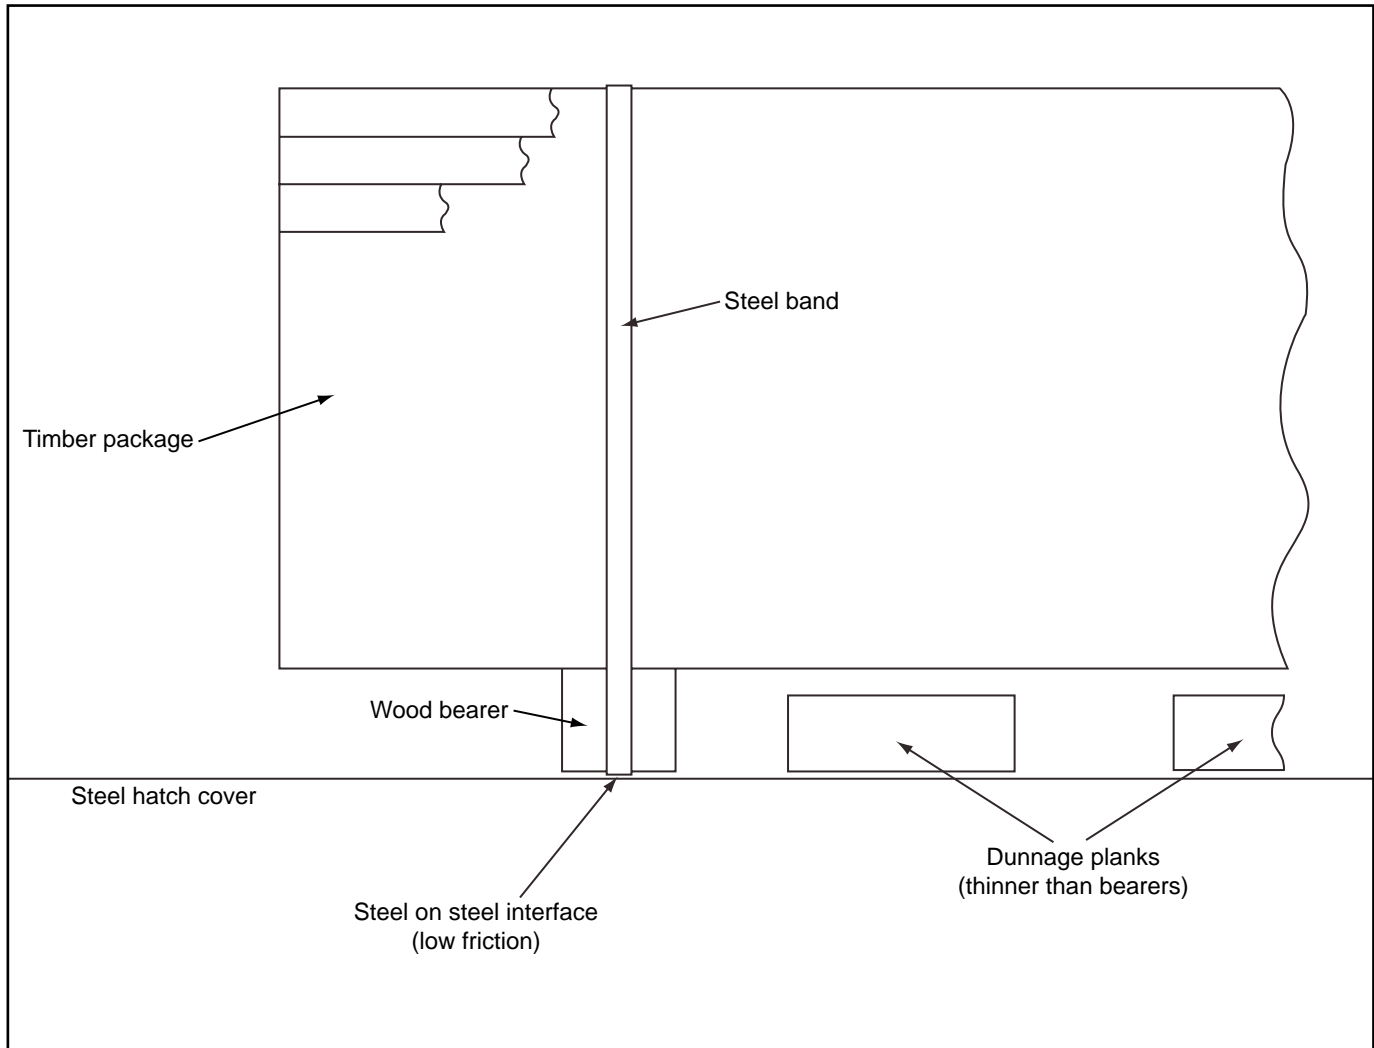
Failed timber rail

Looking forward at main deck level on the starboard side

1. If timber rails are fitted, they should have adequate strength. Detailed structural calculations should have been made to ensure they were strong enough, and this should have been verified by a classification society.
2. The friction between timber deck cargoes and the hatch covers should be maximised. In particular, steel on steel interfaces should be avoided, as the friction is very poor. Wood against steel is much better. Painting the tops of the hatch covers with high friction paint is good practice, especially if deck cargoes are to be carried.

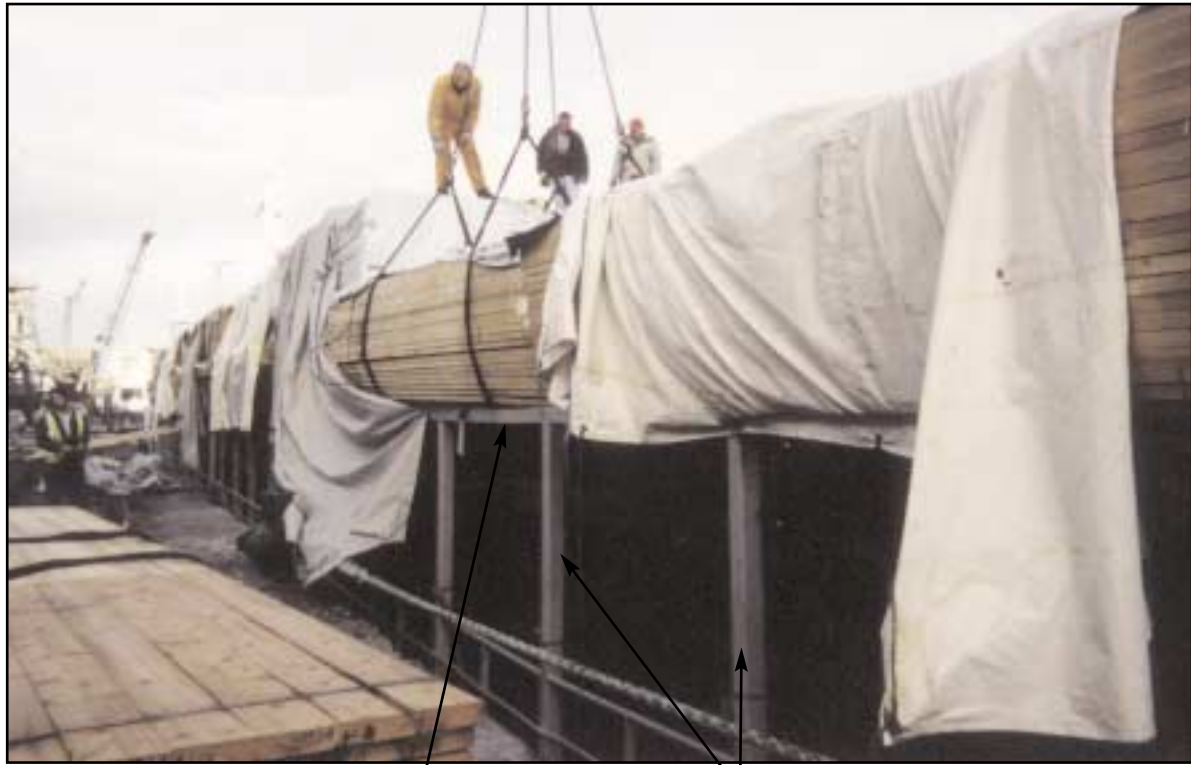
Figure 27

The friction between the lower tier and the hatch covers might well have been poor, but the timber rail prevented this layer from moving transversely. The timber rail comprised a steel framework consisting of stanchions along the main deck (**Figure 27**), which were connected to the sides of the hatch coamings with tie bars. An angle bar was welded to the tops of the stanchions. The timber deck cargo rested mainly on the hatch covers, but the outer parts rested on one surface of the angle bar. The upright part of the angle bar stopped the cargo shifting transversely (**Figure 28**).

Looking aft on port side

Timber rail

Stanchions
