**SAFETY STUDY 1/2001**

**REVIEW OF  
LIFEBOAT AND LAUNCHING SYSTEMS'  
ACCIDENTS**

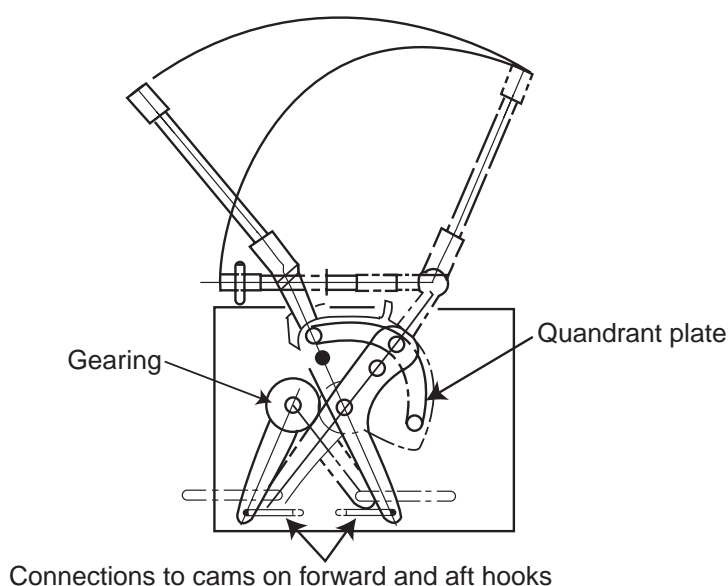
Figure 2

Analysis of a number of accidents reveals that premature hook release has often been caused by the failure to re-set it correctly when the lifeboat was being recovered from its previous launching. This shortcoming stems from a lack of understanding of the mechanism involved, inadequate training and poor maintenance. Once the hook has been incorrectly reset, spontaneous release is possible at any time before the lifeboat is next put in the water **(see Figures 2 and 3)**.

This is compounded by the complexity of the mechanism and operating instructions that are difficult to understand. The diagram, showing the important features of resetting the mechanism, is complicated and makes it necessary to be able to clearly see the actual mechanism to understand its workings. However, viewing the mechanism is difficult, making understanding of the diagram difficult. Other material in the manufacturer's instruction manual was of little help in this task.

The central operating lever is placed adjacent to the coxswain's position, often in such a fashion that the gearing, quadrant and very important safety pin cannot be viewed easily. Indeed it is often impossible for the user to obtain the same view of the mechanism as it is shown on the instruction panel, he can see it only from above, making the important components difficult to identify. This problem is aggravated by these parts being below the bottom boards of the boat in an area of darkness.

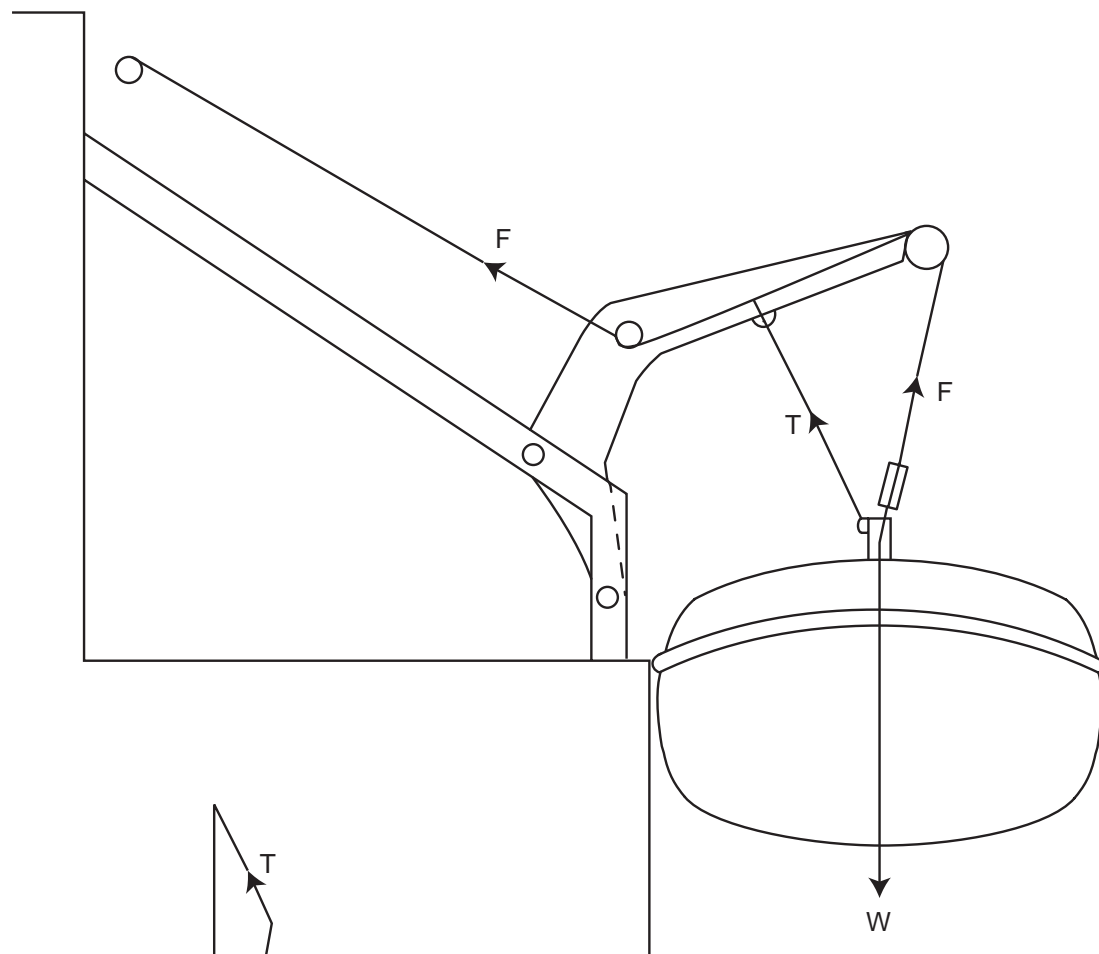
Figure 5

Lifeboat lowered to embarkation level. Winch is stopped at a position such that the tricing pendants have pulled the boat almost into contact with the ship's side, or in very light contact only. The boat's weight ( $W$ ) is shared between the tricing pendants ( $T$ ) and the falls ( $F$ ). Note that the tricing pendant load ( $T$ ) is noticeably less than the boat's weight ( $W$ ).

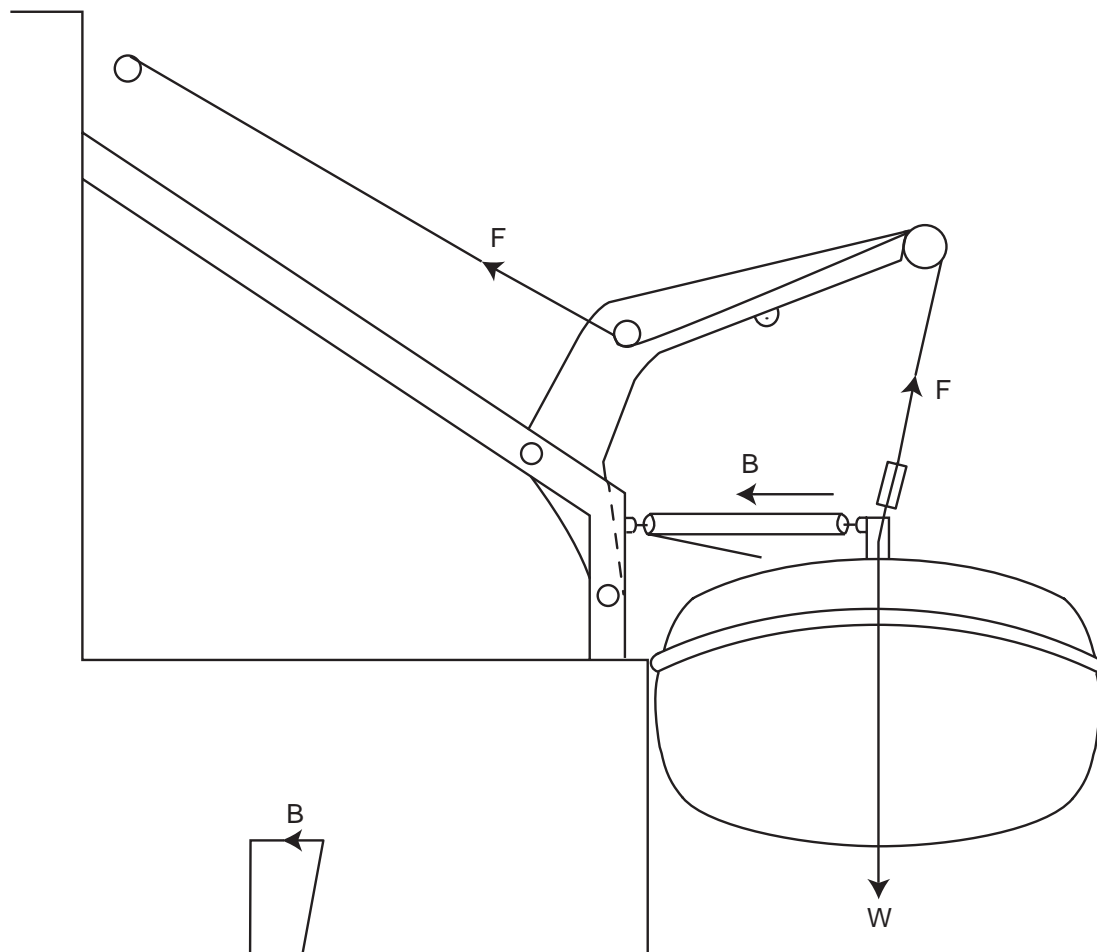
Figure 6

Lifeboat lowered to embarkation level, triced in and the bowing tackles fitted. Once tricing pendants are slipped, properly tensioned bowing tackles retain the lifeboat into the ship's side. Because the bowing forces are virtually horizontal, only the falls load ( $F$ ) supports weight ( $W$ ), as intended. Also,  $F$  is acting in the back falls and contributes to the support of the davit arms.

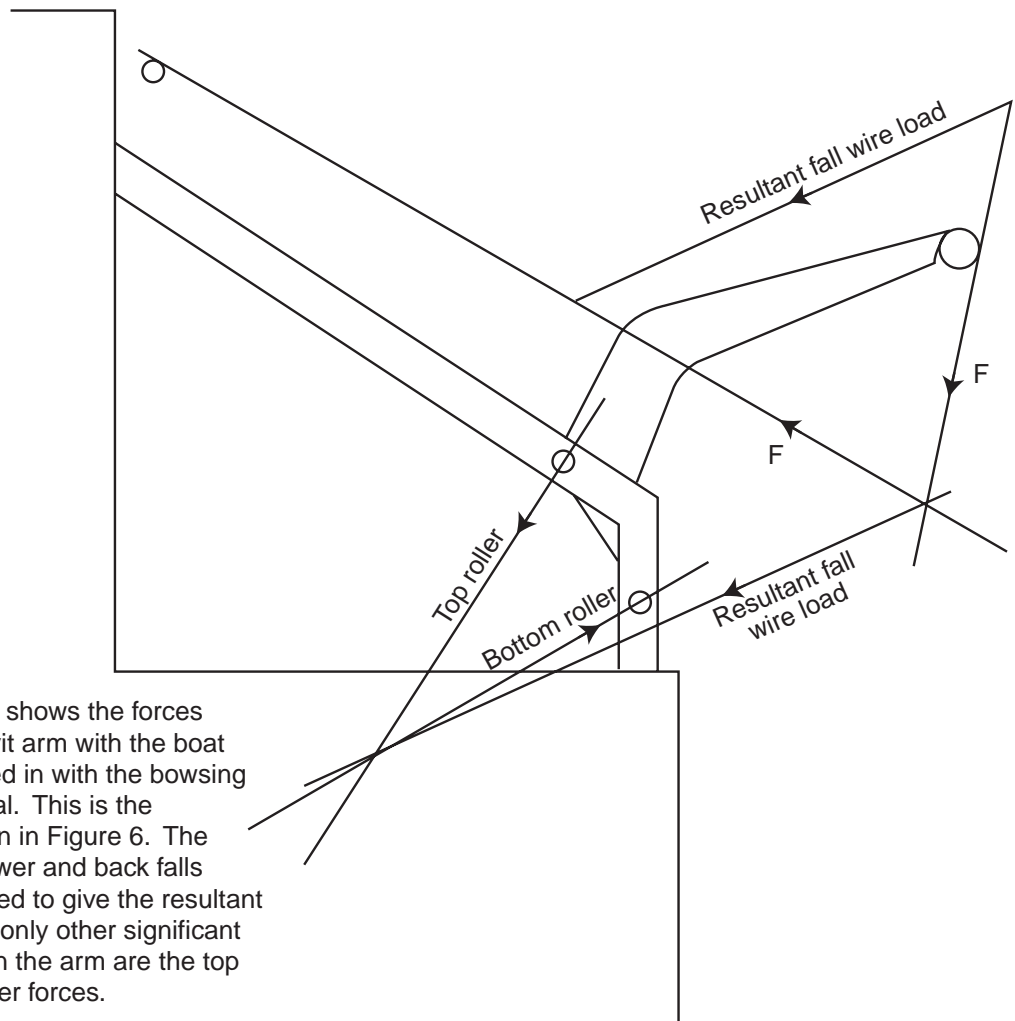
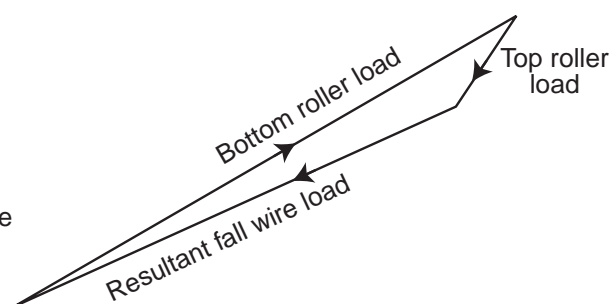
Figure 9

A further consequence of not properly bowing in a lifeboat can occur if the load bearing capacity of the davit arms is dependent on support offered by the back falls which lead inboard from the davit heads (**see Figure 9**). With the lifeboat at embarkation level, and supported by falls and tricing pennants, its weight is shared between them. The greater the proportion of weight taken by the tricing pennants, the less will be taken by the falls. This gives a corresponding reduction in the load on the back falls, which means that their contribution to supporting the davit arm is reduced. This results in an increased portion of the load being taken on the supporting structure of the davit arm and can, on some designs, overload it if the boat is fully laden (**see Figure 10**).

Above diagram shows the forces acting on a davit arm with the boat properly bowsed in with the bowsing tackle horizontal. This is the condition shown in Figure 6. The forces in the lower and back falls have been added to give the resultant wire load. The only other significant forces acting on the arm are the top and bottom roller forces.

The diagram to the right is the above force system giving the relative magnitudes of the forces.
