CONTENTS

SPECIAL BULLETINS

(ALL TIMES IN THIS BULLETIN ARE UTC)

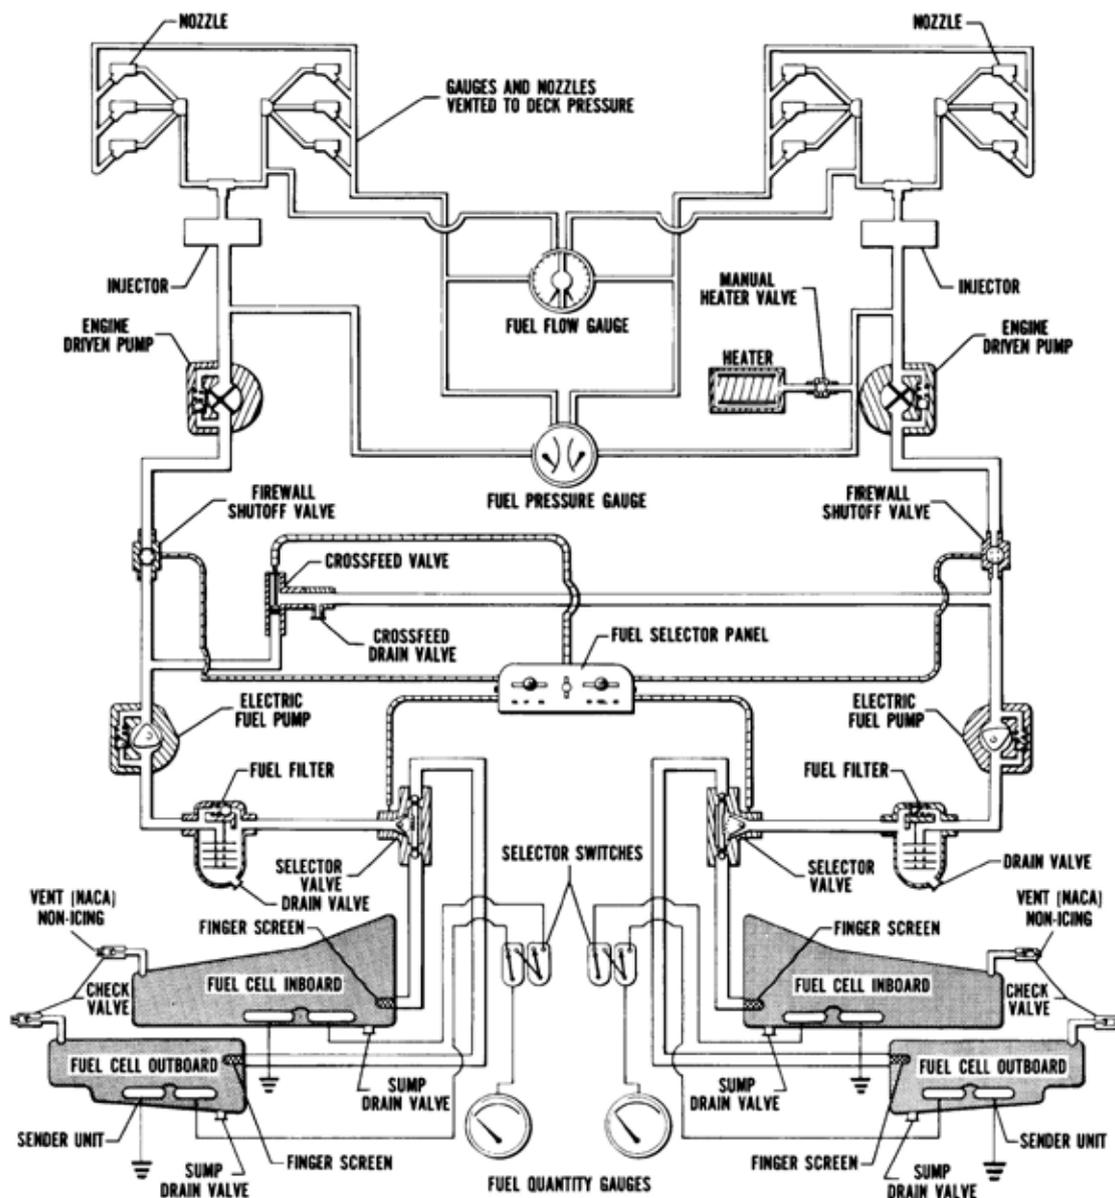
Figure 1

Fuel is drawn from each tank, through a screen located in the tank outlet fitting and on to the fuel tank selector valve. From the fuel tank selector valve it passes through the fuel filter, the electrically driven fuel pump and the firewall emergency shutoff valve to the engine-driven pump.

PA-31-310 Fuel System Schematic
