CONTENTS

(ALL TIMES IN THIS BULLETIN ARE UTC)

ACCIDENT

Aircraft Type and Registration:	Dassault-Breguet Mystère-Falcon 900B, G-HMEV	
No & Type of Engines:	3 Honeywell TFE731-5BR-1C Turbofan engines	
Year of Manufacture:	1986	
Date & Time (UTC):	20 January 2007 at 1651 hrs	
Location:	Approximately 7 nm south-west of Worthing, Sussex	
Type of Flight:	Commercial Air Transport	
Persons on Board:	Crew - 2	Passengers - None
Injuries:	Crew - None	Passengers – N/A
Nature of Damage:	Severe No 3 Engine damage, nacelle cowl holed, slight damage to the horizontal stabiliser	
Commander's Licence:	Airline Transport Pilot's Licence	
Commander's Age:	38 years	
Commander's Flying Experience:	6,515 hours (of which 3,002 hours were on type) Last 90 days - 139 hours Last 28 days - 45 hours	
Information Source:	AAIB Field Investigation

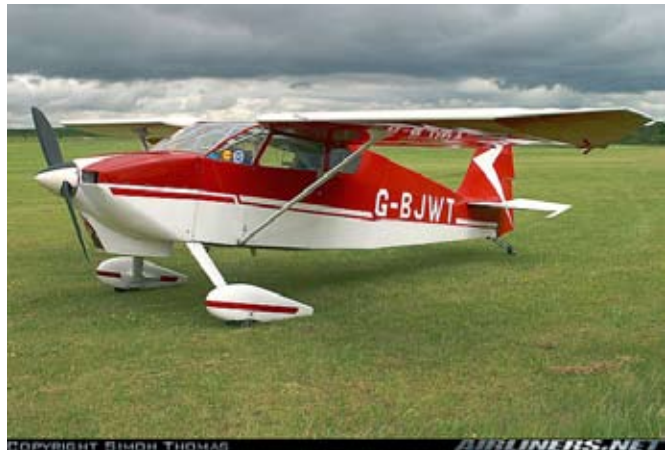
Figure 1

tail-wheeled undercarriage, see Figure 1. The main gear legs are undamped steel struts and are attached to the tubular steel engine mount. These gear legs are 44 inches long with a bend immediately inboard of the axle. They are made of a heat-treatable alloy steel (6150) for which the Wittman drawings specifies:
