COMMERCIAL AIR TRANSPORT

(ALL TIMES IN THIS BULLETIN ARE UTC)

MESSAGE FROM THE CHIEF INSPECTOR OF AIR ACCIDENTS

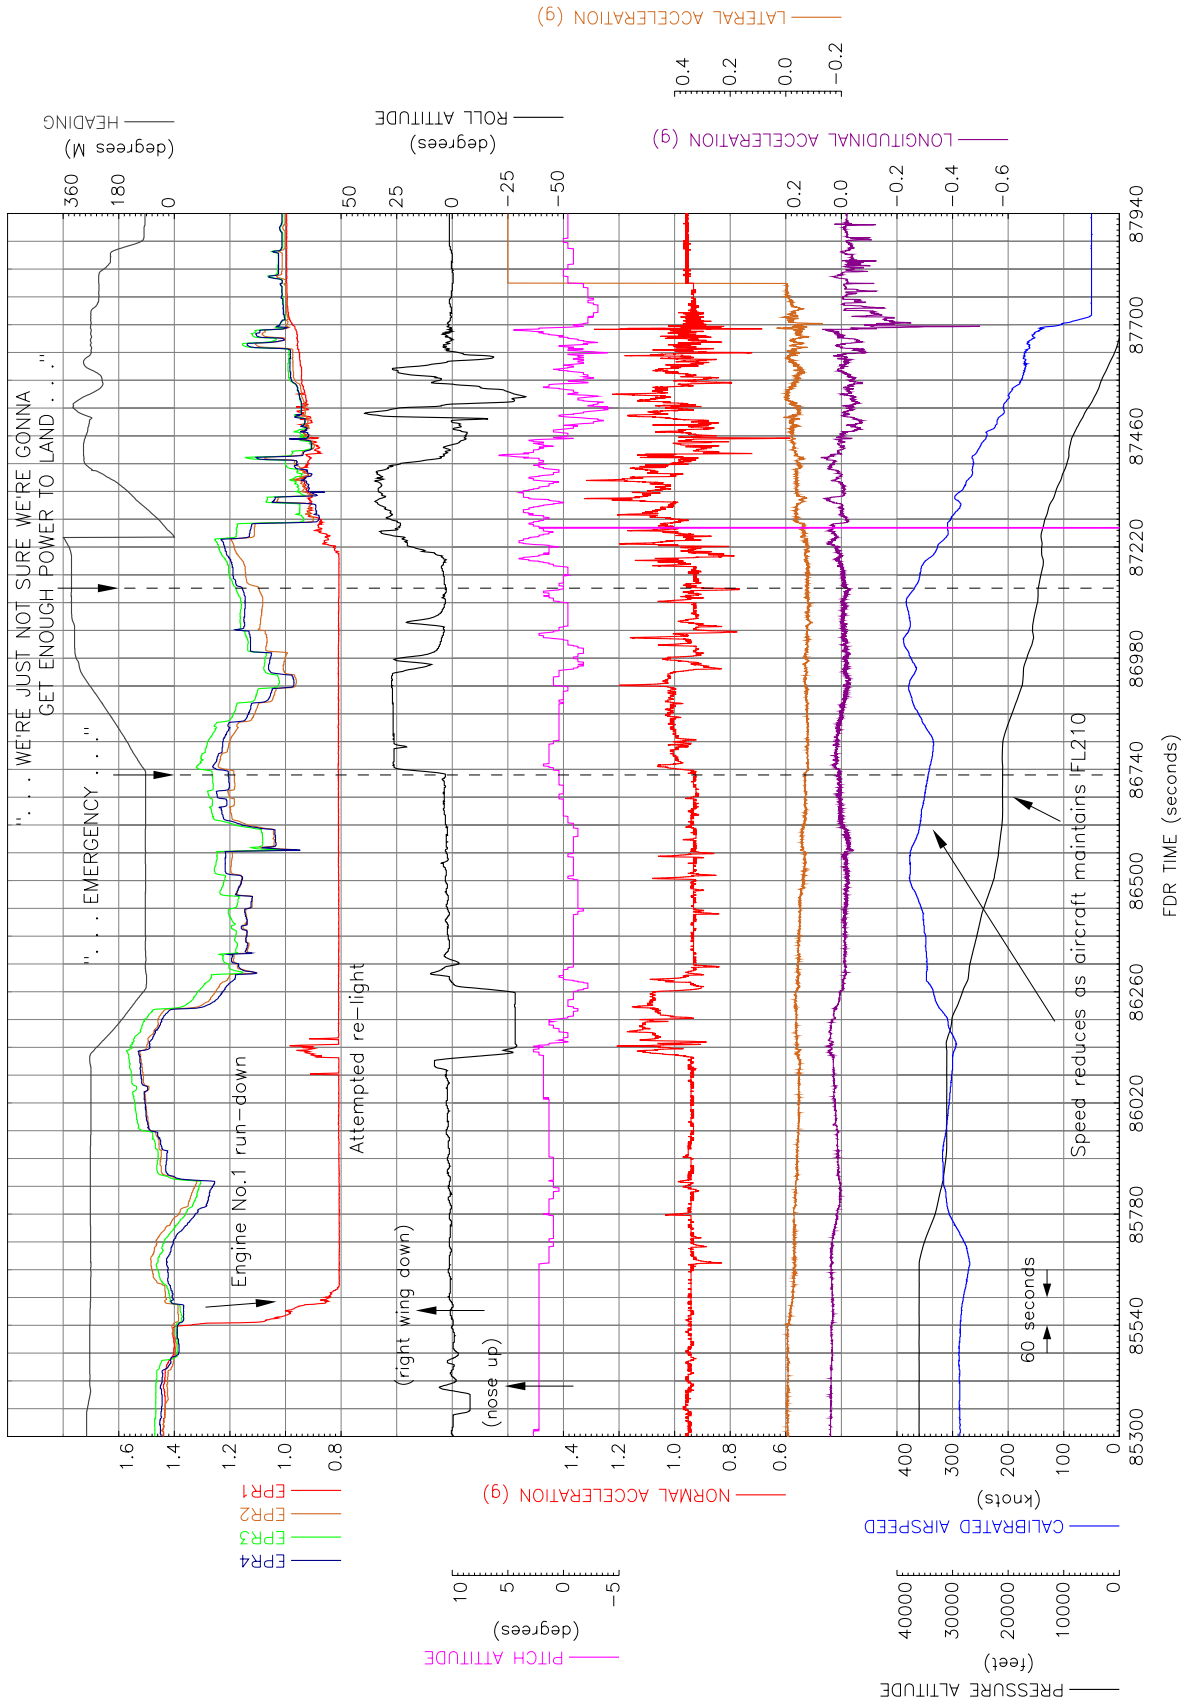
Figure 2

A time-history of the relevant parameters during the incident

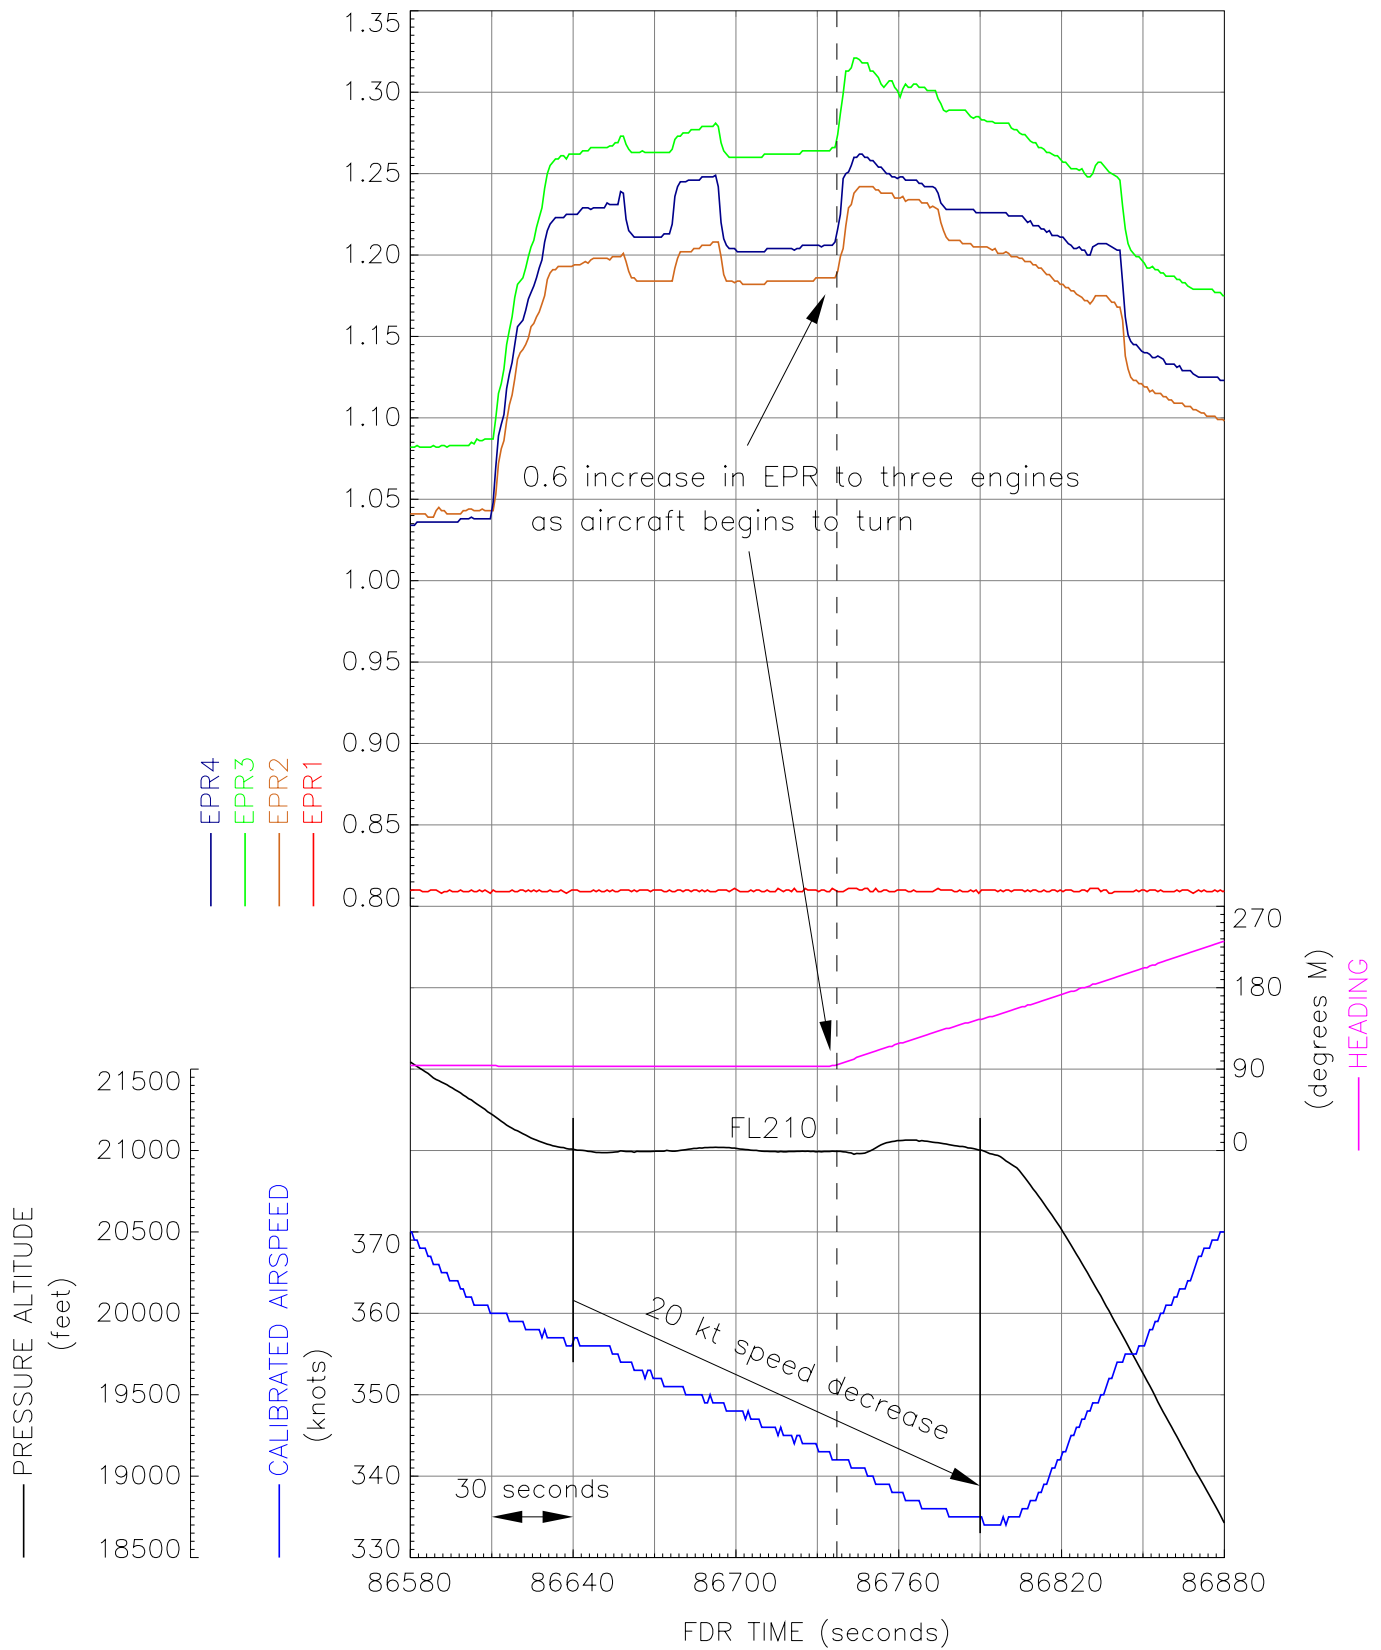
Figure 3

The aircraft remained at FL210 for two and a half minutes during which the CAS steadily reduced from 355 kt to 335 kt. Also during this period, the EPR levels on the other three engines were no lower than 1.18 (Engine No 2) and no higher than 1.32 (Engine No 3), each varying (in unison) and by no more than 0.06 (see Figure 3).

An expanded view time-history of the relevant parameters at FL210

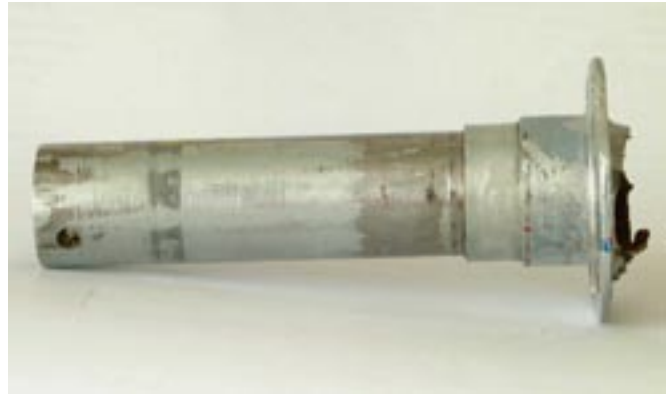
Figure 1

The PFA noted that two failures had occurred in a similar region on Luton Minor stub axles and, as a result, issued a mandatory inspection; MOD/051/001 Inspection of Axle Welds for Cracks & Corrosion dated 2 March 2001. In this inspection it is noted that:

'The undercarriage design is considered adequate if well constructed, however if corrosion is present then cracks may soon appear leading to structural failure'.

Examination of the Stub Axle

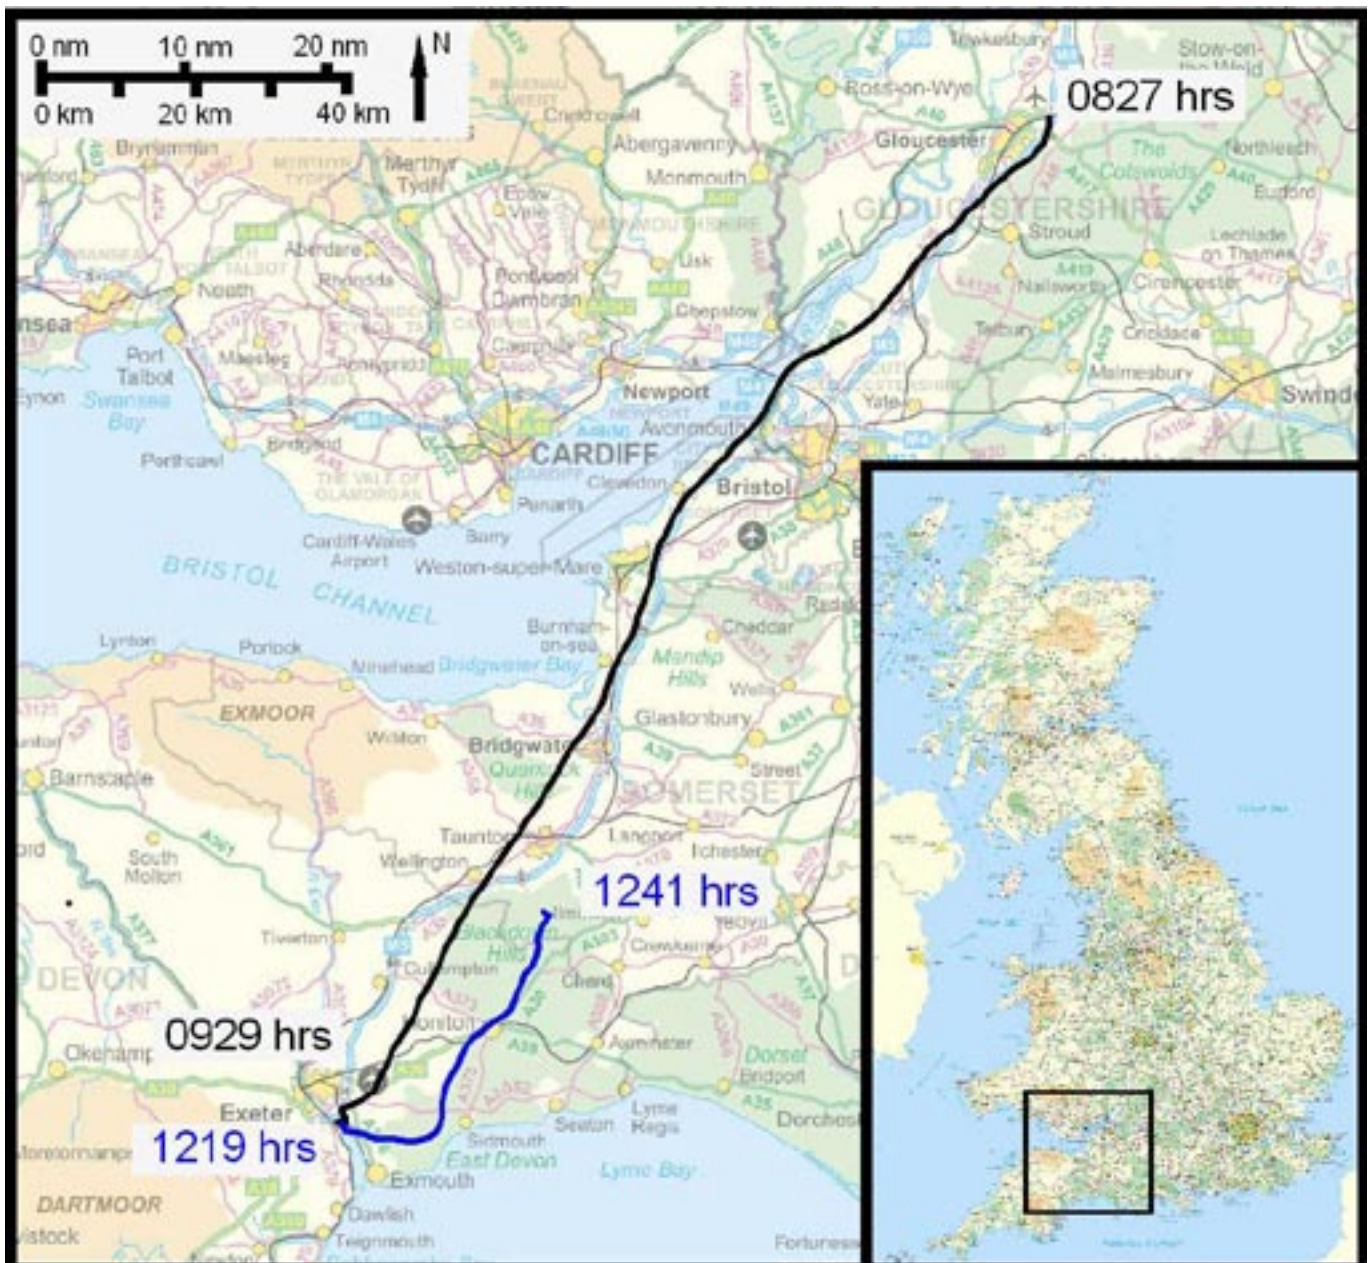
Figure 1 shows the two GPS tracks recorded on the day of the accident. The first flight of the day departed from Gloucester airport, and the first track point was recorded at 0827 hrs with the helicopter in the air. The flight ended at 0929 hrs at Topsham, south east of Exeter. The second flight, during which the accident occurred, departed Topsham at 1219 hrs. The last flight log point recorded was at 1241:29 hrs just south of Priors Park Wood, approximately 5 nm south of Taunton.

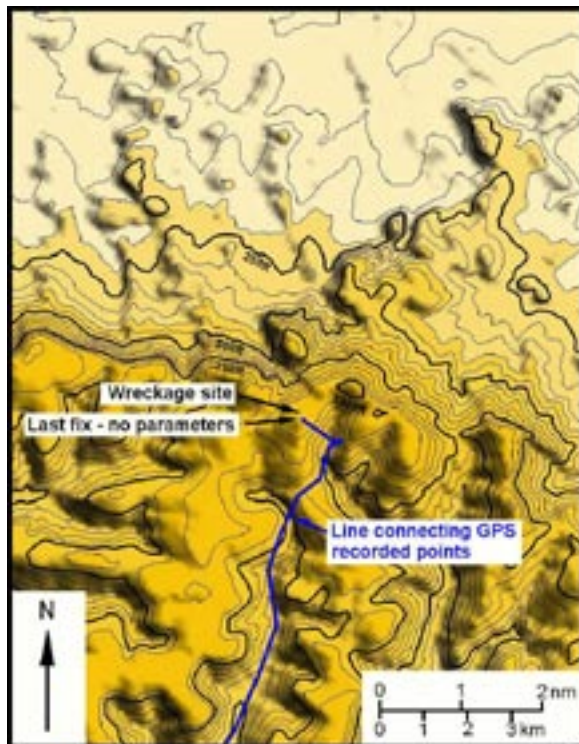
Figure 3

with the Blackdown Hills, Figure 3, and this was the last ridge of hills on track before the terrain fell away towards Taunton and the M5 motorway. A minute or so before the flight log terminated, in the vicinity of Moor, Westhay and Walland Farms, the aircraft slowed appreciably, dropped in altitude and significantly changed its heading. The low sample rate of the GPS did not afford more detailed description of the manoeuvring at the end of the flight.

End section of the accident flight in relation to terrain height

The investigation concluded that the helicopter's flight path angle was some 26° down just before it crashed. The combination of the aircraft's estimated forward speed of 30 to 40 kt and this angle, would result in a rate of descent of approximately 1,500 fpm. This suggests that either the pilot was attempting to regain visual contact with the ground or, possibly, that he was aware that the north side of the Blackdown Hills are steep sided and believed that the helicopter was sufficiently far north to be able to descend through cloud to become visual with the ground over lower lying terrain, as indicated in Figure 3.

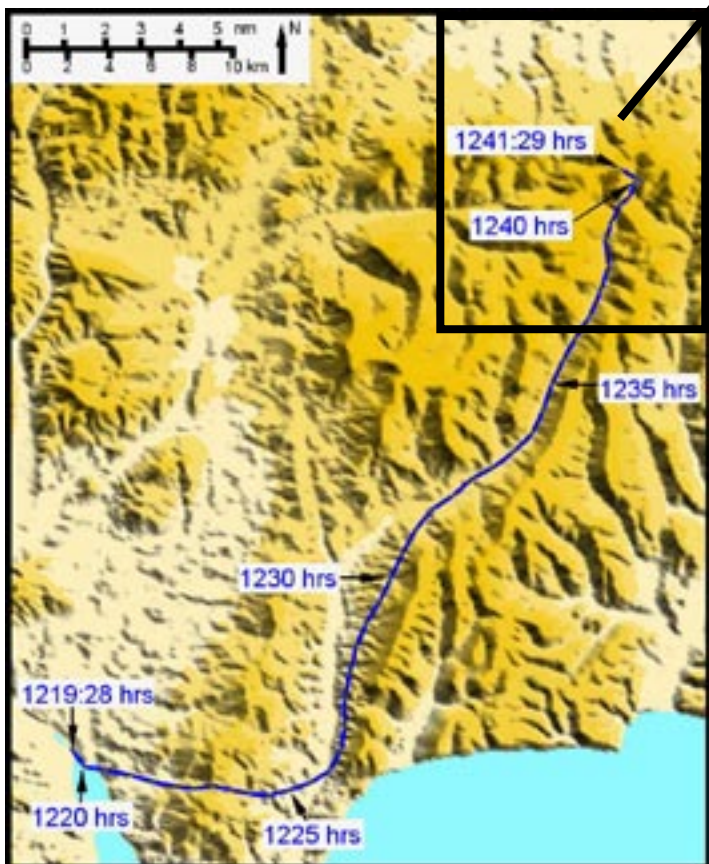
Figure 2 shows the flight path of the accident flight overlaid on a map of the terrain. During this flight, the aircraft initially tracked east and crossed a ridge. The helicopter then flew north-east, following a valley floor at approximately 400 ft agl with an average ground speed of approximately 80 kt. The valley floor elevation increased as the flight progressed. The flight terminated at a location where the valley floor effectively merged

Accident flight track overlaid on a terrain map

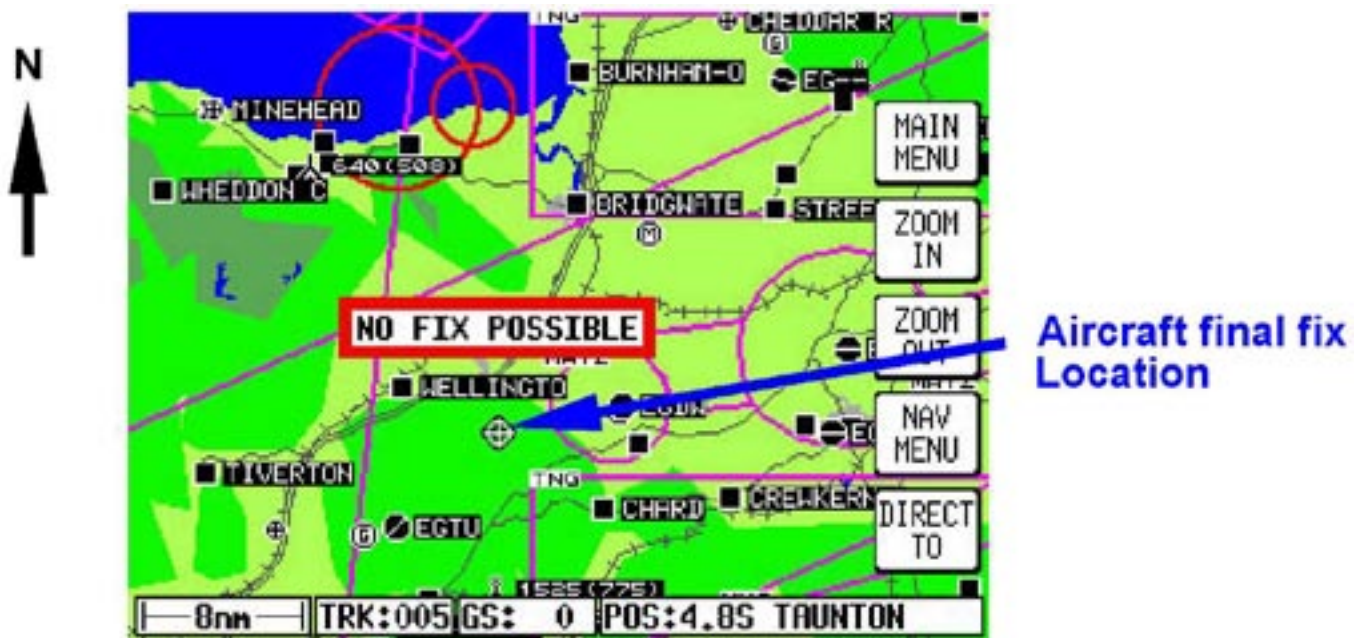
Figure 4

The GPS map display was also downloaded and is shown in Figure 4. This represents the map display at the point of the final fix. The colour coding of the display indicates that lower ground was not far to the north-east of the final fix location.

Screen shot of G-BXLI's final GPS fix.
