MARINE ACCIDENT INVESTIGATION BRANCH

FLYER TO THE LEISURE INDUSTRY

OUZO:

ACCIDENT WITH THREE FATALITIES 21 AUGUST 2006

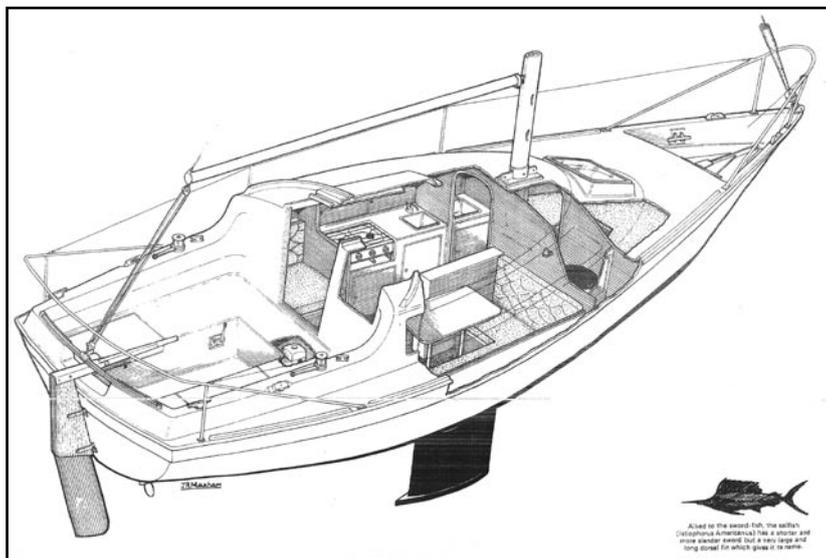
The yacht *Ouzo* sailed from Bembridge, Isle of Wight (IOW), bound for Dartmouth, Devon on the evening of 20 August 2006 with her three regular crew on board. The last record of the yacht was at 2230 when she went out of range of the Southampton/Portsmouth VTS radar system in Sandown Bay. At this time it is believed that the yacht was sailing close hauled in a south-south-westerly direction.

The body of one of the crew members was found in the sea just before midday on 22 August about 10 miles south of the Nab Tower. At about 1900 on

the following day, the bodies of the other two crew were recovered from the sea. They had all been wearing inflated lifejackets and good quality yachting clothing. Despite extensive surface and sub-surface searches no trace of the yacht has been found.
