MARINE ACCIDENT INVESTIGATION BRANCH

FLYER TO THE YACHT DESIGN, BUILDING AND REPAIR INDUSTRY

MAX FUN 35 YACHT *Hooligan V*: KEEL DETACHMENT, CAPSIZE AND LOSS OF ONE CREW

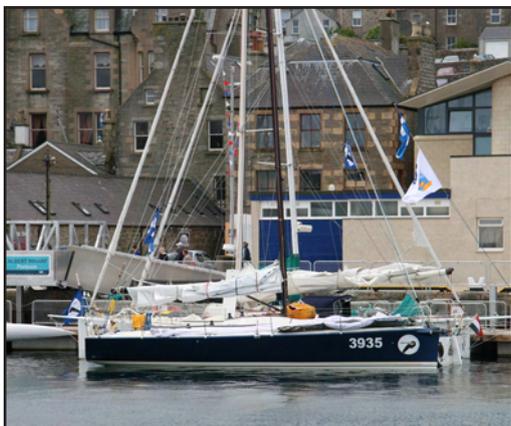
Investigations found that the fabricated steel keel had failed just below the fillet weld connecting the fin to the taper box (**Figure 1**). Laboratory metallurgical analysis confirmed that the keel had suffered fatigue failure in the fillet weld area, which had been subjected to high bending stresses. Defects were also found in the keel taper box welds, and two of the three keel bolts had also failed.

Analysis of the “original” design calculations confirmed that they did not achieve the required Safety Factor of 2. The “as built” keel safety calculations were worse, and these were exacerbated by the addition of the extra bulb weight. The fabricated keel was unable to withstand the “in service” bending stresses and this led to the conditions of failure.

When the boat was taken out of the water at the end of the 2006 racing season, considerable detachment of the keel’s epoxy filler and anti-fouling was found. There was also evidence of possible fine cracking in the steel adjacent to the fillet weld, but this went undetected and so the last chance to prevent the accident was missed.

- The repairer was not sufficiently experienced to appreciate why the keel filler and coating detachment occurred. He occupied himself with removing the corrosion products and priming the bare keel metal rather than finding the reason for the detachment which was probably due to keel flexing. Fabricated steel keels are vulnerable to bending stresses. Where there is doubt, repairers should seek advice on the suitability of using Non-Destructive Examination techniques to determine the keel condition.
