MARINE ACCIDENT INVESTIGATION BRANCH

FLYER TO THE SHIPPING, TANK STORAGE AND CARGO INSPECTION INDUSTRIES

Jo Eik

Release of cargo vapours resulting in two casualties

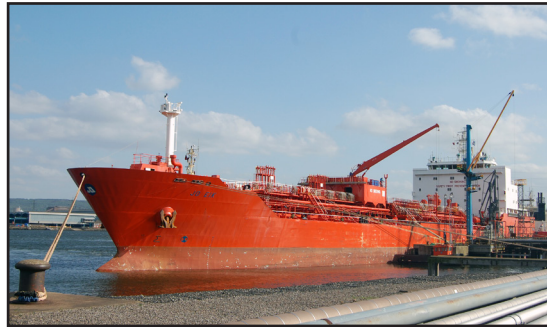
On 6 May 2009 the Norwegian registered chemical tanker *Jo Eik* completed a ship to ship transfer (StS) of a cargo of Crude Sulphate Turpentine (CST) at the Vopak Terminal Teesside. During the final stripping following the mandatory MARPOL pre-wash, a deck rating became unconscious following exposure to CST vapours. The chief officer, who attempted a rescue, was also overcome and another deck rating suffered the effects of vapour inhalation but managed to escape unaided. Both casualties were rescued and made a full recovery.
