## FLYER TO THE FISHING INDUSTRY

### ***Purbeck Isle*: Foundering resulting in the loss of three lives**

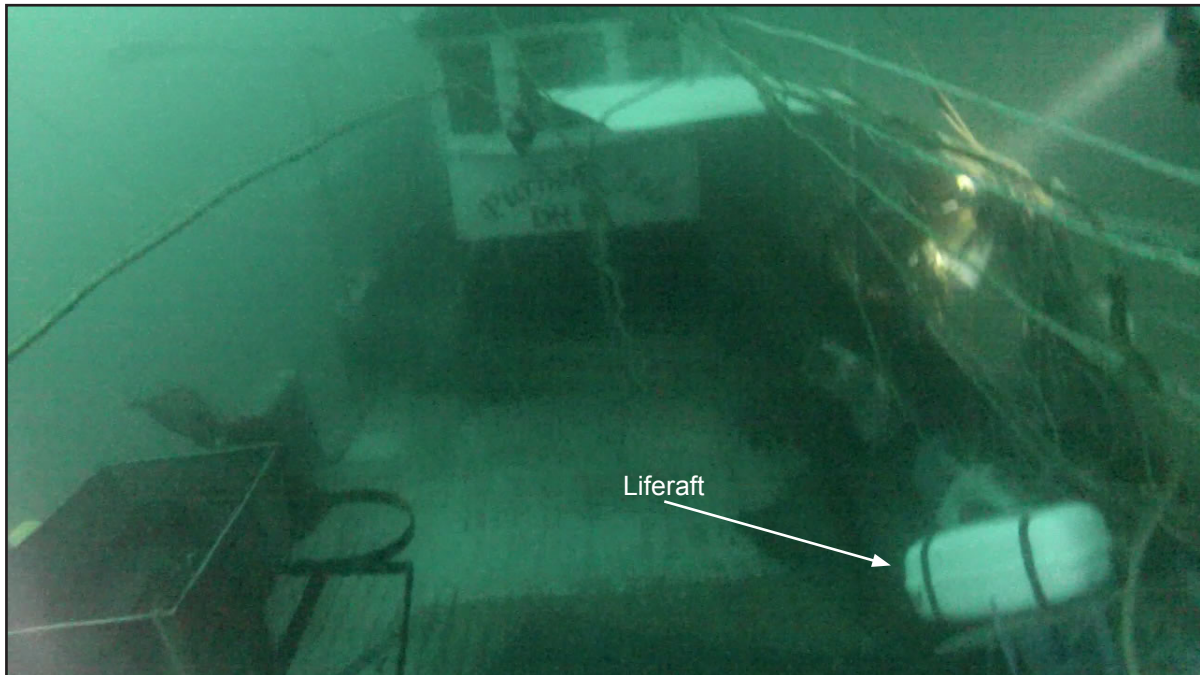
On 17 May 2012, the skipper of the UK registered fishing vessel *Purbeck Isle* and his two young crewmen died because the vessel's liferaft failed to float free and automatically inflate when the 11.6m wooden potting vessel sank suddenly off the coast of Portland, England.
