FLYER TO THE FISHING INDUSTRY

***Purbeck Isle*: Foundering resulting in the loss of three lives**

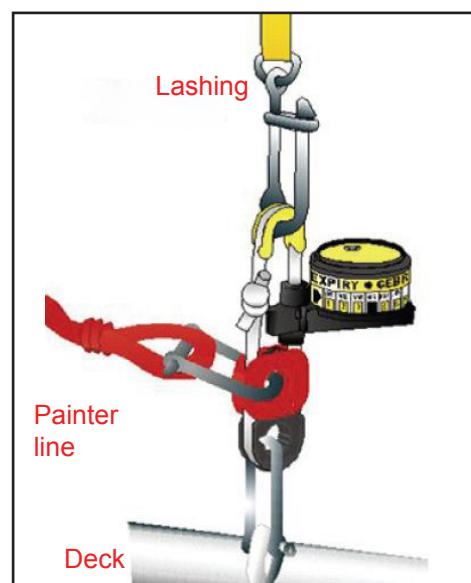
Note: CM Hammar's website includes free interactive training aids and video clips that show clearly and simply how its HRUs should be rigged and how they are designed to work in an emergency (www.cmhammar.com).
