Published 14 August 2014

**CONTENTS****SPECIAL BULLETINS / INTERIM REPORTS**

S4/2014, B787-8	ET-AOP	12-Jul-13	3
-----------------	--------	-----------	---

<b>Aircraft Type and registration:</b>	B787-8, ET-AOP
<b>No &amp; Type of Engines:</b>	2 General Electric GENx-1B turbofan engines
<b>Year of Manufacture:</b>	2012 (MSN 34744)
<b>Location:</b>	London Heathrow Airport
<b>Date &amp; Time (UTC):</b>	12 July 2013 at 1534 hrs
<b>Type of Flight:</b>	Not applicable
<b>Persons on Board:</b>	None
<b>Injuries:</b>	Not applicable
<b>Nature of Damage:</b>	Extensive heat damage in upper portion of rear fuselage
<b>Information Source:</b>	AAIB Field Investigation

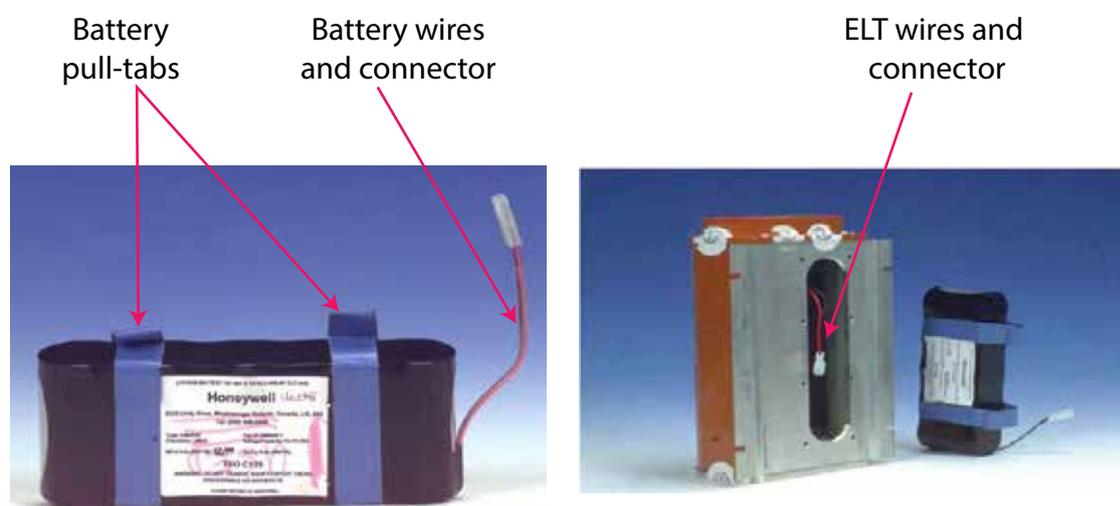
**Figure 3**

The ELT is powered by a five-cell, non-rechargeable 'lithium-metal'<sup>3</sup> battery, installed in the transmitter unit (Figure 3) and manufactured by Ultralife Corporation, under contract to Instrumar Limited.

ELT battery pack and ELT transmitter unit, showing battery compartment

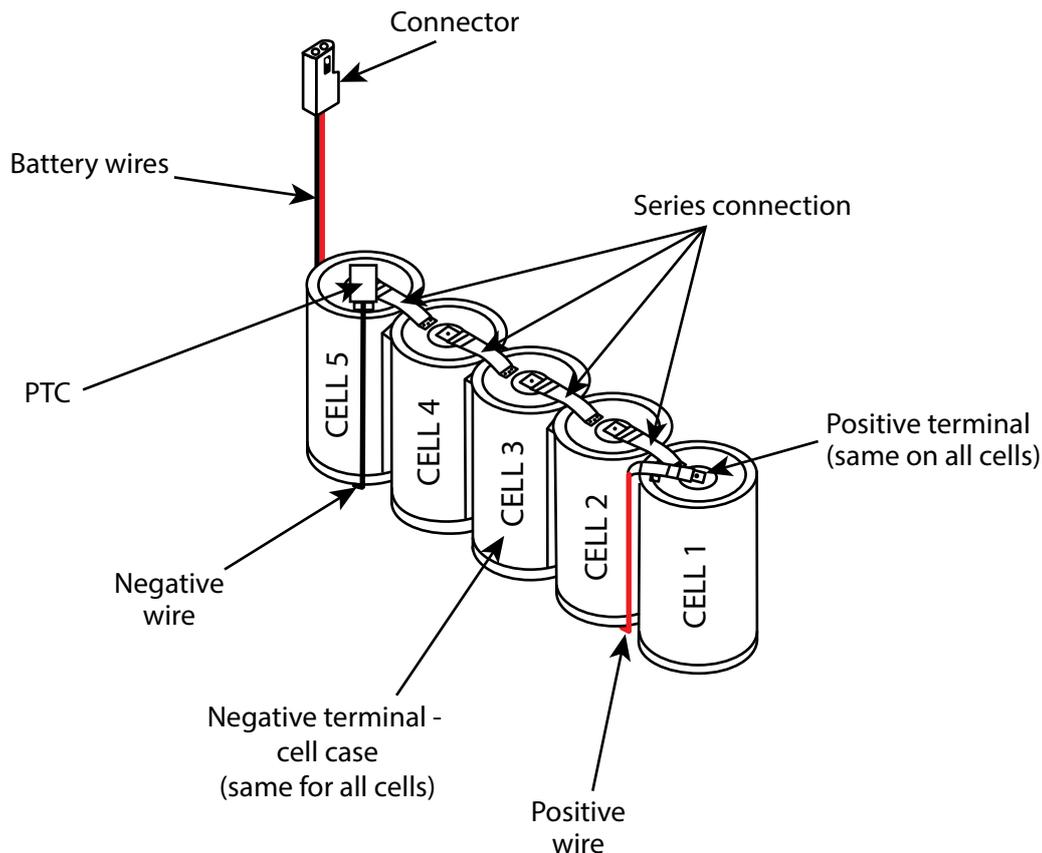
**Figure 4**

Each of the Lithium-Manganese Dioxide ( $\text{LiMnO}_2$ ) 'D-cells'<sup>4</sup> has a nominal voltage of 3 V and the cells are connected in series to provide a 15 V battery, with a nominal capacity of 11.1 ampere-hours (Ah) (Figure 4). The battery is rated to a maximum continuous discharge current of 3.3 amps. Two external battery wires connect the positive and negative terminals of the battery to the ELT power supply circuit card. The chemistry in the  $\text{LiMnO}_2$  cells is considerably different to that used in the rechargeable large-format lithium-ion cells used in the B787 main and APU batteries.

Battery pack illustration (outer shrink-wrap not shown for clarity)

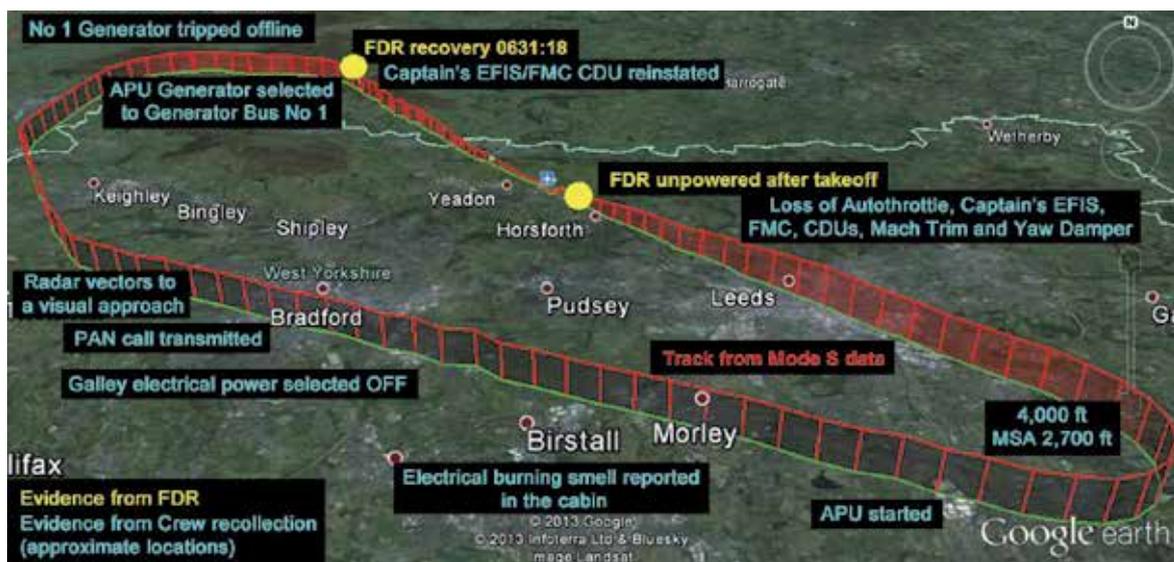
**Figure 1**

Limited sets of flight parameters were transmitted to ATC's radar, throughout the flight, via Mode S transponder returns. These covered a period of 26 minutes and 30 seconds. Figure 1 shows the recorded aircraft track.

Aircraft track from Mode S transponder data, with approximate positions of events from crew recollections

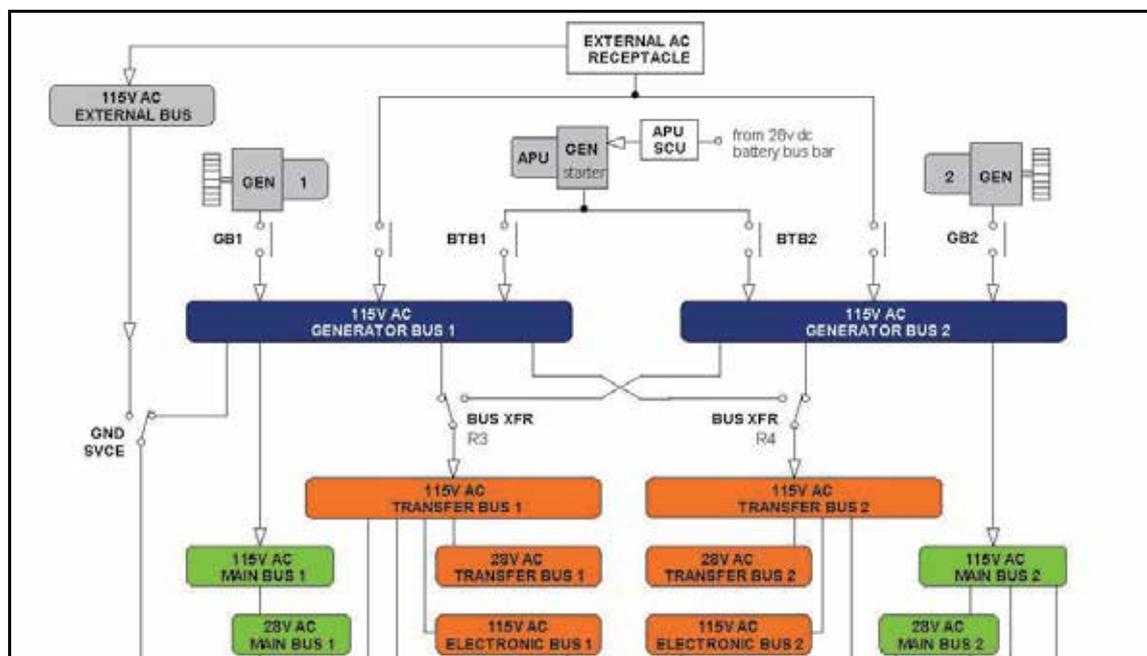
**Figure 4**

Top level electrical system schematic for the Boeing 737-300 (orange denotes busses carrying essential loads and green denotes busses carrying non-essential loads; schematic courtesy of B737MRG)

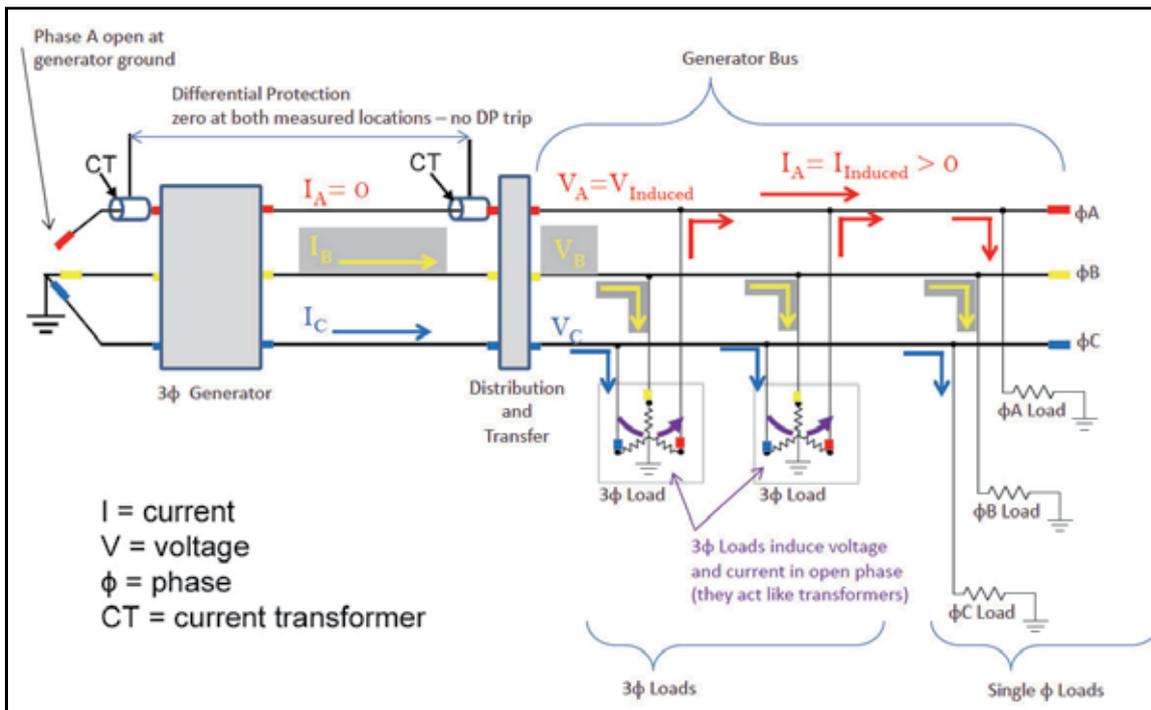
**Figure 5**

There are a number of electrical components on the aircraft that require 3-phase power for operation, such as hydraulic pumps, fuel pumps and transformers. Other lower power components, such as the EFIS screens, instruments and auto-throttle operate using single-phase power. When the phase 'A' generator cable broke at the T191 stud, there would have been a drop in voltage in the phase 'A' line. However, the voltage on phase 'A' would not have dropped to zero because the 3-phase loads, still powered by phases 'B' and 'C', would have induced current and voltage on phase 'A'. This occurs because 3-phase loads are connected across the phases rather than from each phase to ground. This effect is illustrated in Figure 5. There is no current flow in the phase 'A' line between ground and the generator bus, so the current transformers at the generator and generator bus measure the same current and therefore the differential current protection is not tripped. On the Boeing 737-300 there is no measurement of differential current between phases. Inside the generator bus there is current flow in the phase 'A' line due to the voltage induced from the 3-phase components.

Operation of a 3-phase system with phase 'A' open circuit at the generator ground

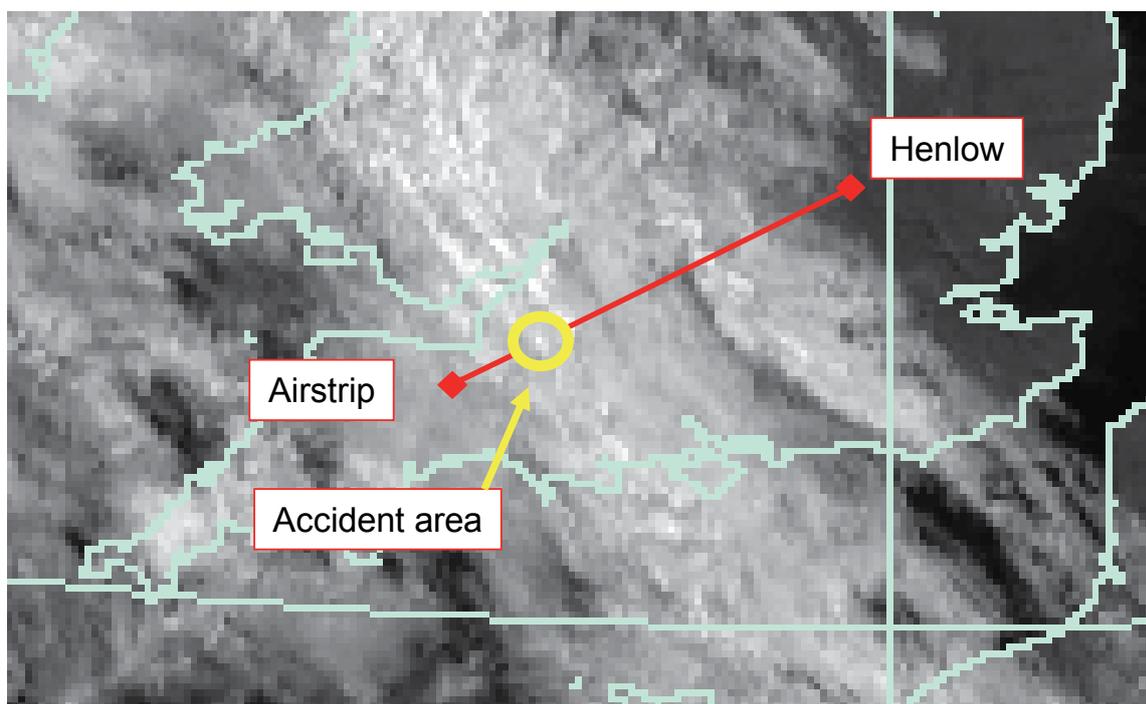
**Figure 1**

Surface analysis charts indicated that the accident area was subject to a light to moderate east to south-easterly airflow, with a weakening warm front moving north-east across the area during the morning. Infra-red and visible satellite images showed thick frontal cloud over southern Wales and central southern England. Figure 1 shows a visible spectrum satellite image taken about the time of the accident.

High Resolution Visible Spectrum Satellite Image  
30 September 2013 at 1100 hrs UTC

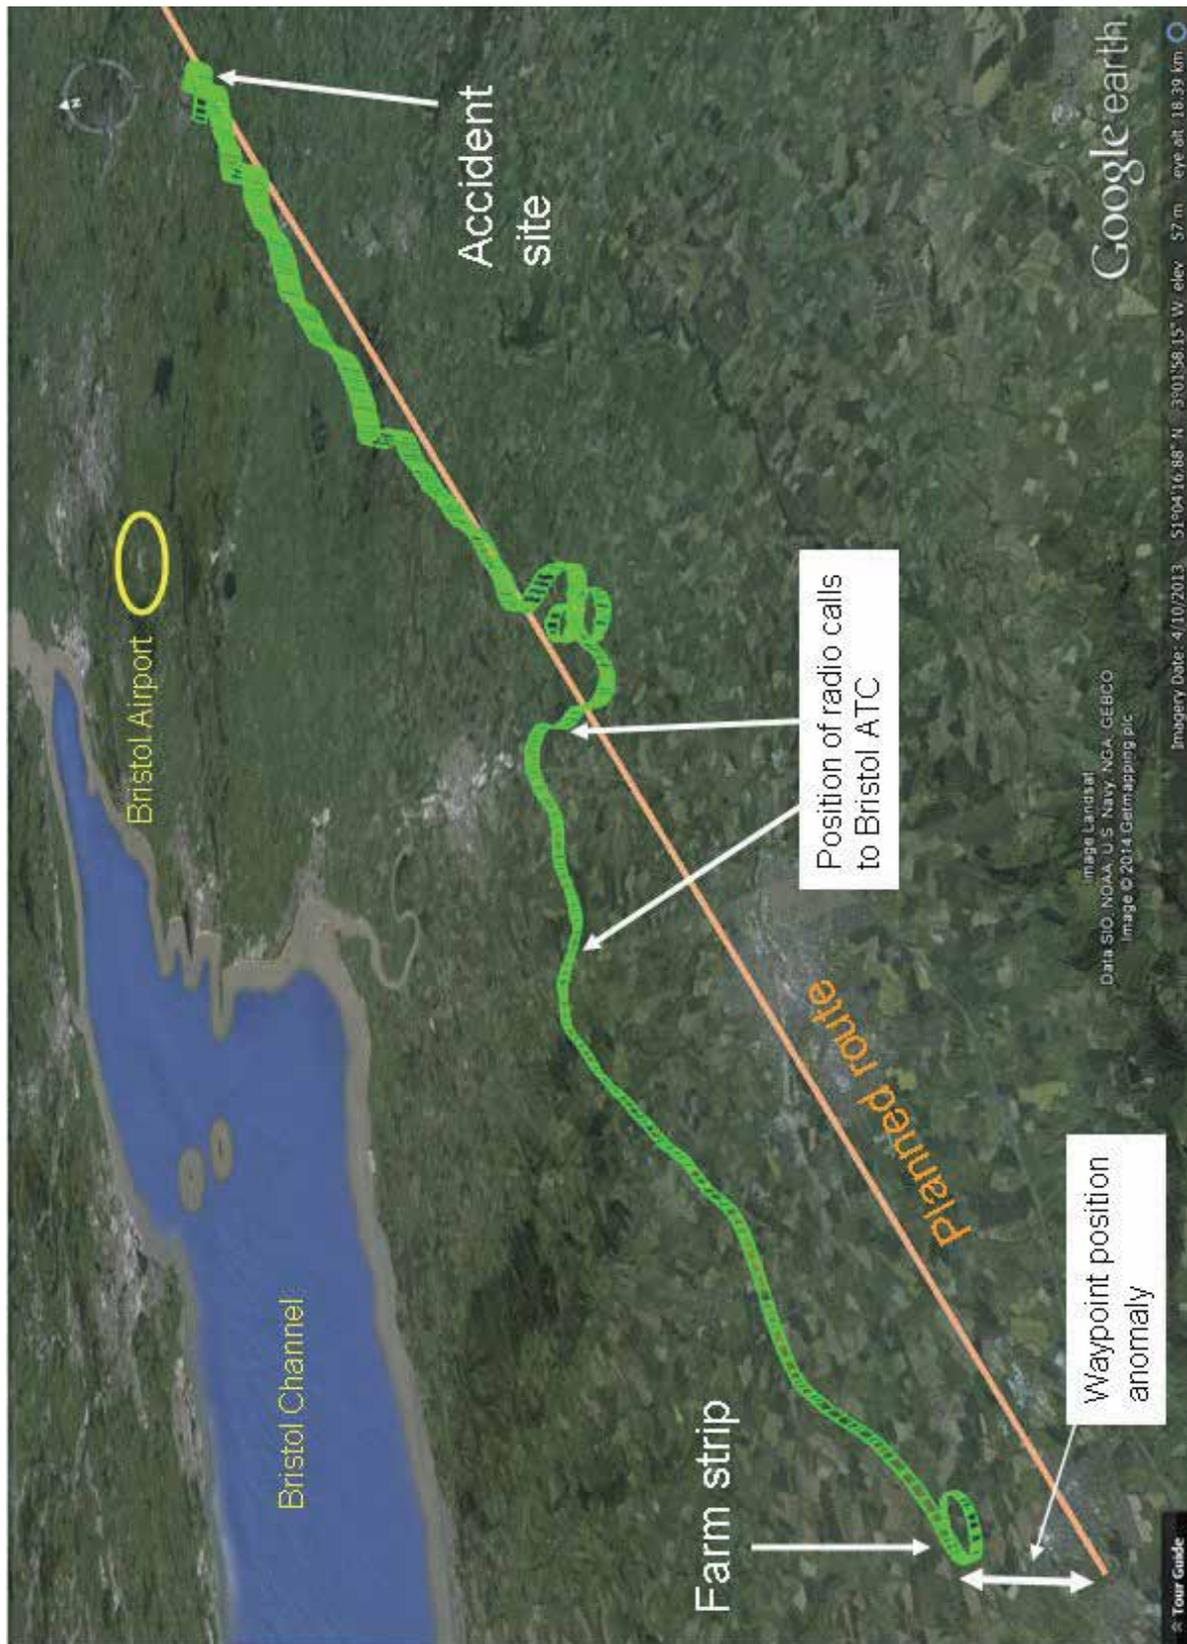
The aircraft took off at 1023 hrs. Instead of converging on the planned route after takeoff as would be expected, the observed track continued to deviate northwards from it until the aircraft was about 8 nm from the farm strip (Figure 2). At range 10 nm, the aircraft turned right through about 150° before flying across the planned route and reversing course again to follow its direction, this time to the south of it. The aircraft then entered a 'figure of eight' manoeuvre before turning to establish on the planned route. There were further deviations from the route but, within 5 nm of the accident site, the position remained within 0.5 nm of it.

**Figure 2**  
Planned route line and GPS track (oblique view)

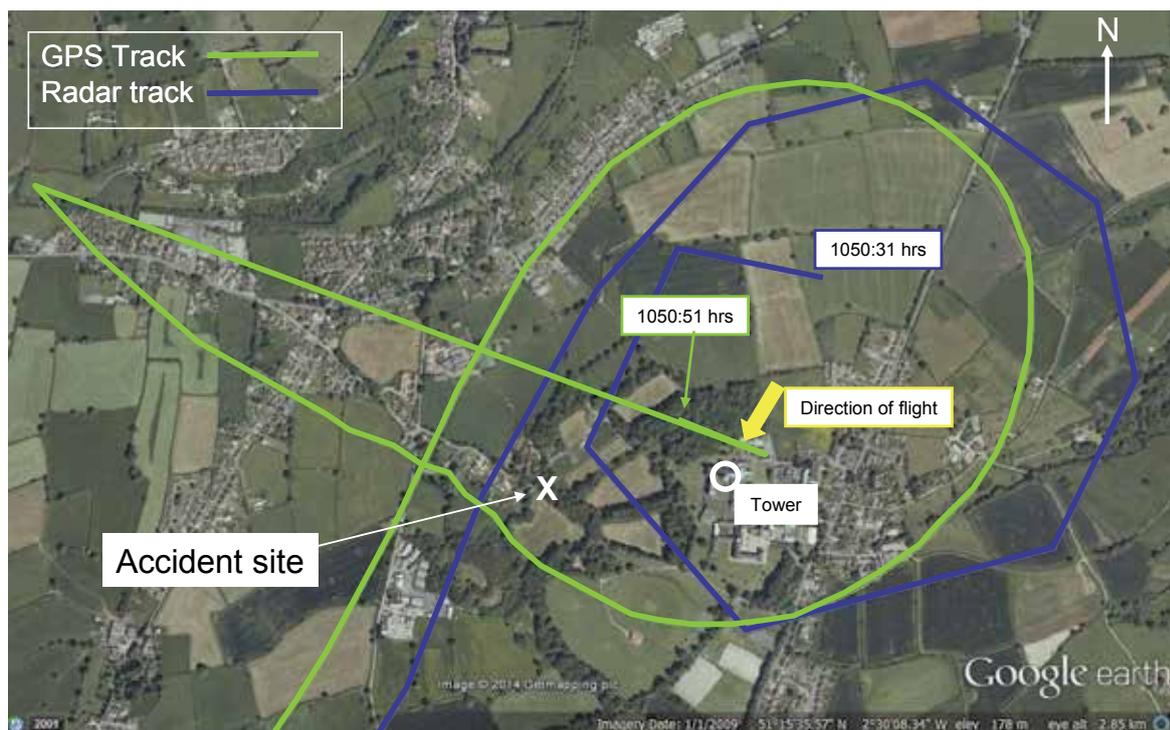
**Figure 3**

Figure 3 shows a combination of the GPS position data and radar derived data. Also shown are the times of the last position points, the direction the aircraft was travelling before it took action to avoid the tower, and the accident site. The discrepancy between the tracks is due to the radar positional accuracy, recording rate and the low level coverage.

GPS and radar tracks for the final stages of the flight
