# Rail Accident Report

## **Derailment at Liverpool Street station, London 23 January 2013**

Report 27/2014  
December 2014

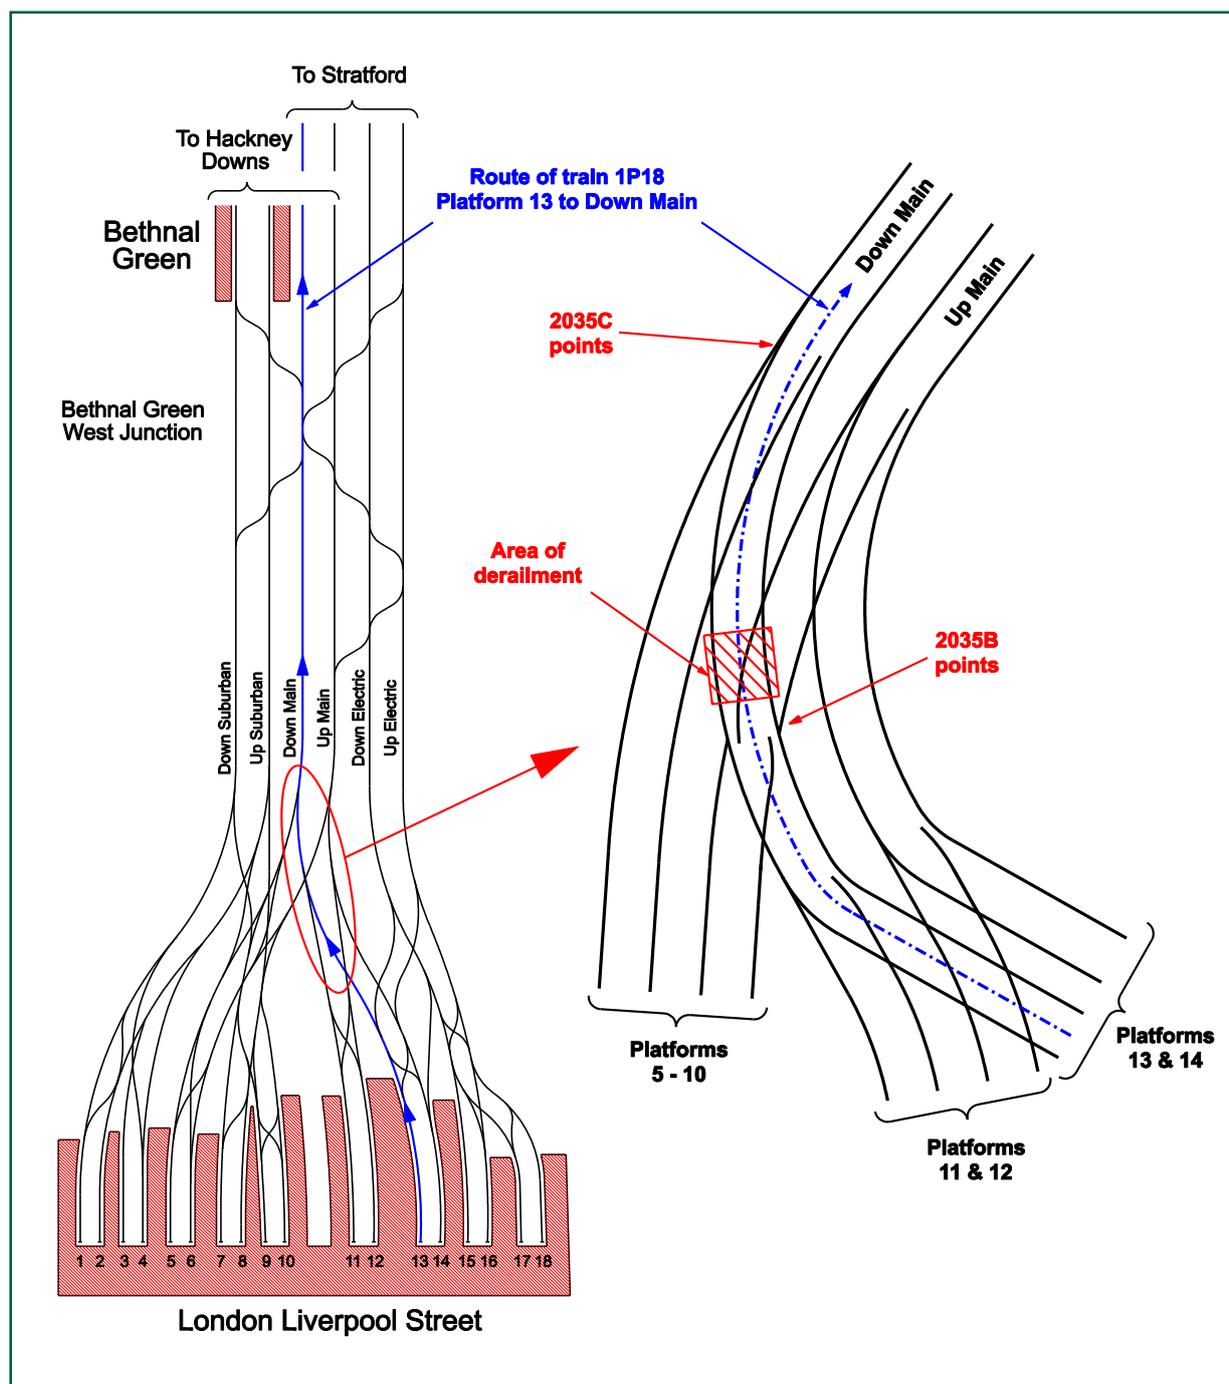
Figure 3: Liverpool Street station and detail of derailment area

- 27 At approximately 10:00 hrs on Wednesday 23 January 2013, train 1P18 departed from platform 13. As the train was passing over 2035B points, and approaching 2035C points (figure 3), on a right-hand curved section of track about 260 metres from the platform end, 19 wheels of the train derailed (figure 5). Of these, 15 wheels were re-railed within 5 metres. The remaining four wheels were on a bogie which travelled in a derailed state for approximately 40 metres (around 6 seconds running time), before forcing its way through (*running through*) the converging rails of 2035C points and re-railing (paragraph 66)).

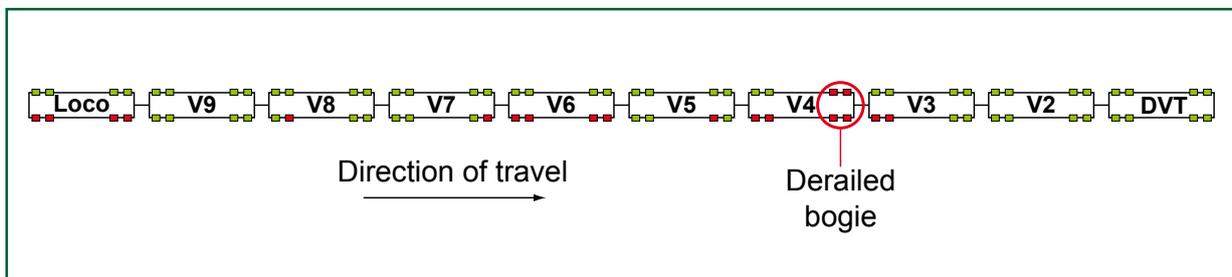
Figure 5: Train 1P18 (derailed wheels shown in red)

64 The first of the wheelsets exhibiting wheel face damage were on the *trailing bogie* of vehicle 3 (figure 5). Damage to the track fixings of the right-hand rail (figure 9) and the absence of damage on the left-hand wheels of this bogie show that these wheelsets continued with the right-hand wheels dropped inside the right-hand *running rail* while the left-hand wheels remained on the rail. Damage to the track fixings indicate that these wheels ran derailed for about 4.5 metres before encountering a *fishplate* forming part of a rail *joint*. As they struck the fishplate, the wheels were raised back up to rail level and guided back on to the running rail (figures 10 and 11).

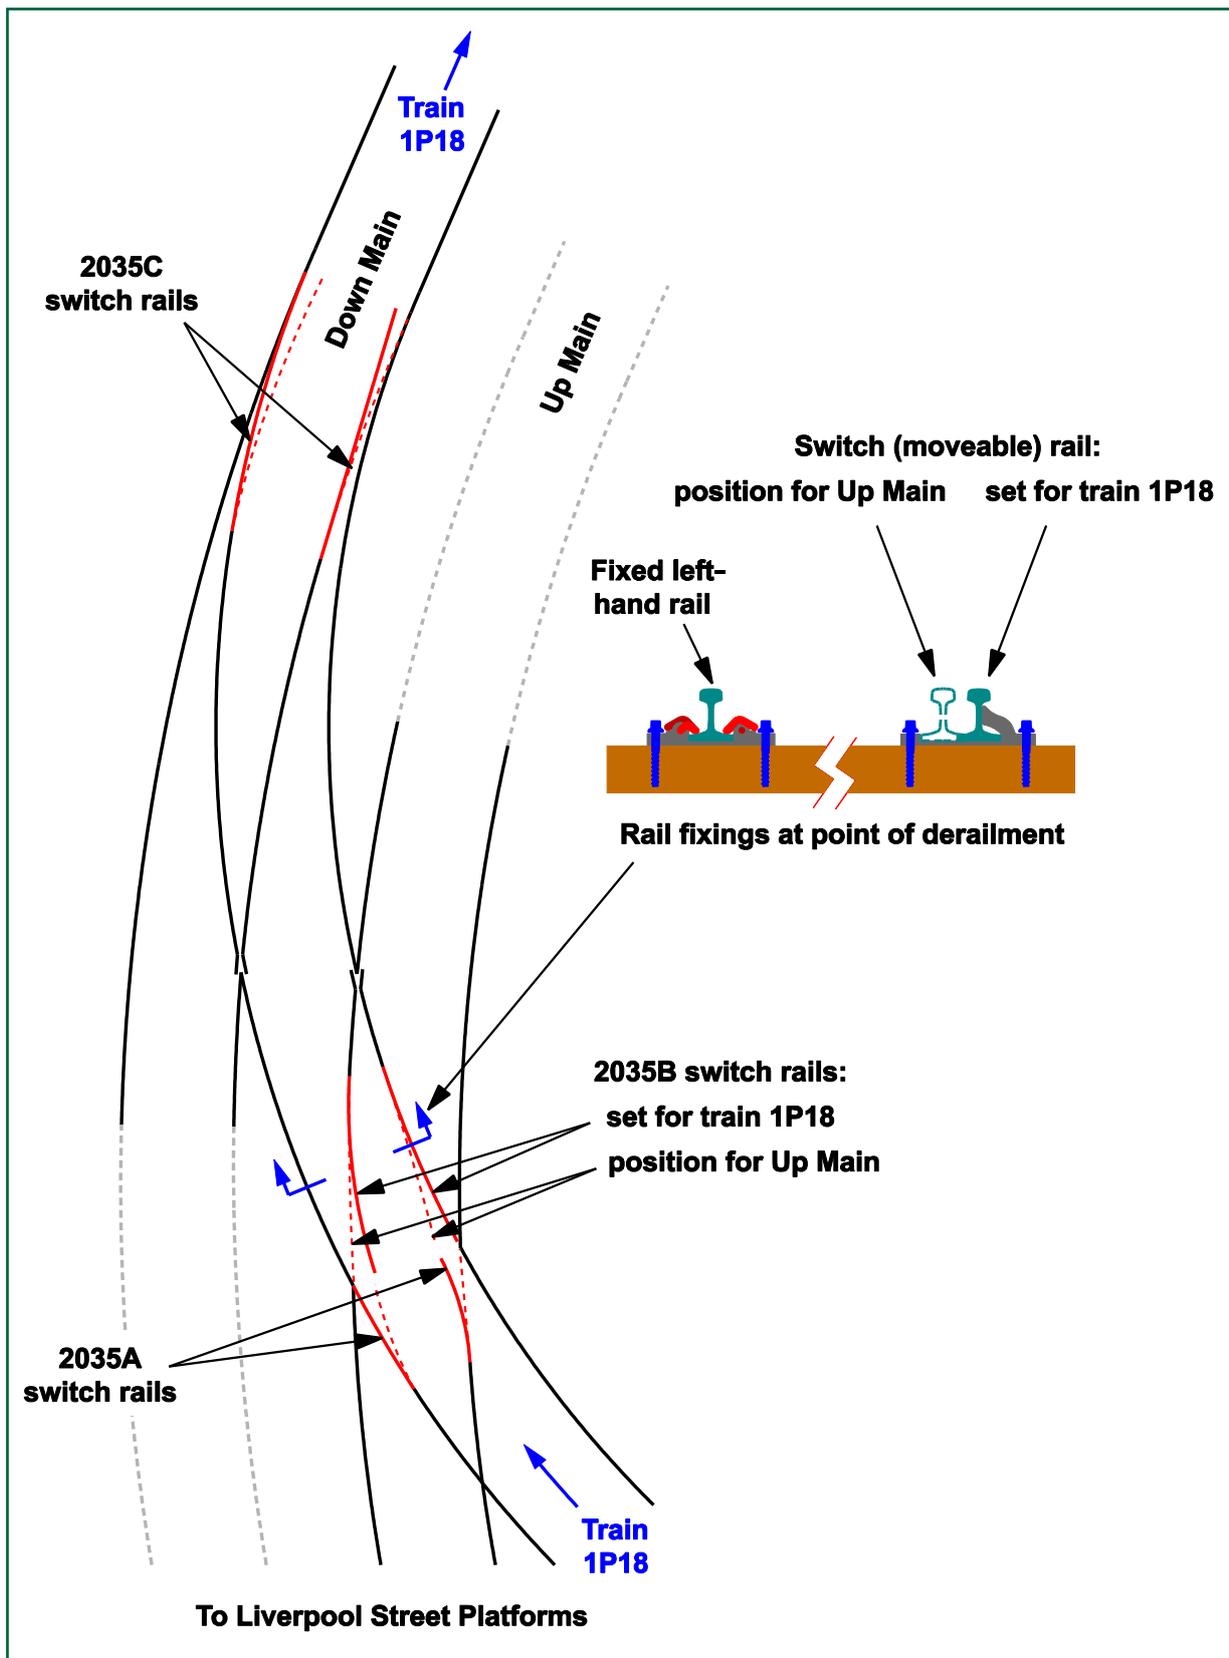
Figure 7: Track layout at incident site

62 These points, together with 2035A points, formed the switch diamond crossing illustrated in figure 7. A description of a switch diamond crossing is included at appendix D.

- 97 The right-hand switch rail is intended to move laterally according to the direction in which 2035B points are set (figure 7). The rail support system allowing this movement does not prevent the top of the right-hand rail moving outwards due to rotation at the foot of the rail. The right-hand rail is not normally subjected to sufficient gauge spreading force (paragraph 69) to cause movement of this type. However, in this instance, it is likely that the displaced position of the left-hand rail meant that the outer edges of the right-hand wheels were running on the inner edge of the switch rail. In this position, the downward load from the wheels, the angled shape of the wheels and the curved rail head combining with the gauge spreading force would result in the top of the switch rail being pushed outwards (figure 20, inset).

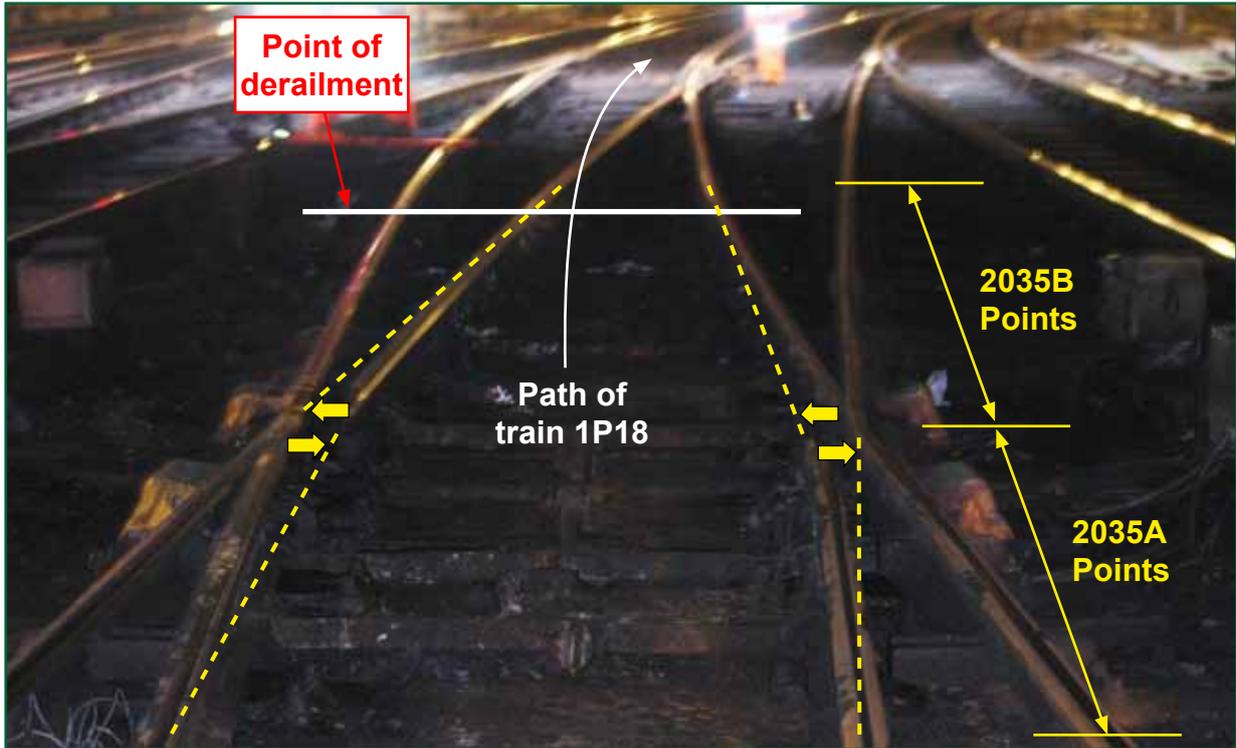
Figure 8: Incident site showing switch rails set for train 1P18 (alternative route shown in yellow)

63 The derailment evidence comprised closely spaced marks on the right-hand rail indicating that all the derailed right-hand wheels of the train had dropped inside this rail approximately five metres beyond the *tip* of the moveable rail (figures 8 and 9). The RAIB has concluded from the wheel face (the outside face) damage on the train, and a lack of derailment marks elsewhere on the right-hand rail, that the 17 right-hand train wheels derailed in turn as they reached this location. At the point of initial derailment the track is on a right-hand curve and the left-hand wheels were running along a section of rail that should be fixed.

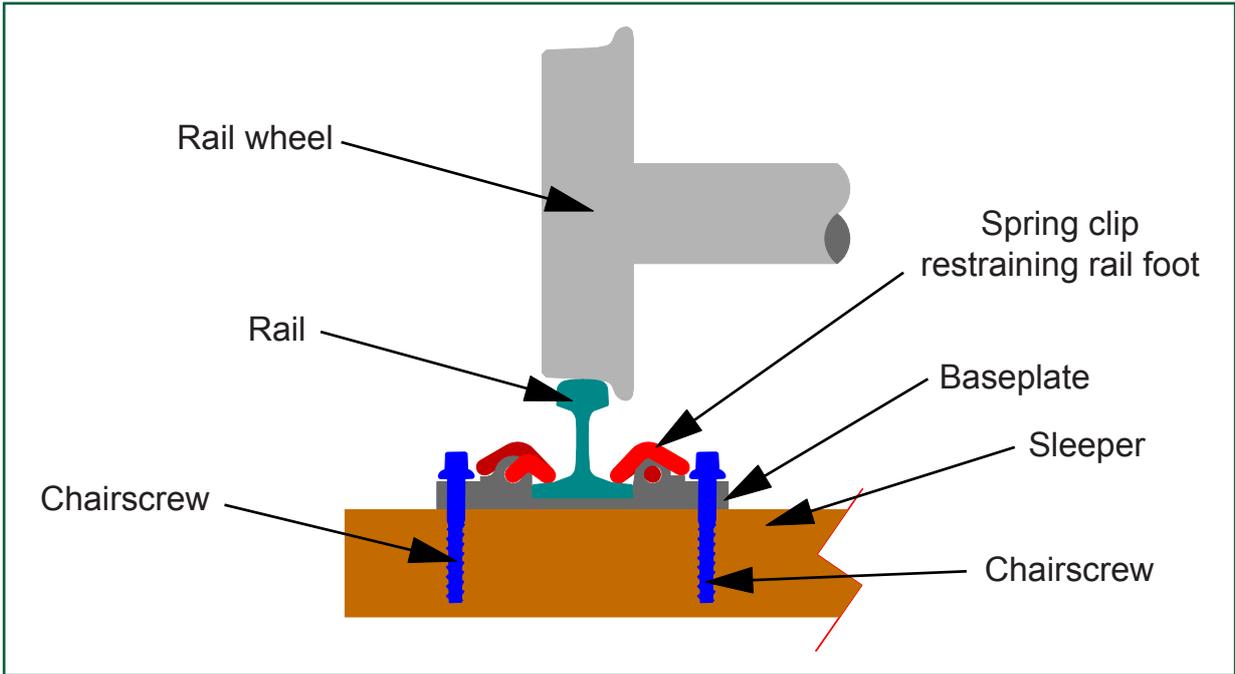
Figure 14: Rail fixing system

- 76 Most rails at Liverpool Street, except switch rails, are fixed to wooden sleepers using a retaining system consisting of a *baseplate* which is screwed to the sleeper using *chairscrews* and *spring clips* which clamp the *foot* of the rail to the baseplate (figure 14). This type of fixing is intended to resist the forces imposed on the rail by train movement.

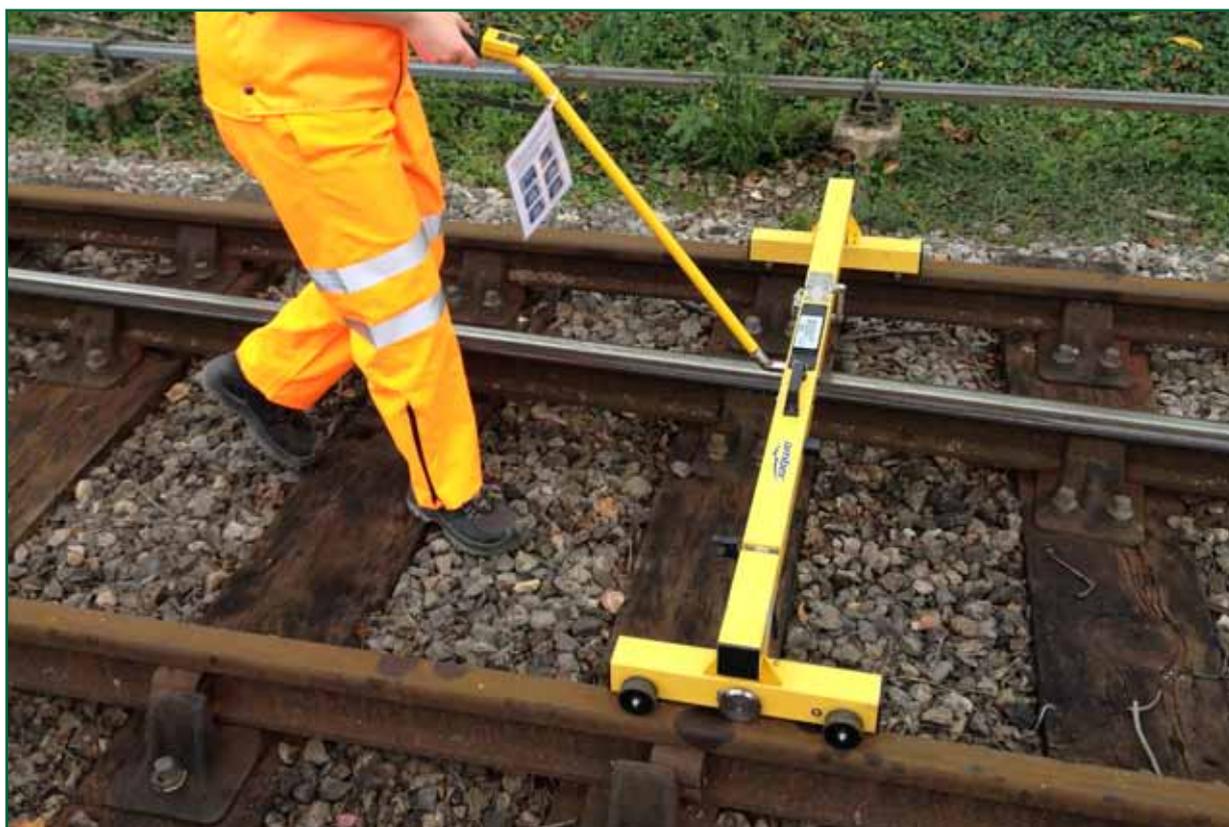
Figure 21: Amber trolley in use (not at accident site)

119 At Liverpool Street the static gauge was recorded using a manual recording device known as an Amber trolley (figure 21). The trolley is lightweight to allow handling by a single person and only applies a small load to the rails. This load is not sufficient to replicate the dynamic movement caused by train loads and so the trolley cannot be used alone to measure dynamic gauge.

120 The trolley measures and records track gauge, and other track geometry characteristics, while it is pushed along the track. It alerts the operator when pre-set track geometry intervention limits, including those for dynamic gauge, have been exceeded. Although the intervention limit relates to dynamic gauge, the trolley is only measuring static gauge.
