Rail Accident Investigation Branch

# Rail Accident Report

**Accidents involving a wheelchair rolling onto the track at Southend Central, 28 August 2013; and a pushchair rolling onto the track at Whyteleafe, 18 September 2013**

Report 17/2014  
August 2014

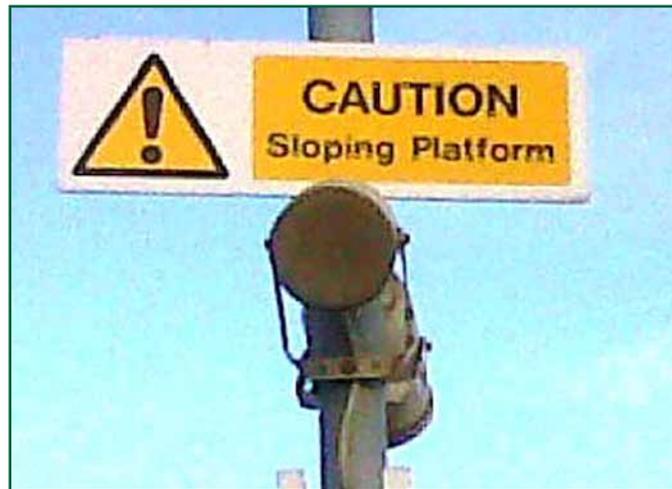
Figure 13: Signage installed at Barrhead station (image courtesy of First ScotRail)

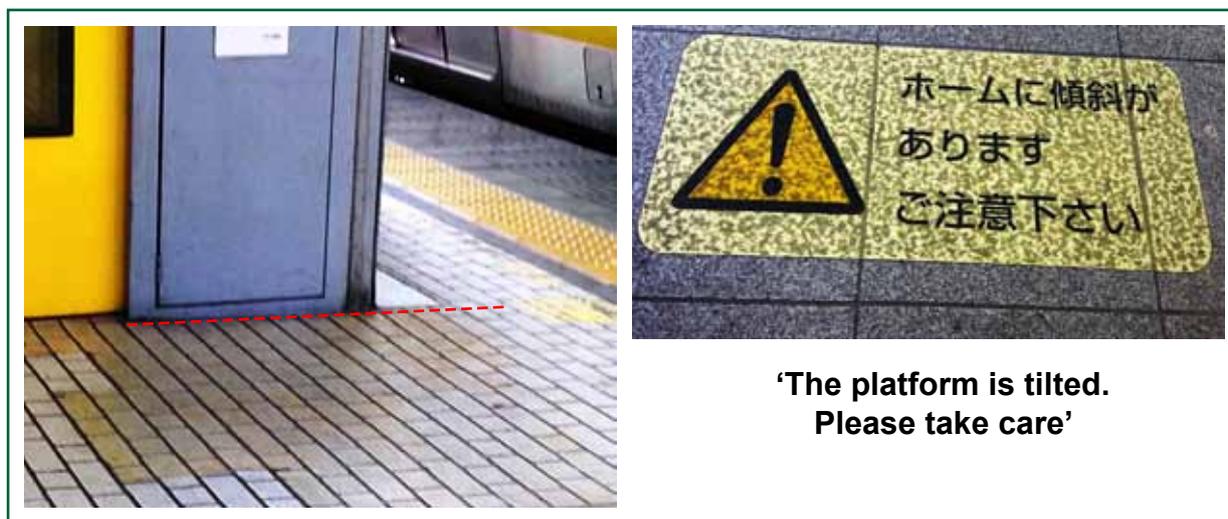
Figure 15: Platform transfers installed at Shinagawa Station, Tokyo, Japan (images courtesy of Professor N. Tyler. University College London)

- d. committed to undertaking a review of international best practice in the management of hazards at stations such as slopes towards the track and gaps between trains and platforms (figures 15 and 16).

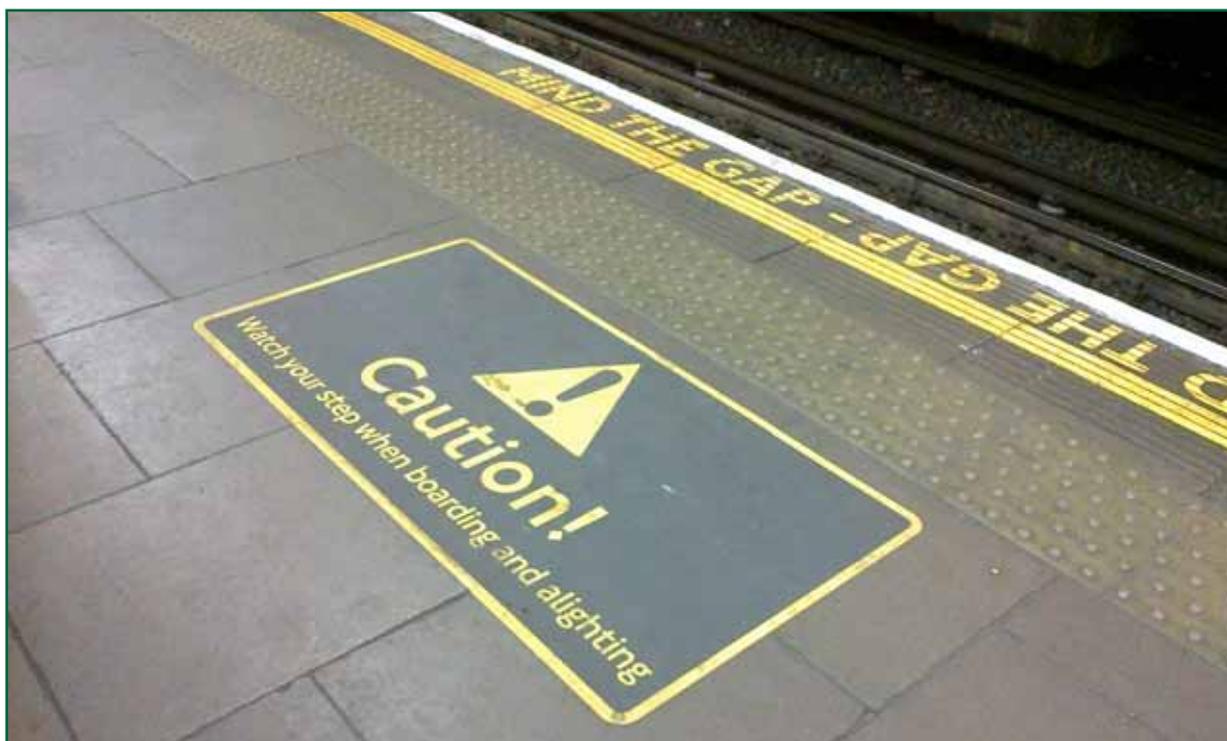
Figure 16: Transfer used on the London Underground

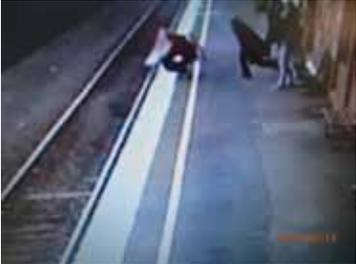
Other worldwide incidents	
<p><b><u>Ashburton station, Melbourne, Australia (Connex, Melbourne (now Metro trains) 2009</u></b></p>	<p>A near miss occurred after a pram holding a 6-month old baby rolled onto the tracks and into the path of an oncoming train as it entered the platform at Ashburton railway station.</p>

<p>The baby's mother had been distracted while she was standing on the platform, and was looking away as the pram rolled off the platform. The baby suffered minor cuts and bruises. It was reported that a previous identical accident had prompted the train operator to review the design of platforms in the Melbourne area, but the standards only require new platforms to slope away from the railway track.</p>
<p><b><u>Tooronga station, Melbourne 2010</u></b></p>	<p>A pram rolled off the platform and into the path of an approaching train at Tooronga station. No further details were supplied.</p>
