# Rail Accident Report

## **Accident involving a pantograph and the overhead line near Littleport, Cambridgeshire 5 January 2012**

Report 06/2013 v2  
November 2013

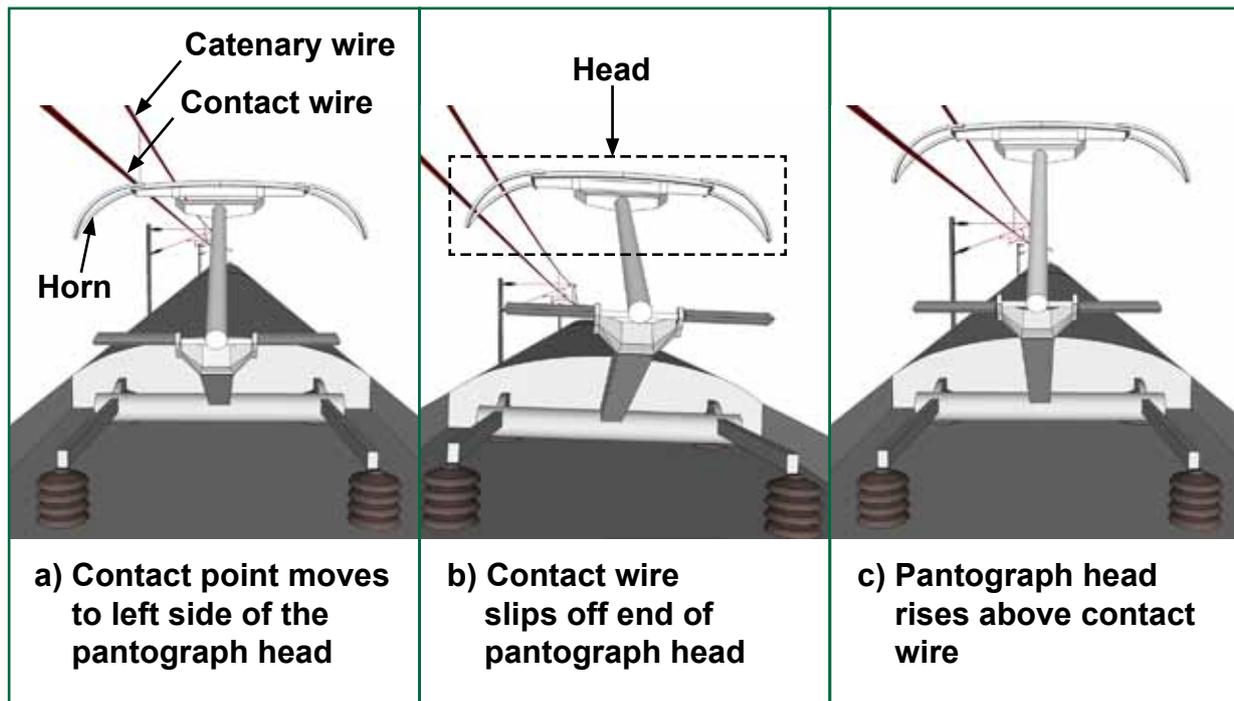
Figure 3: Illustration of process of dewirement

- 29 As the train approached the accident location, the contact point between the contact wire and the pantograph moved towards the left side of the pantograph head (facing the direction of travel) and reached a position where it slipped off the left end of the pantograph head. This allowed the pantograph head to move upwards past the contact wire (figure 3), as evidenced by witness marks on the left-hand horn (the curved side of the pantograph head).

- 92 The train's pantograph became derailed between masts C119/04 and C119/02 (the location at which the first dropper wires were broken). This was as a result of the wire moving off the left-hand end of the pantograph head, as indicated by wire marks on the left-hand horn.

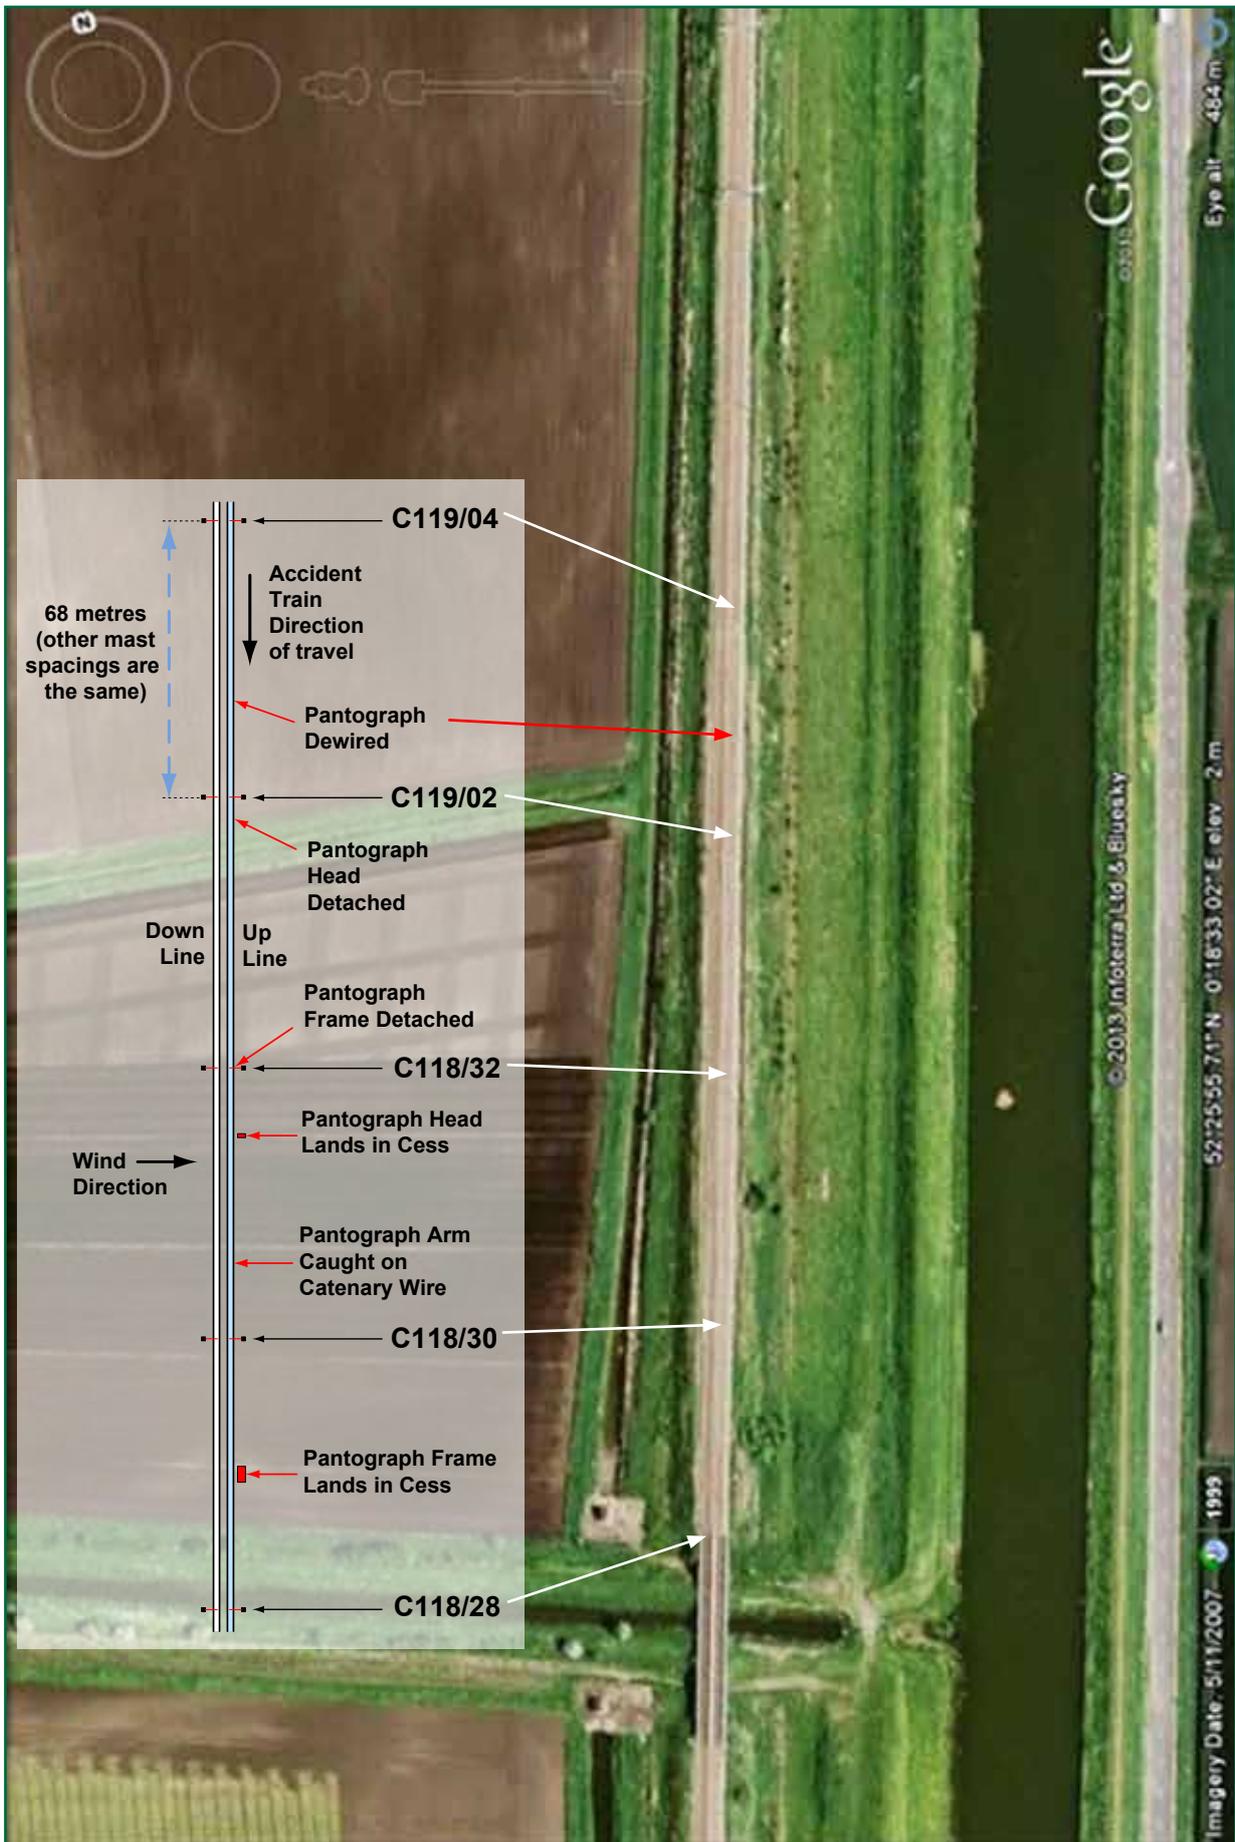
Figure 13: Overview of the accident location

- 65 The RAIB examined the damage to both the pantograph and the overhead line equipment. This, in conjunction with photographic evidence of where the damaged components came to rest, allowed the RAIB to develop a likely sequence of events that led to the dewirement and detachment of the pantograph (figures 13, 14 and 15).

- 66 The pantograph became dewired to the right of the contact wire (figure 14a), between electrification mast numbers C119/04 and C119/02.
- 67 The pantograph head moved into the gap between the contact wire and the catenary wire, and broke a dropper wire as the train moved towards electrification mast C119/02 (figure 14b).

- 68 At mast C119/02, the overhead line was supported from the left, while the pantograph arm was positioned to the right of the contact wire. The pantograph head passed this mast without hitting any of the cantilever structure (figure 14c).

- 69 The pantograph head, still between the contact and catenary wires, hit the first dropper wire after mast C119/02 (figure 14d). Adjacent to this dropper wire was a jumper wire, which had a much bigger cross section (it was designed to make a good electrical connection between the catenary and contact wires, rather than to provide mechanical support). It is likely that the pantograph head became detached from the arm as a result of hitting the jumper wire. The next five dropper wires, up to mast C118/32, remained intact as the pantograph arm passed to the right of them.

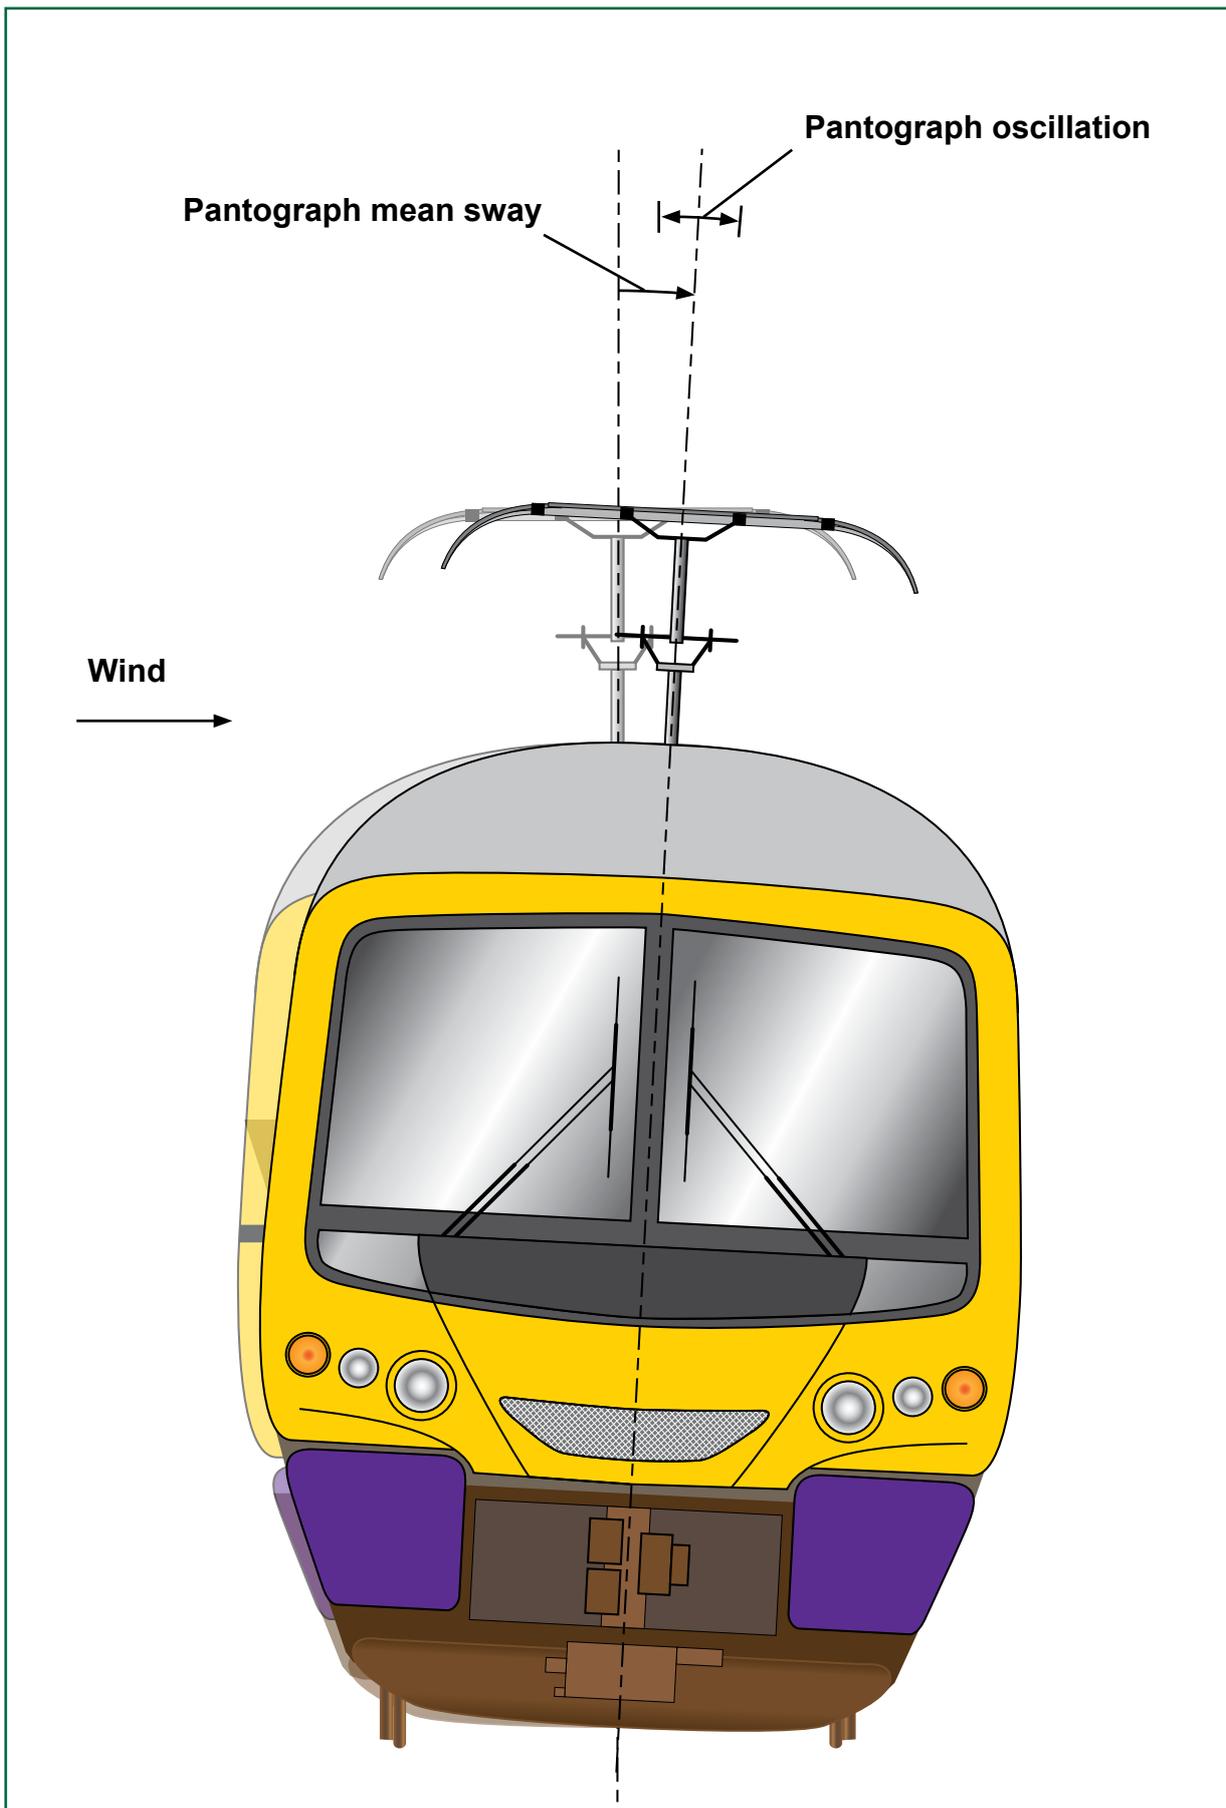
Figure 19: Illustration of train sway

- 102 The post-accident modelling considered two scenarios with winds gusting to 37 mph and 55 mph (16 m/s and 25 m/s), similar to the likely wind range at the accident location (paragraph 56). The modelling showed that the train swayed about a mean position on the down-wind side of the track centre line (figure 19).

- 103 The RAIB has used the RSSB modelling data to assess the approximate mean sway and the approximate amount of oscillation at the pantograph head for a lightly loaded train with a pantograph height of 4.96 metres (the accident situation) in the likely range of wind speeds. A mean sway of 72 mm, with an oscillation of 37 mm each side, was obtained for the lower end of the range (42 mph gust at contact wire height). Corresponding values of 111 mm and 39 mm were obtained for the upper end of the range (61 mph gust at contact wire height).

- 104 The calculated sway values lie within limits given by Railway Group Standard GM/RT2149 'Requirements for defining and maintaining the size of railway vehicles'. This standard allows a maximum pantograph deviation from track centre of 190 mm at 4.3 metres contact wire height and a wind speed of 35 m/s (78 mph). This corresponds to a maximum pantograph deviation of approximately 220 mm at the contact wire height of 4.96 metres (recorded by the *new measurement train* at the accident site in November 2011). This maximum value allows for the effects of the *canted track* provided at some curves.

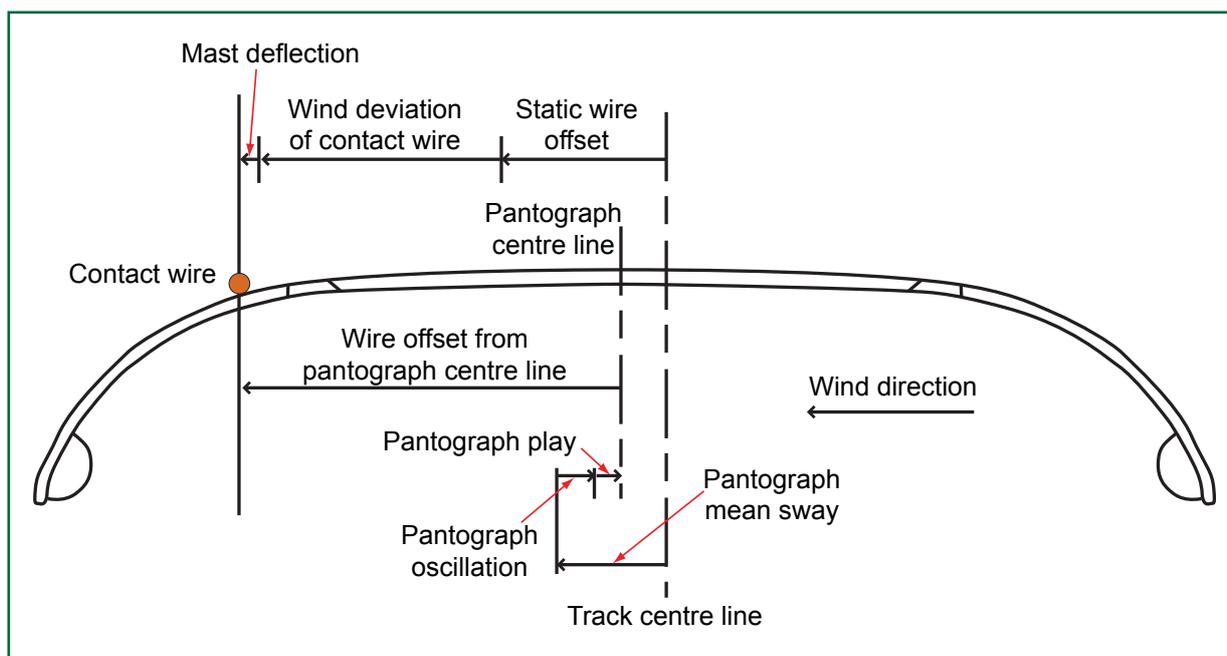
Figure 20: Pantograph head profile showing the factors affecting the contact wire position

- 105 Table 4 and figure 20 summarise the characteristics which affect the contact position of the overhead line on the pantograph at the wind speeds of interest. Positive values indicate movements in the direction tending to cause dewirement. Oscillating values (eg pantograph play) are shown in the configuration most likely to cause dewirement.

- 106 This shows that, if the most adverse effects occur simultaneously, the contact wire could deviate up to 465 mm from the centre of the pantograph during the maximum likely gust speed at the time of the accident. However a higher deviation would be possible in the presence of the feasible gusts (paragraph 112).
- 107 The pantograph head is curved downwards towards the ends, to allow the contact wire to run on and off the pantograph as the train passes the ends of wire runs and locations where adjacent lines converge and cross. It also has an upwards force applied to it to keep it in contact with the overhead line (paragraph 40). Because of this the pantograph will push up past the contact wire, and dewirement will occur, if the wire moves too far from the centre line of the pantograph head.

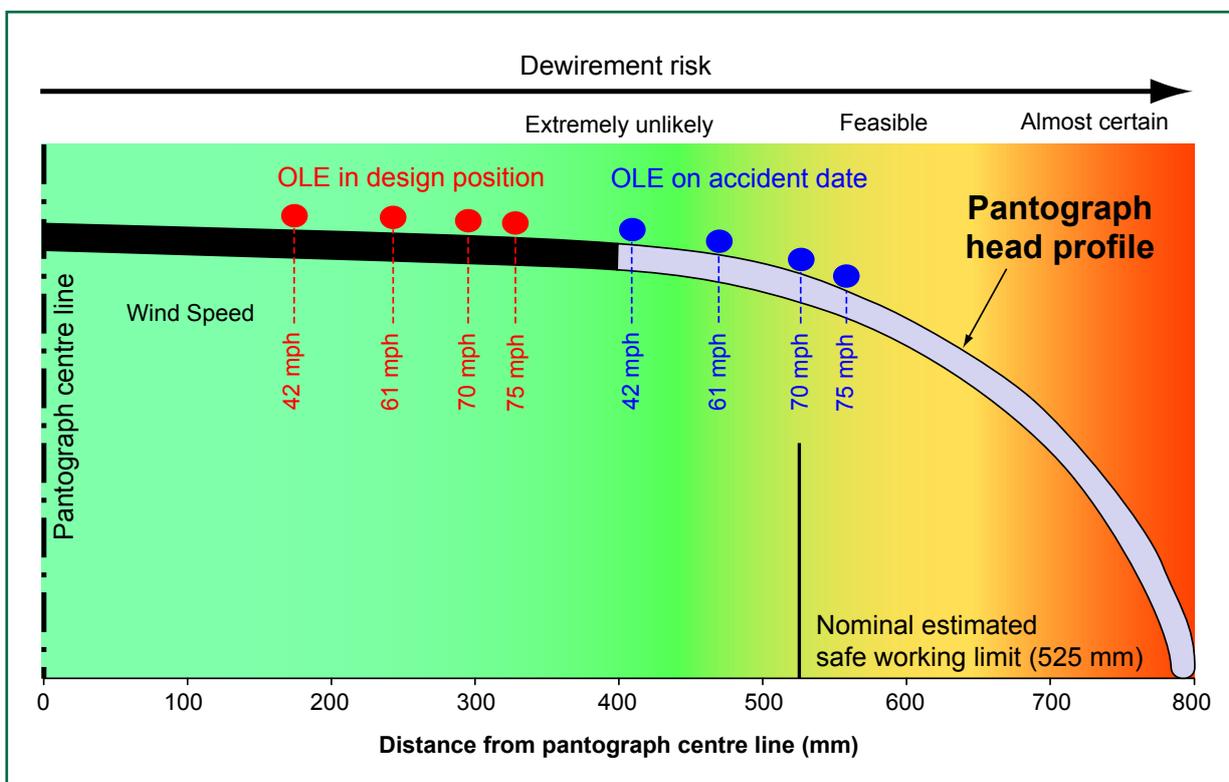
Figure 21: Illustration of dewirement risk in high winds (worst case conditions)

- 114 Figure 21 gives a qualitative illustration of how the dewirement risk relates to contact wire position on the pantograph head. This shows that a dewirement starts to become feasible when the contact wire moves past the safe working limit. As the wire moves further across the pantograph head, the likelihood of dewirement increases, until it becomes almost certain as the contact wire moves towards the end of the horn. Factors affecting the likelihood of dewirement include the time that the contact wire remains beyond the safe working limit, the tension in the contact wire, and the up force on the pantograph.

- 115 Figure 21 also shows the worst case positions of the contact wire in different wind conditions, indicating that a dewirement was feasible in gusts of 70 mph, with the likelihood increasing for higher wind speeds. Figure 21 also shows that dewirement would have been extremely unlikely to have occurred if the overhead line had been maintained in the design position.

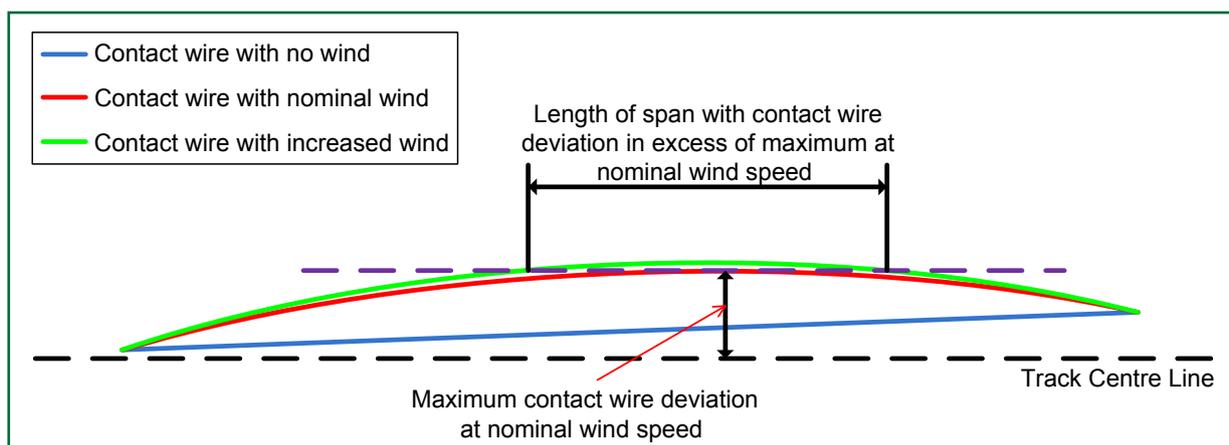
Figure 22: Effect of increased wind speed

- 116 The contact wire deviations due to wind, shown in table 4, are the maximum values which occur at only one position on the 68 metres long wire span. However, a significant length of wire is close to this value. As a result, if the wind speed is increased, even by a small amount, a significant length of wire moves beyond the original deviation (figure 22). For example, if the wind speed is increased by 1 mph, more than 15% (10 metres) of the span moves to a position beyond the original maximum deviation. Similarly, if the wind speed increases by 5 mph, more than 34% (23 metres) of the span moves to a position beyond the original maximum deviation. This shows that a small change in the wind speed can have a large effect on the length of the overhead line that exceeds a defined wind deviation, and thus a large effect on the probability of a dewirement occurring. The lengths of span affected by changes in the wind speed do not change significantly for wind speeds in the range 42 mph to 70 mph (19 m/s to 31 m/s).

- 117 A similar effect can be seen if the distance between the contact wire and the pantograph centre line changes for other reasons. For example, a 10 mm increase in this dimension results in approximately 21% (14 metres) of the span moving beyond the original contact position, when the wind speed is 61 mph (27 m/s), and 18% (12 metres) of the span when the wind speed is 70 mph (31 m/s).

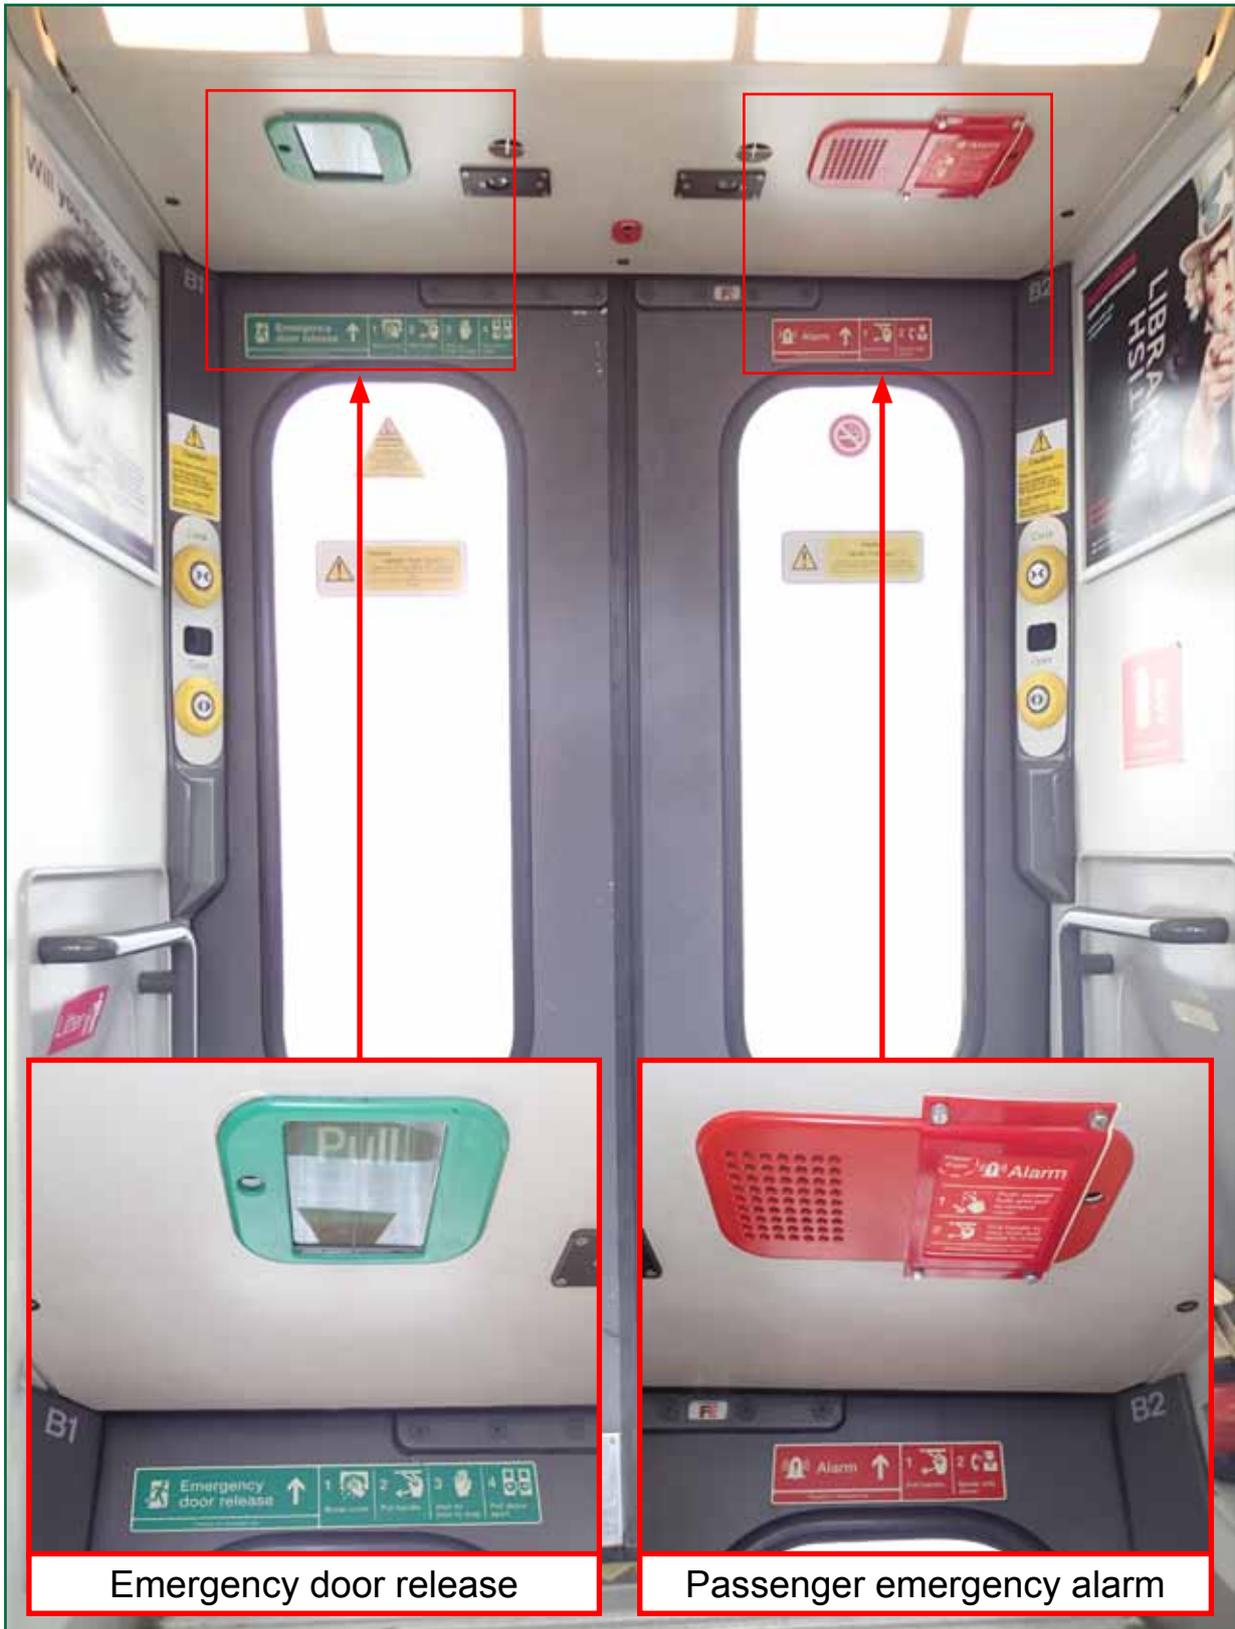
Figure A1: PEA and emergency door release handles

- A6 After the windows were broken by the falling pantograph, at least two passengers attempted to operate the nearest PEA handle, while the driver allowed the train to continue coasting. However, they were unable to remove the plastic cover to gain access to the handle. After several attempts they gave up, and a passenger decided to break the cover to the emergency door release handle, and to operate this instead. Because the train's speed did not appear to be reducing, the passengers believed that the driver was not intending to stop. They were unaware that he was attempting to reach a convenient access point and was intending to stop at Queen Adelaide crossing.
