# Frigg Field Cessation Plan Close Out Report

## Close Out Report

Stavanger 12 May 2011

TOTAL E&P NORGE AS

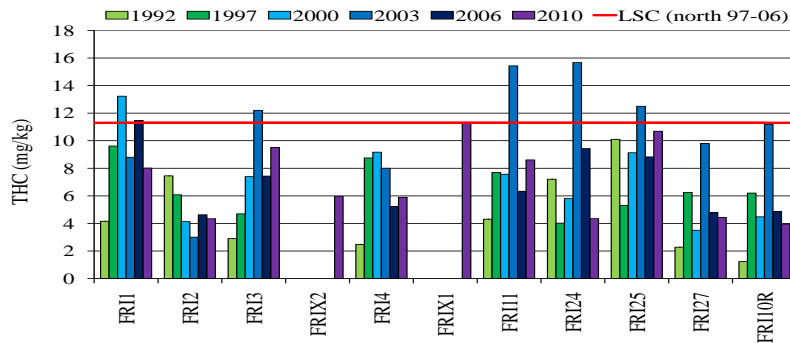
Figure 62. Total Hydrocarbon Content (TCH) measured on the Frigg Field since 1992 compared to LSC<sub>97-06</sub> (red line).

The conclusion from the 2010 survey is that all stations within the Frigg Field consist mainly of sand (94-99 %) where the content of the total organic matter is low (0.45-0.76 %). The concentrations of the Total Hydrocarbon Content (THC) are low (4-11 mg/kg), and none of the measured THC-concentrations are above the Level of Significant Contamination<sup>2</sup> (LSC), as shown on Figure 62

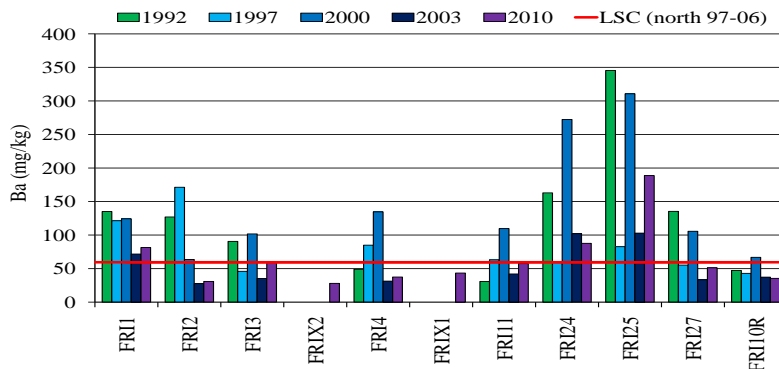
Figure 63. Barium (Ba) concentration measured on Frigg Field since 1992 compared to LSC<sub>97-06</sub> (red line).

The concentrations of barium (Ba) are in the range from 28 to 189 mg/kg. Three stations have Ba-concentrations above LSC-level. A number of the stations have metal concentration larger than the LSC (north97-06) as shown on Figure 63 and these elevated levels are most pronounced where the fauna is slightly different from the other field stations.

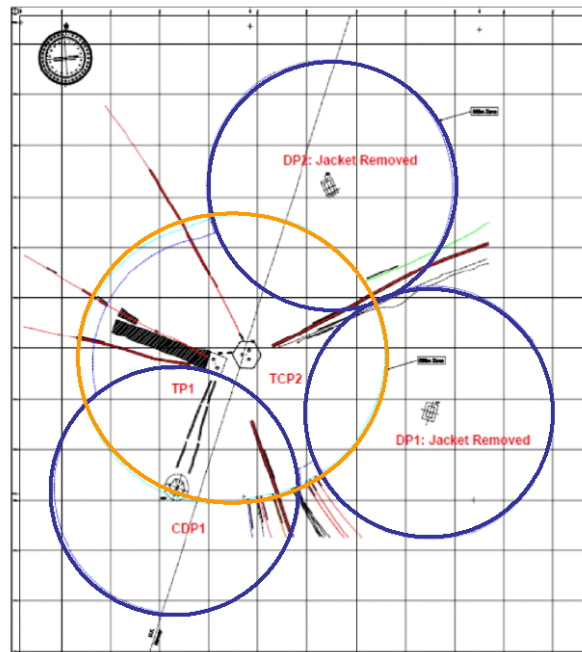
Figure 65. Area covered in the trawl tests in 2008 (within brown circle) and in 2010 (within brown and blue circles)

Both the “chain net” and the bottom trawl passed the area successfully. Consequently the SFF issued a “Clear Seabed Certificate” which is attached to Appendix 1, Table 25, documenting that the seabed covered was free from any obstructions which could prevent any future bottom trawl fishing.

Three locations prevented the “chain net” to pass. On one location the “chain net” got stuck and was lost and the trawler had to go to Shetland for a replacement before continuing. However, the bottom trawl sweep using a normal trawl net was performed successfully.

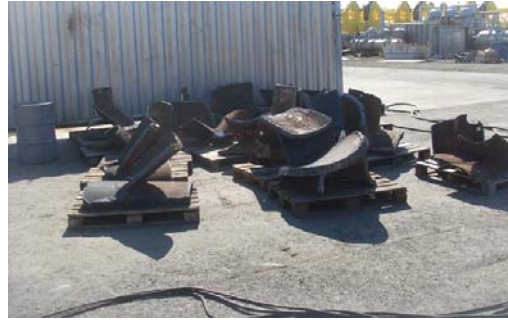
**Figure 70.** Part of nodes cut out from the DP1, DP1 and QP jackets ready to be sent to the laboratory

A number of representative nodes have therefore been cut from the DP2, QP and DP1 steel jackets at different locations and sent to a laboratory for detailed inspection to check their structural response, see Figure 70.
