Rail Accident Investigation Branch

Rail Accident Report

**Train struck and damaged by equipment cabinet door in Watford Tunnel
26 October 2014**

Report 12/2015
August 2015

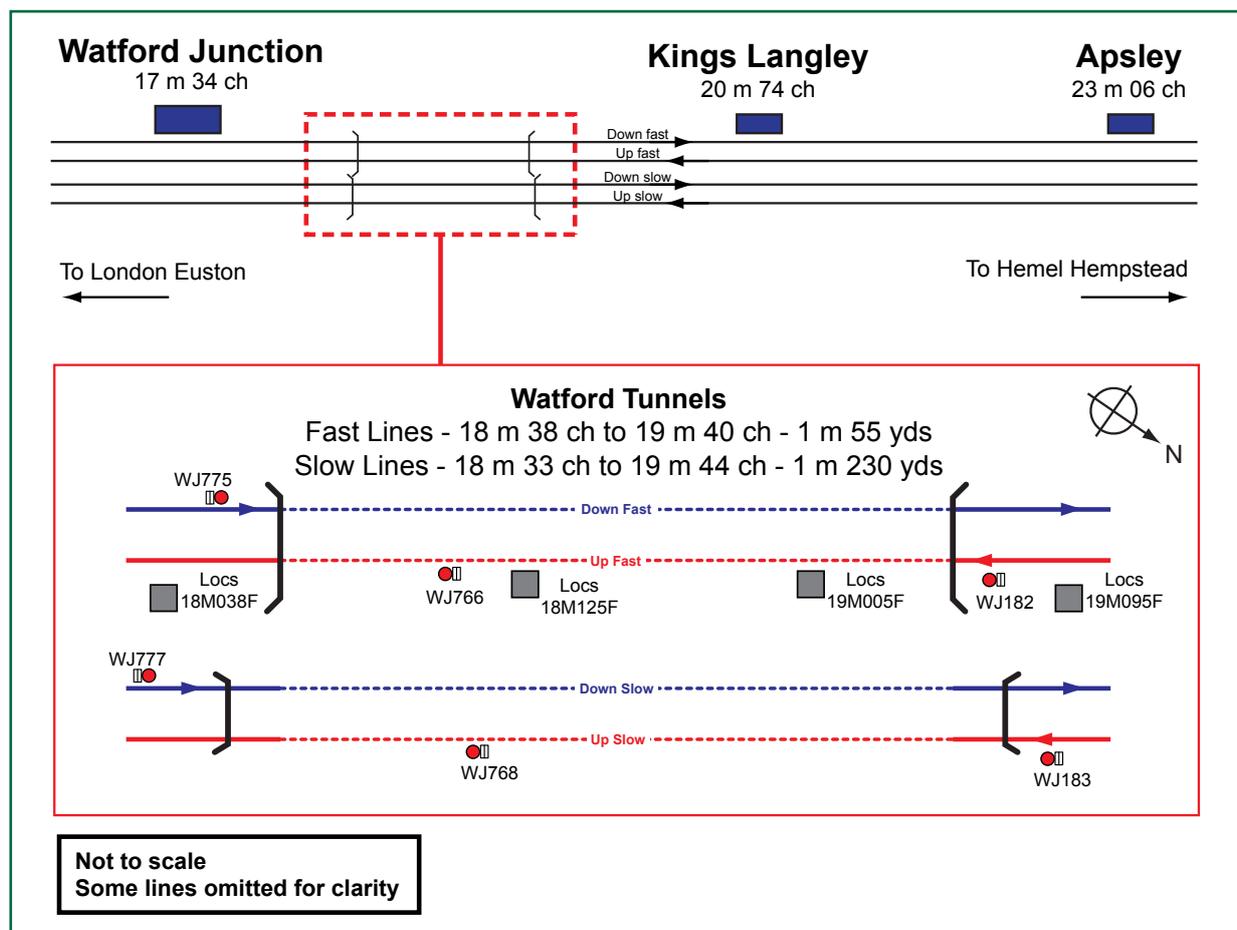
Figure 2: Track layout showing the location of the equipment and site of work

- 5 The Watford Tunnels are on the West Coast Main Line, and comprise separate bores for the fast and slow lines (two tracks in each bore). The fast line tunnel is just over a mile (1.6 km) in length, with the southern portal located at 18 miles 38 chains¹ from London Euston.
- 6 The lines through the tunnel are electrified using 25 kV overhead line equipment and equipped with four-aspect signals which, at the time of the accident, were controlled from Watford Power Signal Box². The maximum permitted speed on the fast lines is 110 mph (177 km/h).

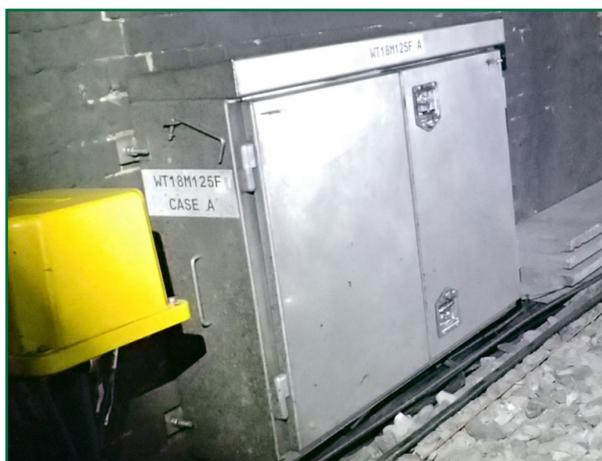
Figure 3: The cabinet in its original condition in Watford Tunnel

- 13 The cabinet involved in the accident was one of a number of such cabinets installed in Watford Tunnel on 4 October 2014 (figures 3 and 4). It contained equipment associated with the operation of signalling equipment in the tunnel. The installation of the cabinets was part of a project that started in 2009 to update the existing signals and associated equipment in the Watford area and to transfer control of the signalling equipment from Watford Power Signal Box to Wembley Main Line Signalling Control Centre.

³ Witness evidence shows, and the RAIB observed, that a document tray within the cabinet may have prevented the doors from closing fully (so that they could be secured) without pressure being exerted to push the document tray into the body of the cabinet.

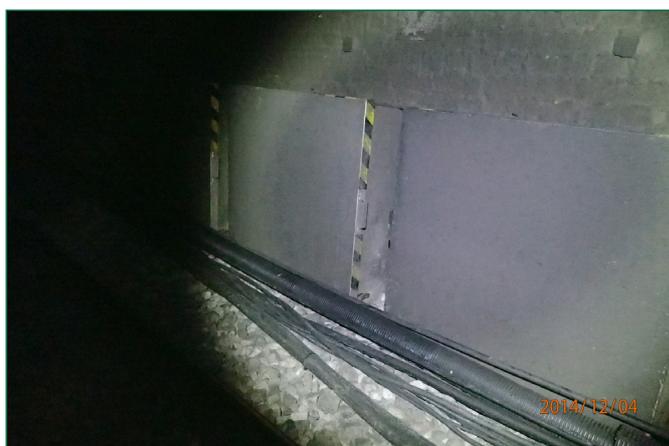
Figure 17: The standard cabinet design with lift-off panel

- 73 After Network Rail instructed Siemens in November 2013 not to use the tunnel refuges for siting the cabinets Siemens set about procuring a suitable product and looked at several design options (figure 17) for 'off the shelf' products that already had *product acceptance* for use on Network Rail's infrastructure.

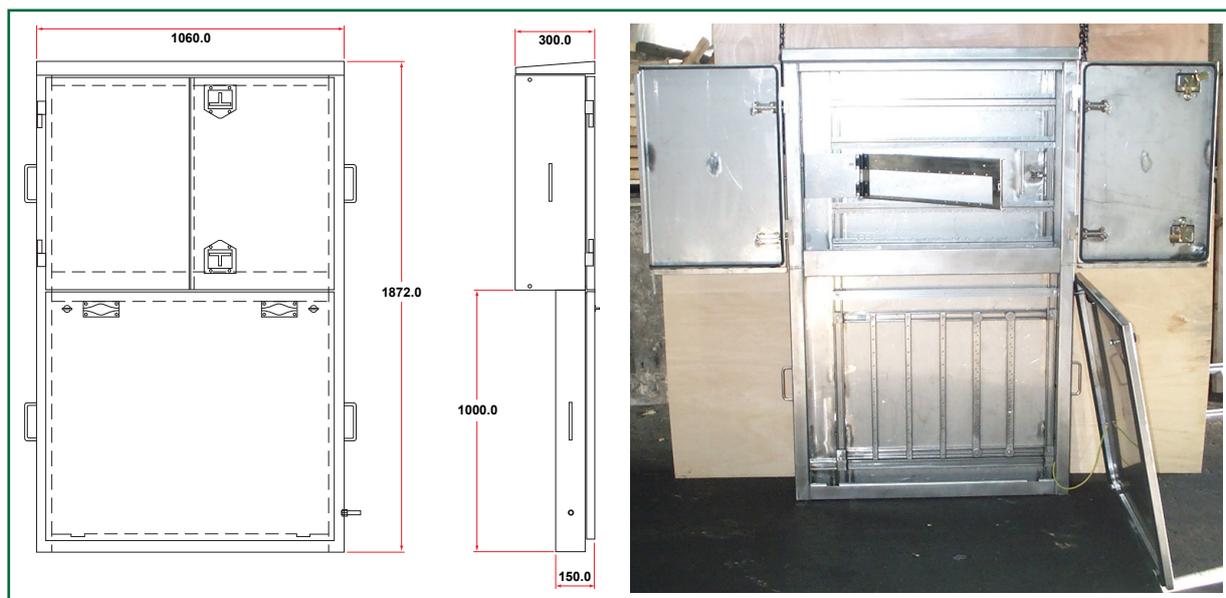
Figure 18: The slimline double chamber cabinet with lift-off panel (bottom) and double doors (top) specifically designed for the Thameslink project (Belsize Tunnel) in 2004 (image supplied courtesy of MGB Engineering, Plymouth)

- 74 The RAIB understands that some of Siemens' signalling technicians who had previously worked on the Thameslink project identified an alternative design that they had used in Belsize Tunnel which therefore had product acceptance (figure 18). In December 2013, Siemens' design risk log showed that the CEM had recorded that an assessment of the solution for providing tunnel cabinets should be completed, as Siemens intended to use the same cabinets as those used on the Thameslink project, but use of the cabinet would be dependent on a site analysis and an additional IDC. The CEM closed this entry on 21 February 2014 showing that the cabinets would now be mounted on the tunnel wall. The additional IDC did not take place.

- 75 Between February and June 2014, Siemens contacted the Sales Engineer at Henry Williams Ltd asking him to look at the engineering options that were available. The cabinet had been originally designed to meet the specific electrical requirements and gauge constraints in Belsize Tunnel (paragraph 79), and there were other differences in the equipment to be included within the cabinet for its use in Watford Tunnel. Siemens' CDM requested several modifications to the original cabinet design, including a reduction in height. The Belsize Tunnel cabinet was, in effect, two cabinets mounted vertically, but only one was needed for Watford Tunnel. The lower of the two Belsize Tunnel cabinets featured a lift-off panel and the upper cabinet had hinged doors. However, when Siemens modified this arrangement to utilise only a single cabinet, they selected the hinged door version. Had they selected the cabinet with the lift-off door, the accident could not have happened in the same way as it did on 26 October 2014. Although the door could have been left off completely (in which case it would have been blown around the tunnel by the train), the absence of the door would have been much more apparent to the testers.
