AAIB Bulletin

4/2015

CONTENTS**SPECIAL BULLETINS / INTERIM REPORTS**

AAIB FIELD INVESTIGATIONS**COMMERCIAL AIR TRANSPORT****FIXED WING**

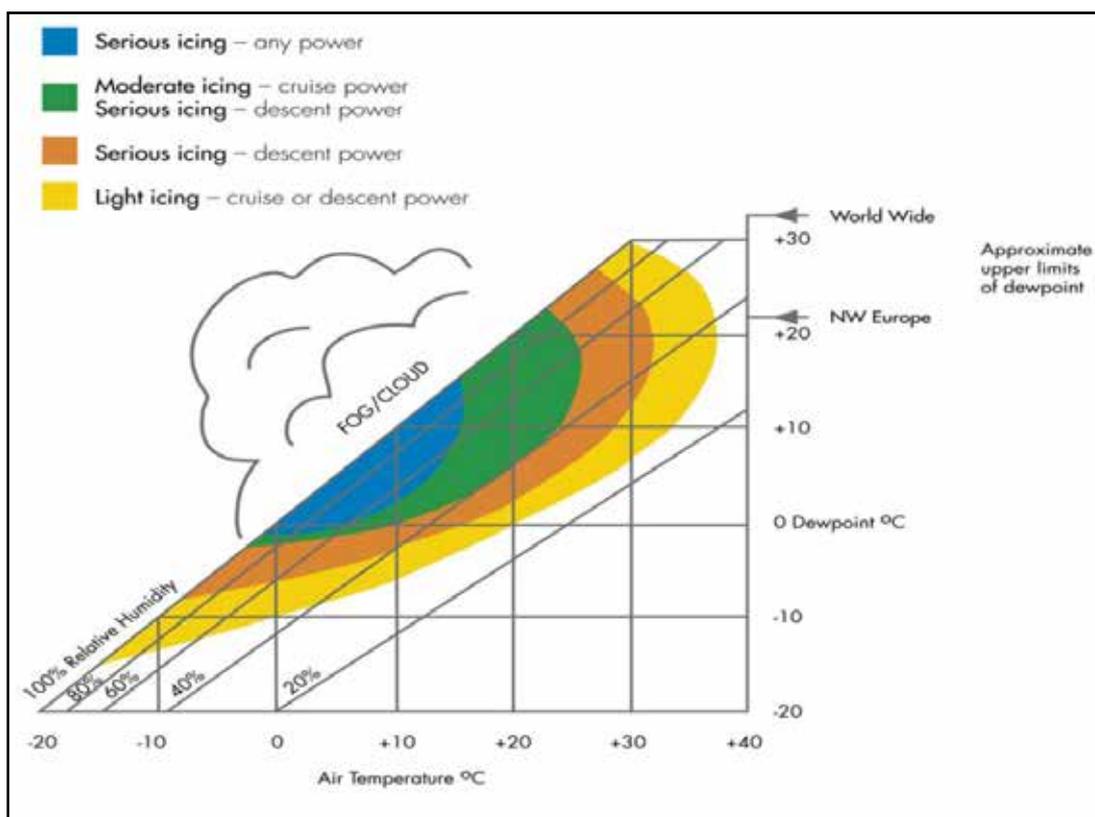
Figure 1

He lowered the nose slightly and tried to turn the aircraft left to force land in a field but it stalled, struck trees beneath him and came to rest in the field. The pilot was uninjured but the aircraft suffered substantial damage.

The pilot considers that the behaviour of the engine was consistent with either carburettor ice or water in the fuel. He reported that he normally applies carburettor heat upon entering the circuit and, whilst he could not definitely recall whether he did on this occasion, he saw no reason to believe that he had omitted such a habitual action. The weather conditions were such that the aircraft was flying in the 'Moderate icing risk at cruise power and serious icing risk at descent power' portion of the carburettor icing chart published by the Civil Aviation Authority (Figure 1). The carburettor float chamber had not been checked for the presence of water at the time of preparation of this Bulletin.
