Rail Accident Report

Tram collision with pedestrian near Market Street tram stop, Manchester 12 May 2015

Report 06/2016
April 2016

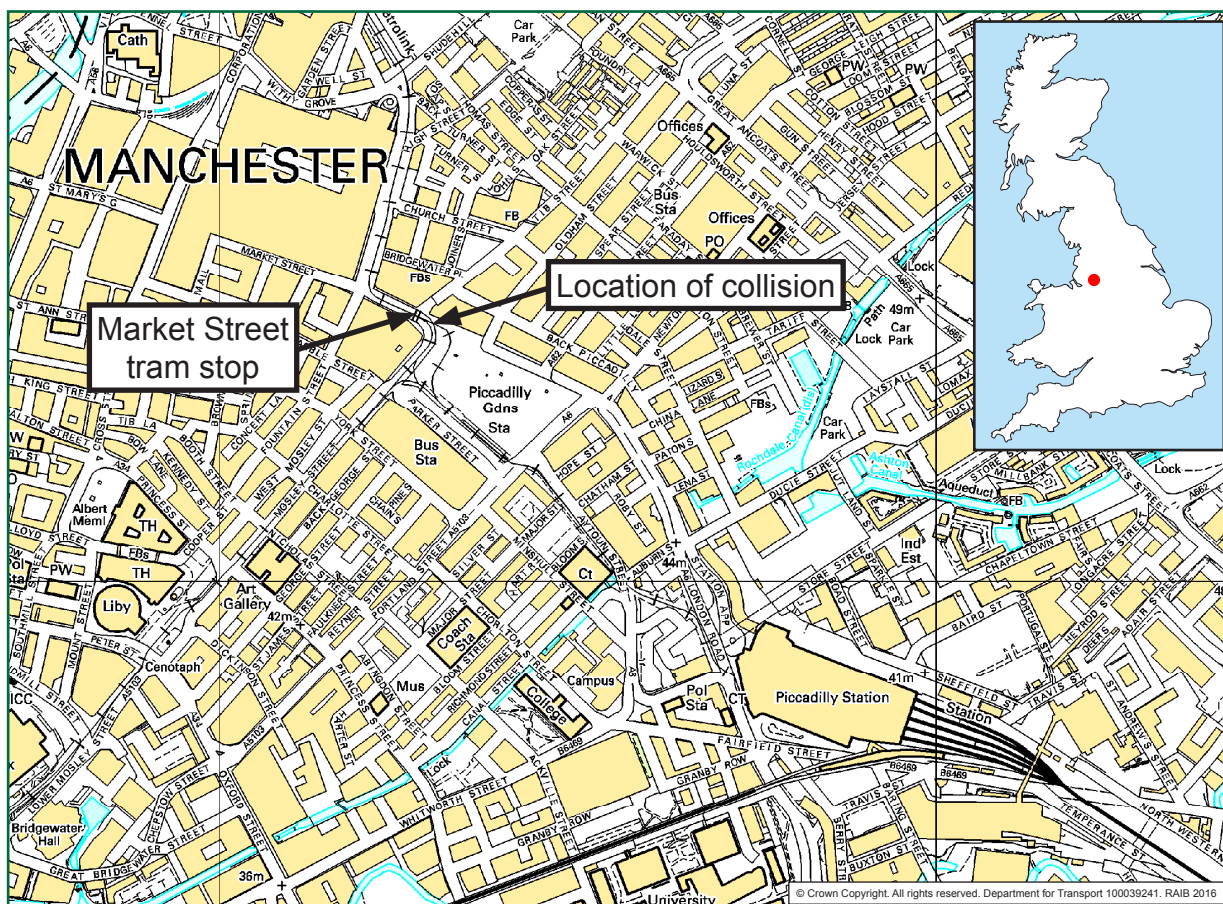
Figure 1: Extract from Ordnance Survey map showing central Manchester and the location of the accident

- 3 At about 11:13 hrs on Tuesday 12 May 2015 a tram collided with an adult pedestrian about 25 metres to the south east of Market Street tram stop in central Manchester (figure 1). The tram was running from Bury to Etihad Campus via Market Street and Piccadilly Gardens. It was travelling at 9.3 mph (15 km/h) at the time of the collision.

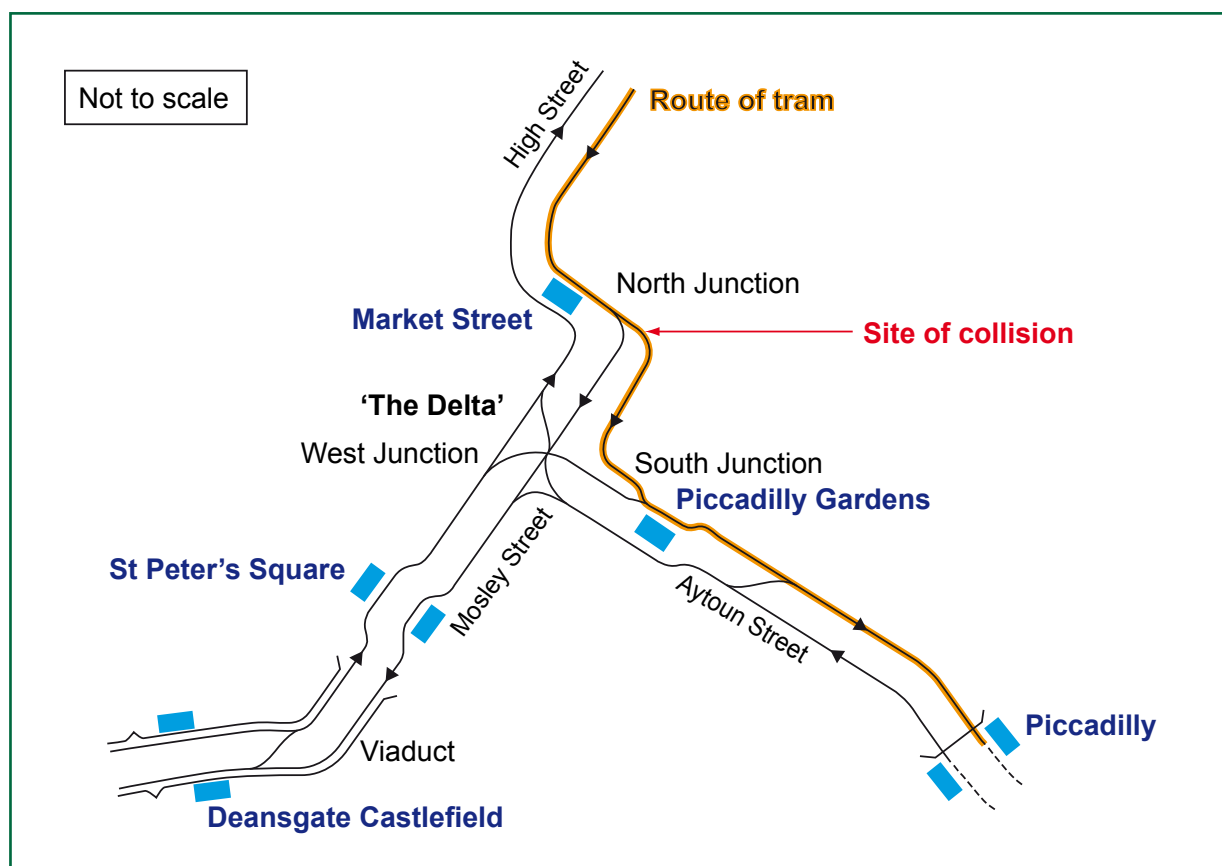
Figure 4: Track layout, Central Manchester, showing diverging routes at North Junction

- 6 The Piccadilly Gardens area in Central Manchester is at the hub of the Metrolink system¹. Tramway infrastructure in this area includes North, South and West junctions, the 'Delta' and the Market Street and Piccadilly Gardens tram stops (figure 4). Piccadilly Gardens and the section of Market Street in which the tram stop is situated in a pedestrianised area (closed to motor traffic except trams and vehicles requiring access).

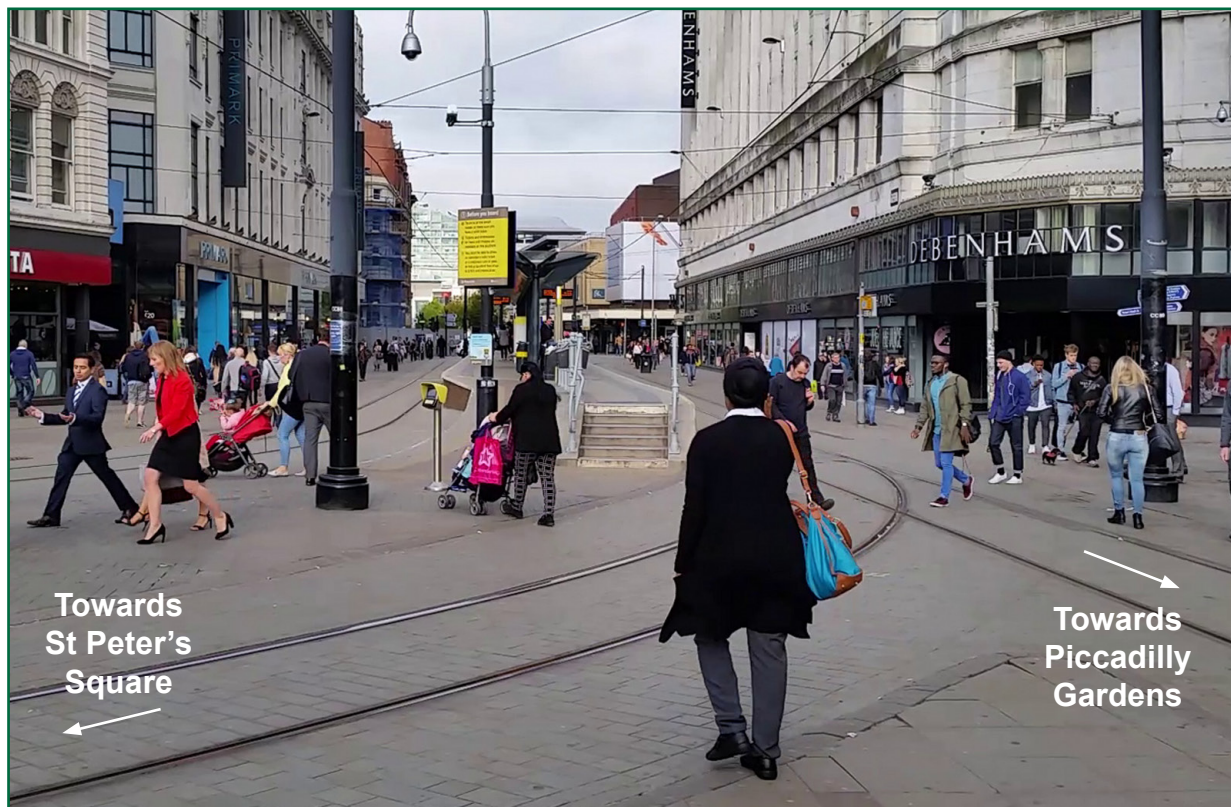
Figure 5: View along Market Street towards High Street, with Market Street tram stop in the centre

- 7 The tram involved in the accident had passed from an *off-street tramway* into an *on-street tramway* at Manchester Victoria station. After travelling south along High Street, which is classed as a segregated on-street tramway (see appendix D), the tram turned left into Market Street. This area is classed as an integrated on-street tramway as, although other road vehicles are not normally present, the surface in which the rails are laid is available for use by pedestrians (figure 5).

- a. integrated on-street tramways;
 - b. segregated on-street tramways; and
 - c. off-street tramways⁵.
- 28 The Piccadilly Gardens area in Manchester, including Market Street, is a pedestrianised area in which trams share the space with pedestrians (figure 5). As such, it falls within the definition of an integrated on-street tramway as well as being a form of *shared space*.
