Rail Accident Investigation Branch

# Rail Accident Report

**Derailment of a freight train near Langworth,  
Lincolnshire  
30 June 2015**

Report 11/2016  
June 2016

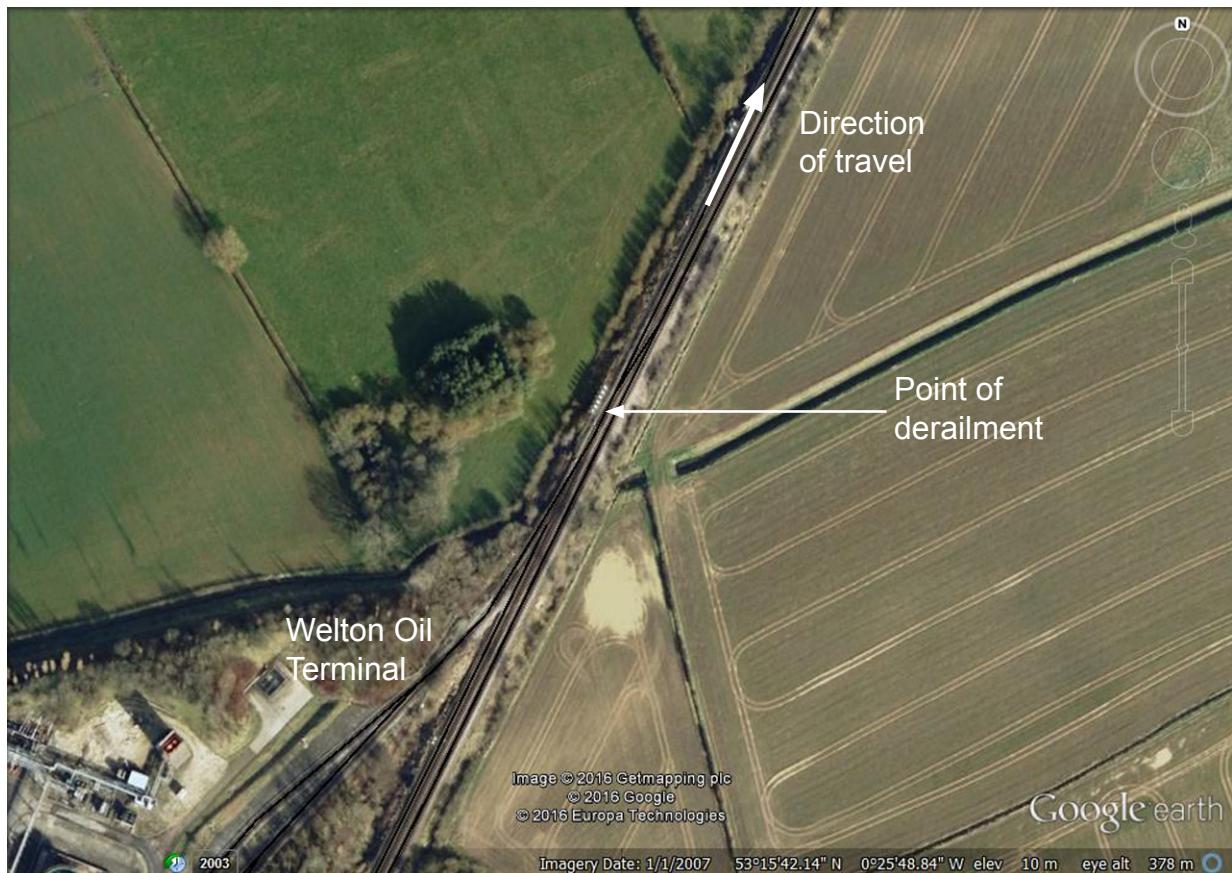
- 8 The accident occurred near the village of Langworth, on the *up main* line, immediately beyond the junction with the disused Welton Oil Terminal sidings, at 35 miles 1686 yards<sup>1</sup> (figure 3). The railway at this location comprises two tracks and has a maximum line speed of 75 mph (120 km/h) for passenger trains and 50 mph (80 km/h) for freight trains. The track at the point of derailment is straight and level.

Figure 3: Google earth image showing location of derailment

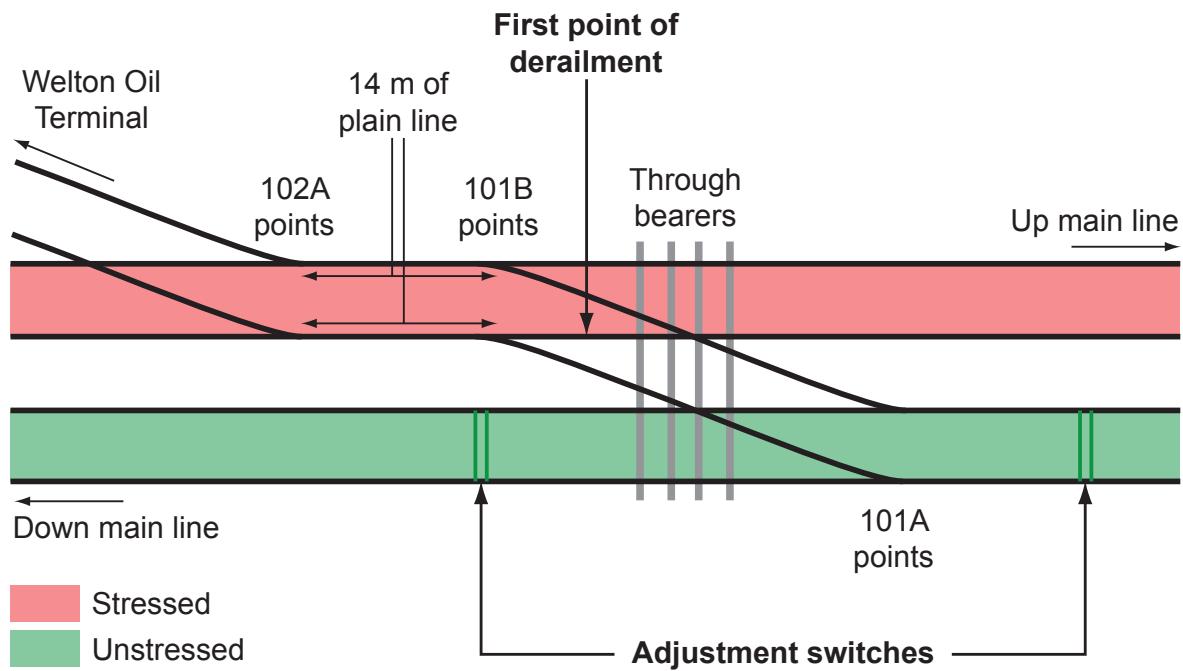
Figure 4: Layout of Welton switches and crossings (not to scale)

- 17 The derailment occurred within an area known as the Welton switches and crossings, associated with directing traffic to and from the Welton Oil Terminal<sup>3</sup>. The switch and crossing assemblies make up numbered sets of *points*, and if there are two point ends in a set, they are identified as the ‘A’ and ‘B’ ends. Train movements to and from the Welton Oil Terminal were controlled by 102A points (figure 4). These points were installed on wooden bearers (*sleepers*) and operated by means of a point motor controlled from the signal box at Langworth.

- 18 Beyond 102A points in the up direction there was a 14 metre section of *plain line* (figure 4) to 101B points where the derailment occurred. The two sets of points are described as ‘closely abutting’ because of the short distance between them. Train movements from 101B points could either go straight ahead on the up main line or be directed over the crossover to 101A points on the *down main* line. Points 101A and 101B were installed on concrete bearers and also operated by point motors controlled from the signal box at Langworth.

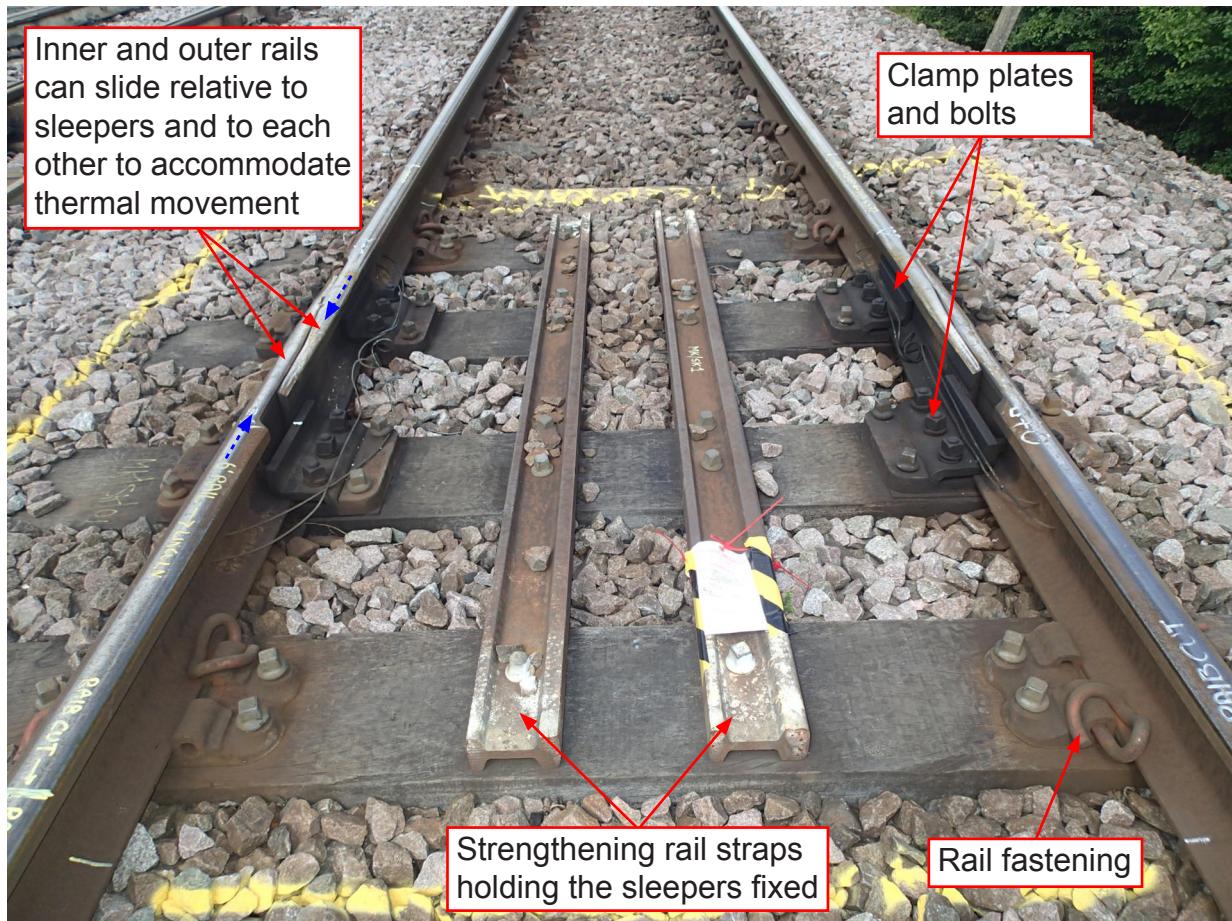
Figure 5: Adjustment switch on the down main line at the Lincoln end of 101A points

- 80 A track layout comprising a crossover between stressed and unstressed rails (figure 4) is unusual on Network Rail infrastructure. It is theoretically possible that, had the adjustment switches protecting 101A points on the down main line been seized or had reached the end of their travel, thermal stresses could have been transferred via the crossover to 101B points. The RAIB arranged for both sets of adjustment switches to be forensically examined and both were found to be in working order with capacity for further movement.

- 95 One of the checks made during the forensic examination of the adjustment switches (figure 5) was the torque tightness of the bolts in the clamp plate. Clamp plate bolts secure the adjustment switch rails to the baseplates and are required to be tightened on to a spring washer, leaving a 1 mm gap in the spring washer. Achieving this gap consistently on all the bolts should provide the requisite level of clamping load in the bolt. This is in preference to torque tightening the bolts and reliance on a consistent level of friction between the components of the bolted assembly to achieve the required clamping force.
