## *St Apollo* (BA 359) Grounding and flooding in Inninmore Bay, Sound of Mull, Scotland 24 August 2015

### SUMMARY

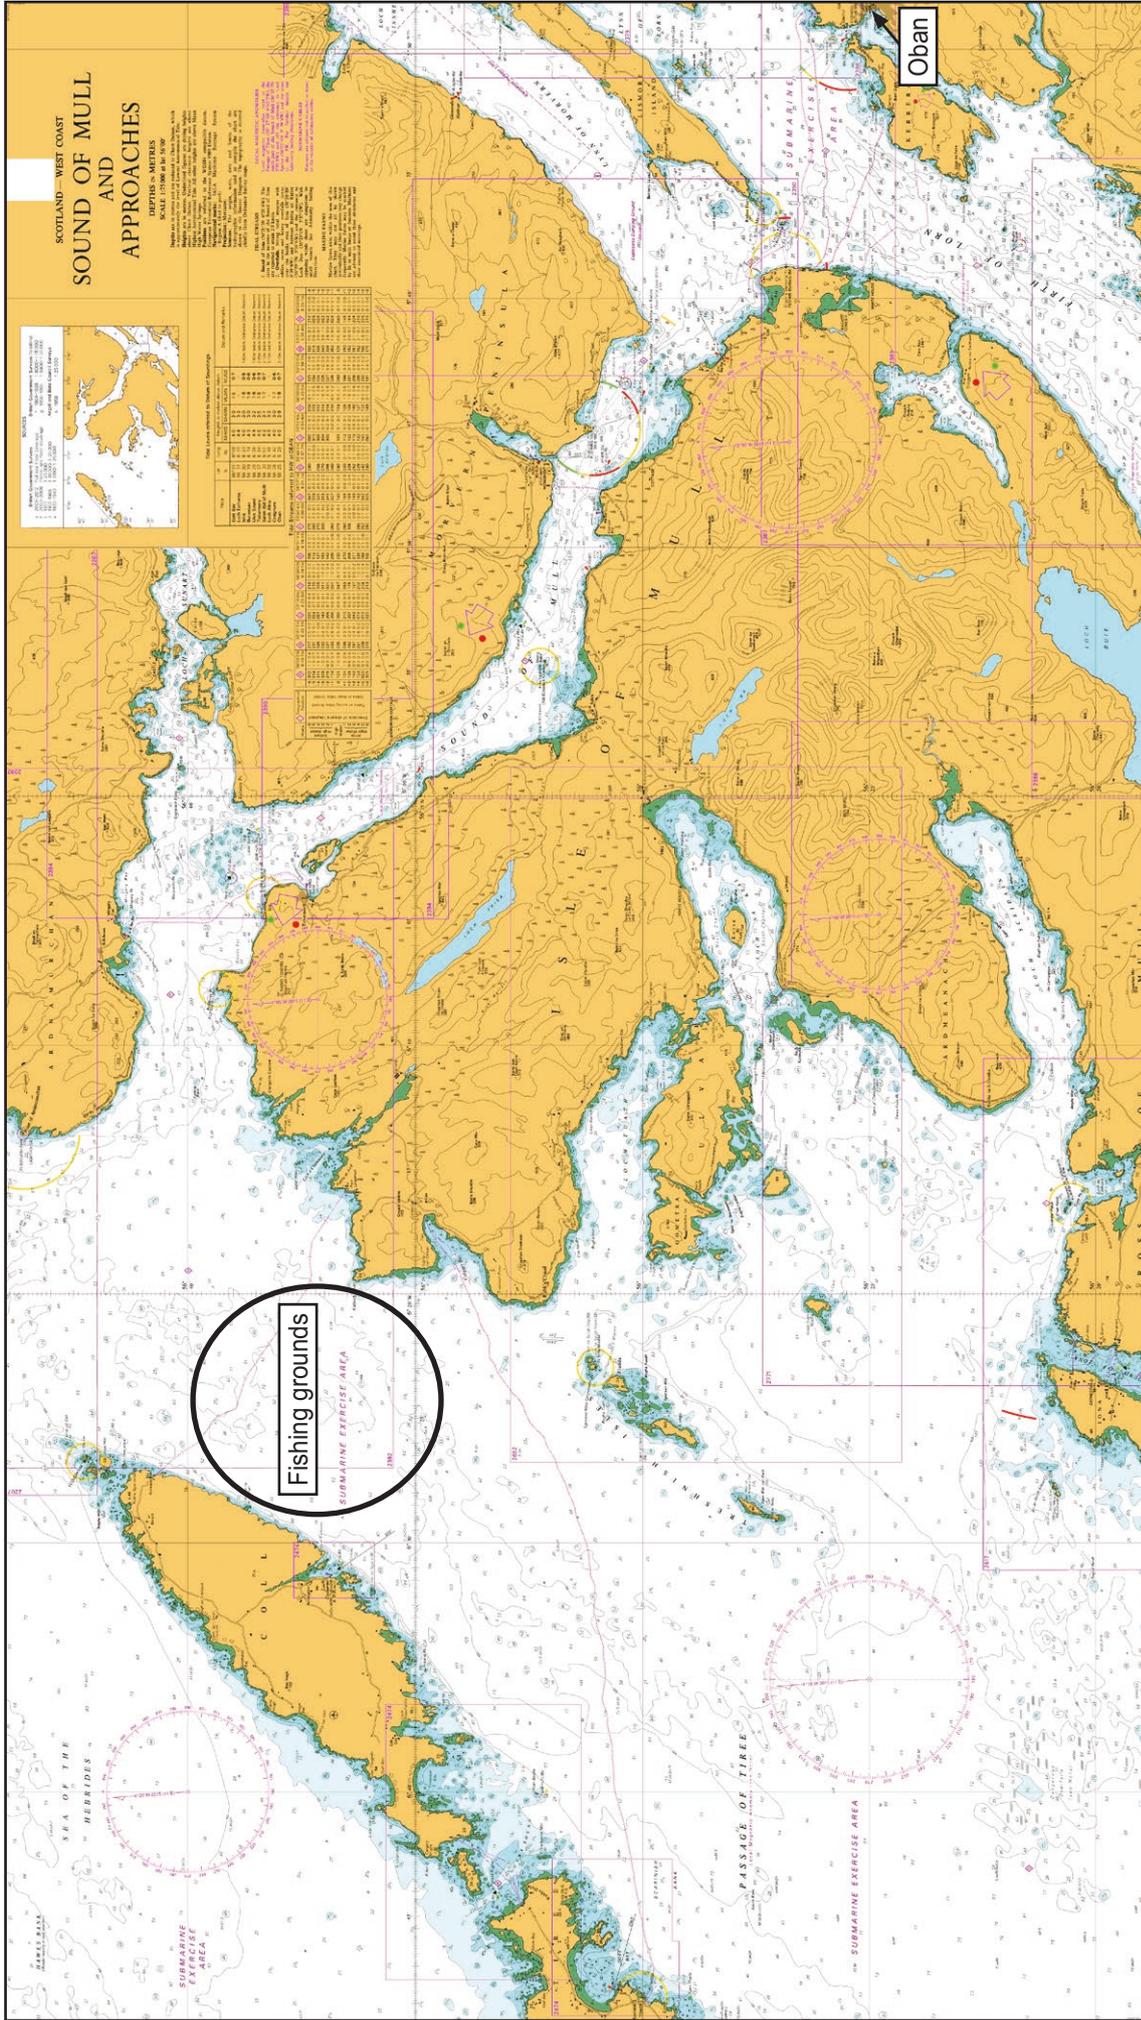
Figure 1: Chart showing Oban and St Apollo's fishing grounds

At approximately 1700 on 23 August 2015, *St Apollo* arrived alongside in Oban on the west coast of Scotland (**Figure 1**). The vessel's skipper and four crewmen landed a catch of scallops and provisioned the vessel with stores, fuel, water and ice. Two liferafts were also replaced.
