Rail Accident Investigation Branch

# Rail Accident Report

## Collision between a train and a piece of equipment at Barrow-upon-Soar, Leicestershire, 14 February 2016

Report 21/2016  
October 2016

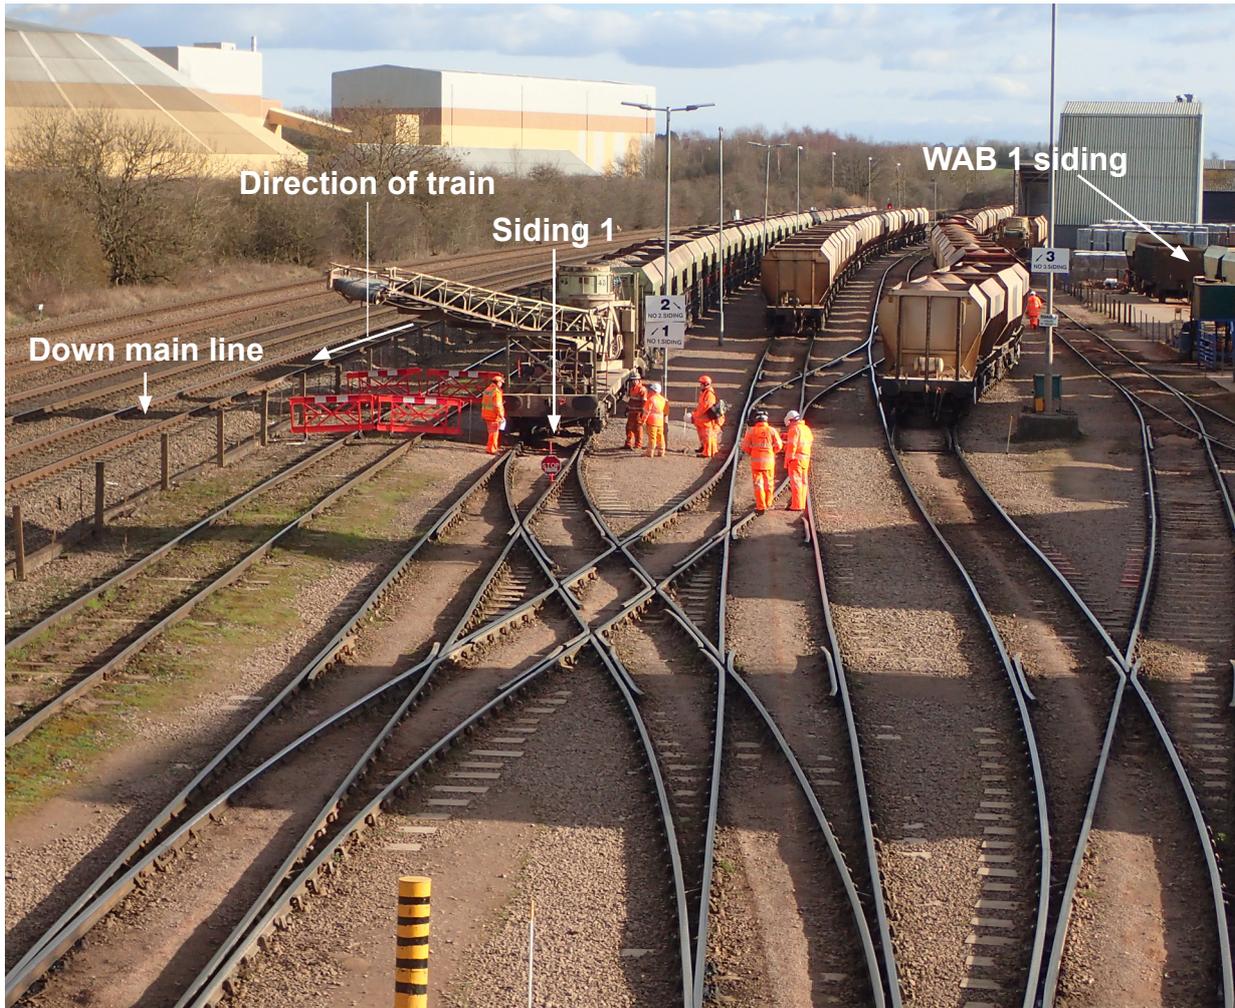
Figure 2: Site of the accident

- 3 At around 10:26 hrs on Sunday 14 February 2016, a passenger train collided with an unloading wagon conveyor boom projecting from an aggregates train standing in Barrow-upon-Soar sidings (figures 1 and 2). The train was travelling at approximately 102 mph (163 km/h). The driver applied the emergency brake and the train stopped approximately 0.72 miles (1.17 km) from the point of impact.

- 25 The Tarmac PIC briefed the locomotive driver and member of groundstaff in the control cabin. The driver and groundstaff then shunted unloading wagon REDA92545 onto the SDT hopper wagons for the Peterborough train which had already been loaded with stone and were in siding 1 (figure 2). This train was scheduled to depart at 05:43 hrs the following day (Monday). The driver and groundstaff then proceeded to shunt other wagons that needed to be moved to make up other trains.

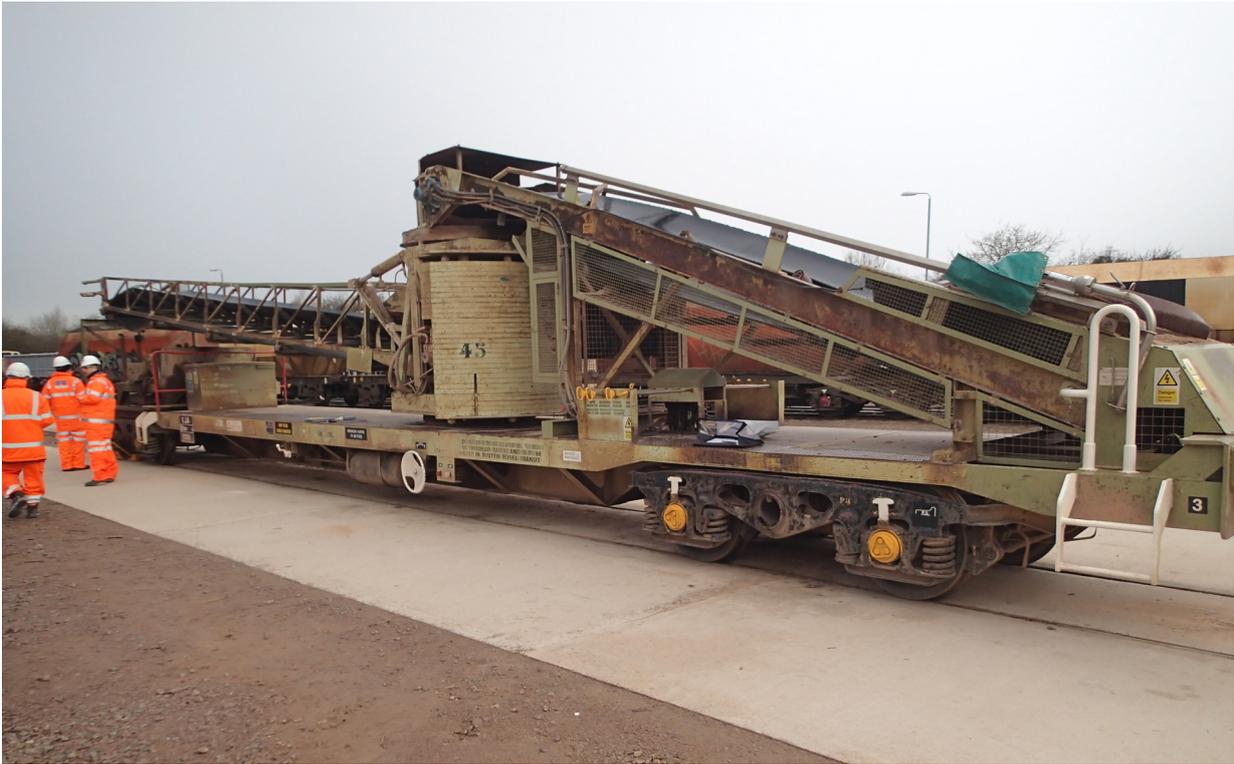
Figure 4: SDT unloading wagon REDA92545

- 16 The train involved was the 10:20 hrs passenger service from Leicester to York, reporting number 1F01. It comprised a 7-car diesel-electric multiple unit, number 222 005.
- 17 The wagon involved (figure 4) was an unloading wagon, number REDA92545, which is part of the self-discharge train (SDT) fleet. The wagon is fitted with a conveyor belt mounted on a boom which can rotate in plan view (figure 5). Its purpose is to provide a means of discharging stone from the hopper wagons which make up most of the SDT fleet. The boom can be rotated to discharge the stone to either side of the wagon.

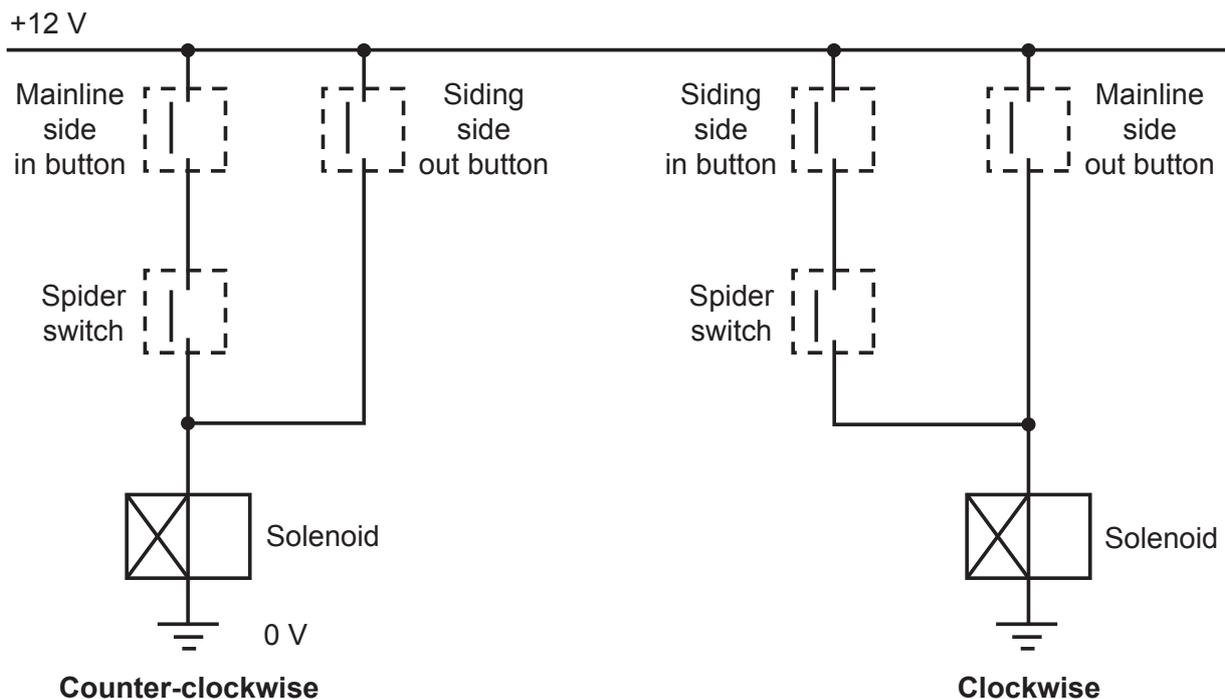
Figure 6: Circuit diagram

- 29 Fitter 1 replaced the switch contact block on (paragraph 49) the inwards slewing push button on the main line side and tested it, but the fault was still present. He then considered that the fault might be with the 'spider' switch which detects which way the boom has slewed. It is mounted in the centre of the wagon behind the slewing turret (figure 5) and has arms which engage with rods attached to the turret. This switch has two pairs of contacts, one of which is wired in series with the 'in' push button on each side, and is arranged such that the 'in' push button only becomes active when the boom is slewed to that side. This means that the boom can only be slewed in towards the centre using the controls on the side that the boom is slewed out over. Figure 6 shows the circuit diagram of the slewing control circuit, as surveyed by the RAIB after the accident.

- 66 Neither Tarmac nor Wabtec had any written information on the electrical control circuits of the wagon. The RAIB examined a similar unloading wagon, number REDA92546, to derive the slewing control circuit diagram (figure 6). The RAIB then checked that the circuit was same on the incident wagon, REDA92545, and carried out tests of it. During these tests the normally open switch on the out button on the main line side of the wagon was operated a number of times and stuck on one occasion (figure 11). This would have caused the boom to move out of control to the end of its travel, had the solenoids on the hydraulic valve not been disconnected for the test.

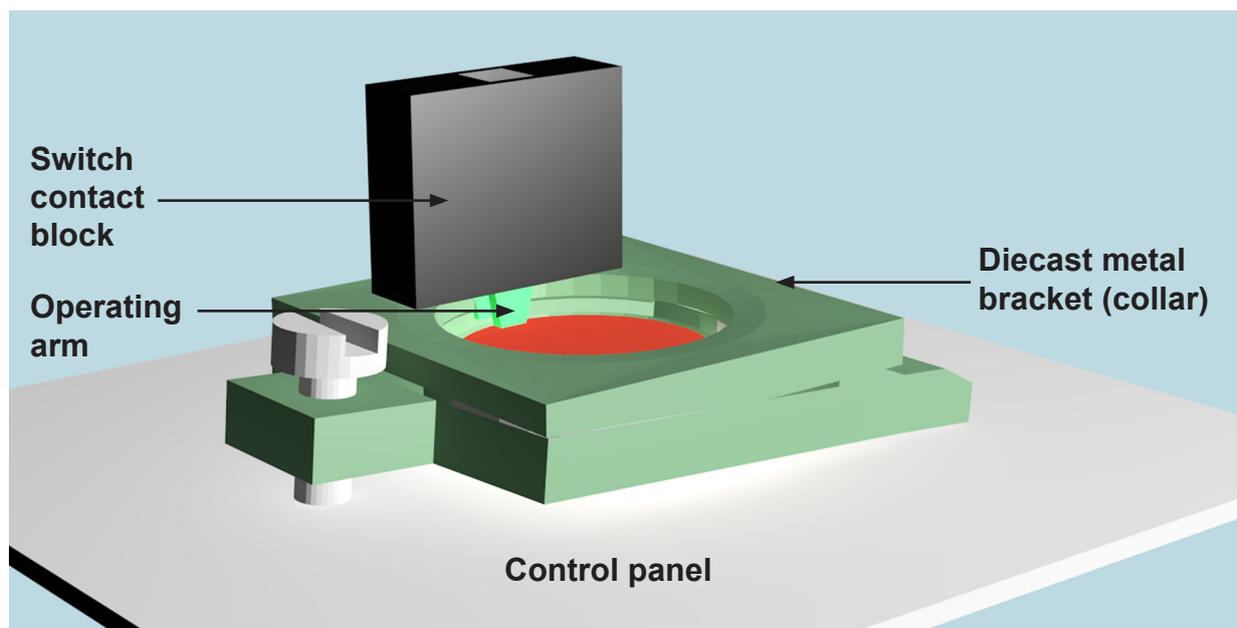
Figure 9: Arrangement of switch and button unit (button coloured red)

- 49 Behind the button unit, within the control panel enclosure, there is a diecast metal bracket (or collar) which secures the button unit and provides a mounting point for one or more switch contact blocks (figure 9). These switch blocks are not rated to be waterproof or dustproof (paragraph 78). Each of these switch blocks is itself sprung and has a protruding operating arm which presses against the back of the push button (coloured red in figure 9). It is possible, when the pushing force is removed, for the button to return to the normal position but the switch block remain in the operated position if the switch block were to stick in that position. If this were to occur, it would not be apparent from the front of the panel, as the button would spring back out.
