# ***AAIB Bulletin***

***11/2016***

<b>Aircraft Type and Registration:</b>	Piper PA-46-350P Malibu Mirage, N186CB	
<b>No &amp; Type of Engines:</b>	1 Lycoming TIO-540-AE2A piston engine	
<b>Year of Manufacture:</b>	1990 (Serial no: 46-22085)	
<b>Date &amp; Time (UTC):</b>	14 November 2015 at 1134 hrs	
<b>Location:</b>	Buttles Farm, Churchinford, Somerset	
<b>Type of Flight:</b>	Private	
<b>Persons on Board:</b>	Crew - 1	Passengers - 3
<b>Injuries:</b>	Crew - 1 (Fatal)	Passengers - 3 (Fatal)
<b>Nature of Damage:</b>	Aircraft destroyed	
<b>Commander's Licence:</b>	Private Pilot's Licence	
<b>Commander's Age:</b>	56 years	
<b>Commander's Flying Experience:</b>	600 hours (of which 260 were on type) Last 90 days - 17 hours Last 28 days - 4 hours	
<b>Information Source:</b>	AAIB Field Investigation

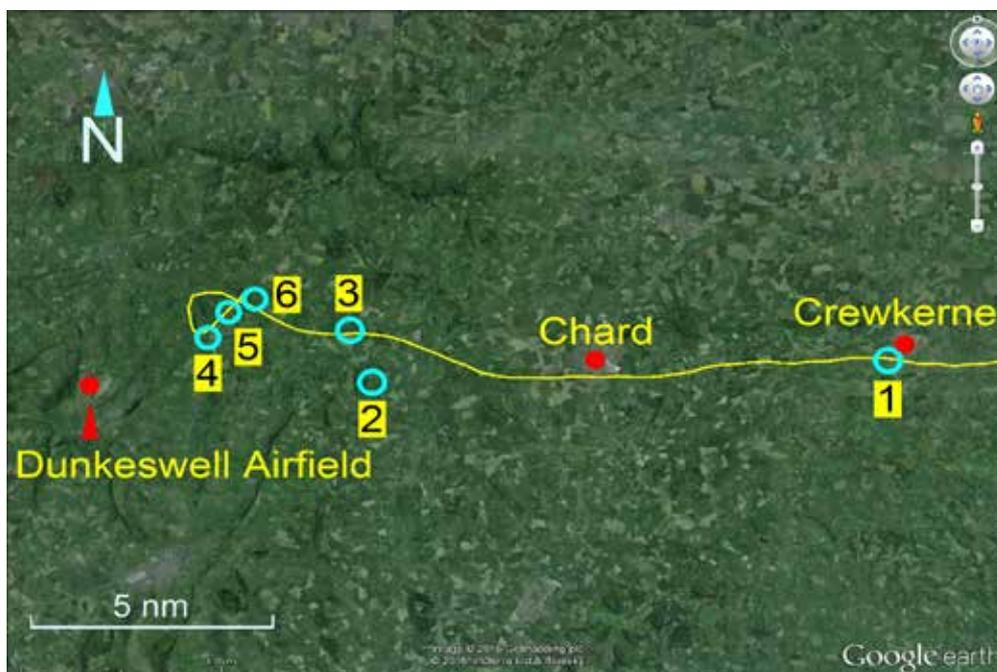
**Figure 1**

A map showing the location of several of the witnesses is at Figure 1.

Witness locations and radar track of the accident flight

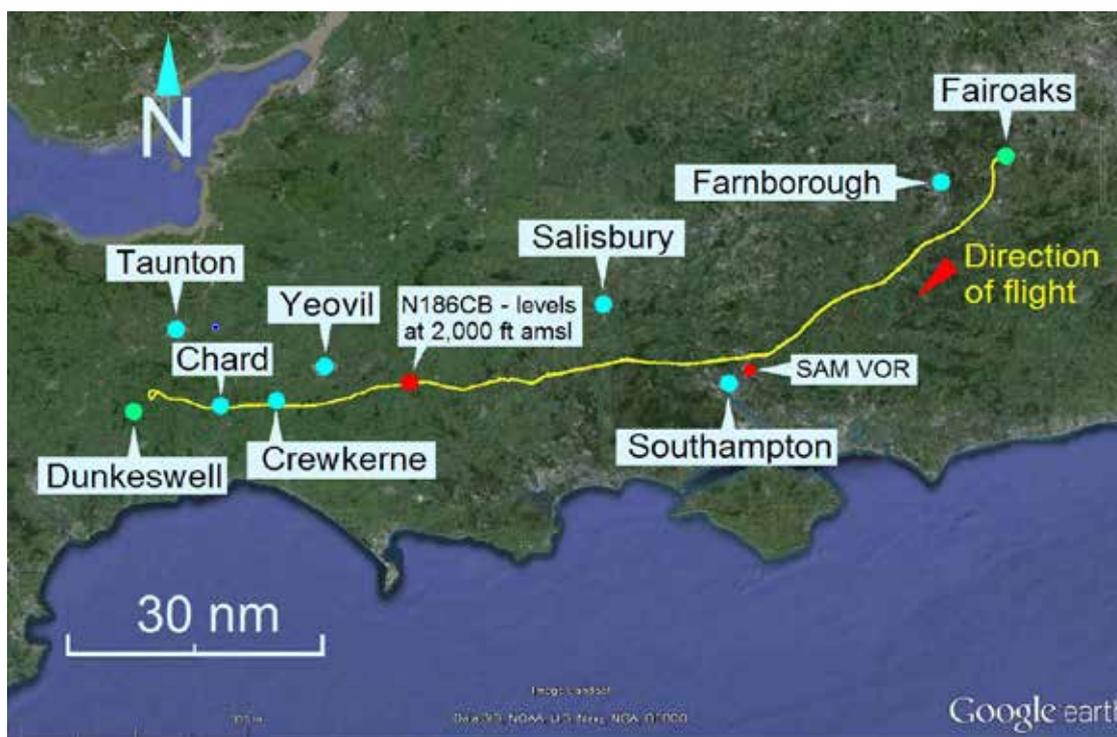
**Figure 2**

Combined radar track of the flight from Fairoaks

At 1120 hrs, 32 nm to the east of Dunkeswell, the aircraft was flying level at about 2,000 ft amsl and at a groundspeed of 130 kt (Figure 2). It maintained an altitude of between 1,900 ft and 2,000 ft amsl whilst following a course towards Dunkeswell, consistent with

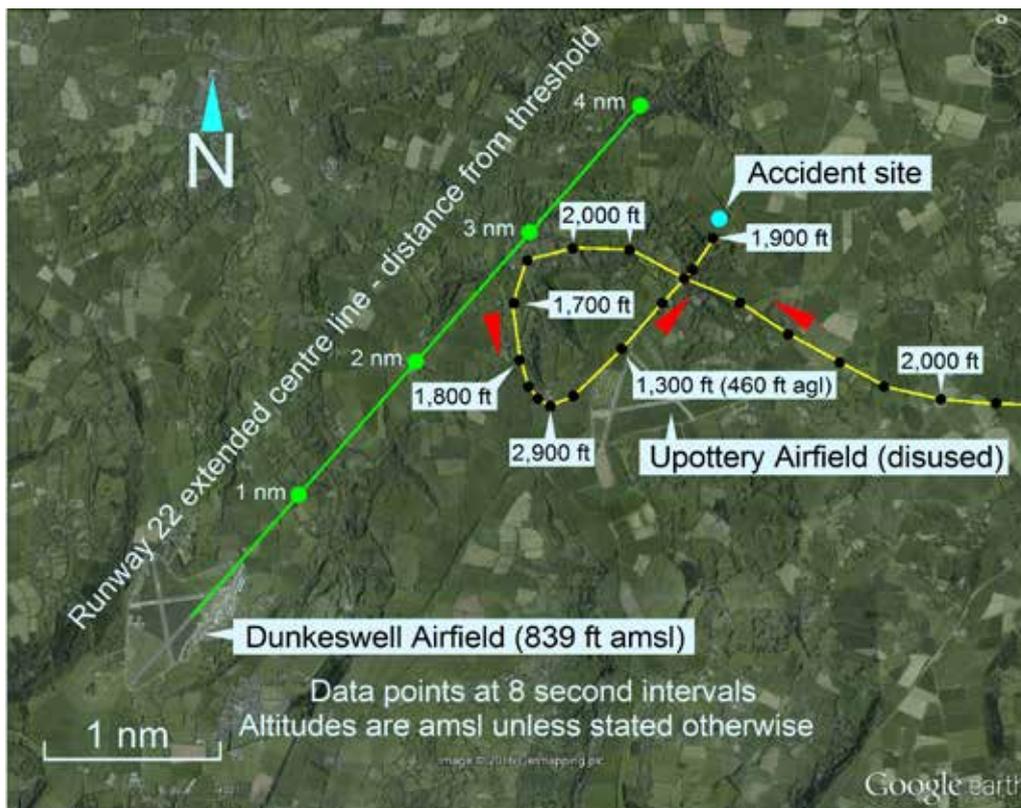
**Figure 4**

At an altitude of about 2,000 ft amsl<sup>11</sup> (about 1,375 ft agl) and a range of 3 nm from the runway threshold (consistent with a vertical approach path of 3.5°), the aircraft proceeded to close to within approximately 150 m of the extended centreline (Figures 3, 4 and 5). However, rather than establishing onto the final approach, the aircraft continued to turn to the left whilst also descending. The aircraft's groundspeed at this point was 144 kt and its estimated airspeed was 153 KIAS, based on the reported wind of 220° at 16 kt. During the turn towards the extended centreline, the turn rate progressively increased from 0.25°/sec to 1.8°/sec over a 24 second period.

Approach to Dunkeswell (Burrington Comb radar) – plan view

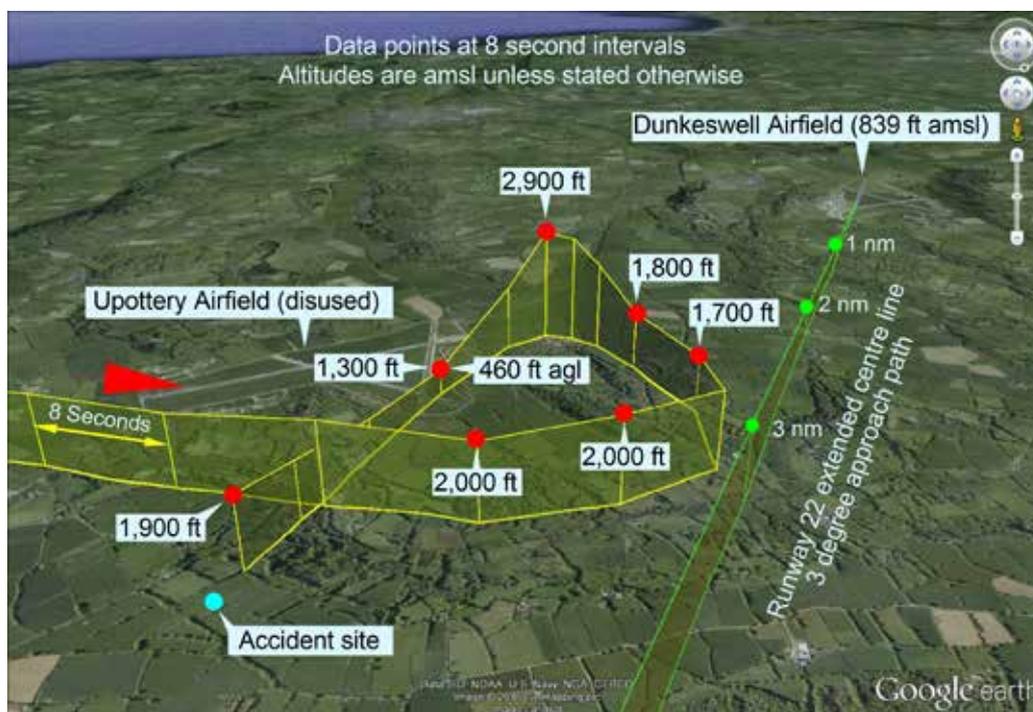
**Figure 5**

Approach to Dunkeswell (Burrington Comb radar) – view looking south

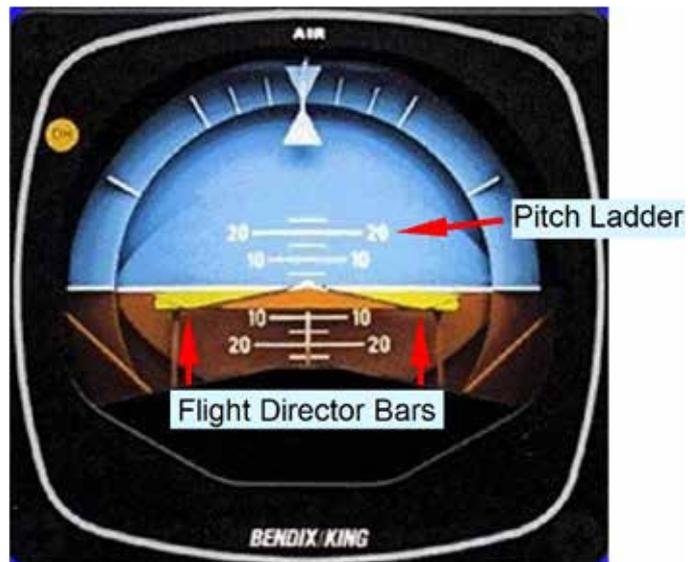
**Figure 6**

The aircraft was fitted with two vacuum-driven attitude indicators for redundancy. The attitude indicator on the left side of the instrument panel was a Bendix/King KI256 Flight Command Indicator with flight director bars (Figure 6). The pitch ladder on this instrument reads up to 25° nose-up and the movable face of the instrument meets a physical stop between about 50° and 60° nose-up<sup>13</sup>.

Bendix/King KI256 Flight Command Indicator  
(attitude indicator)

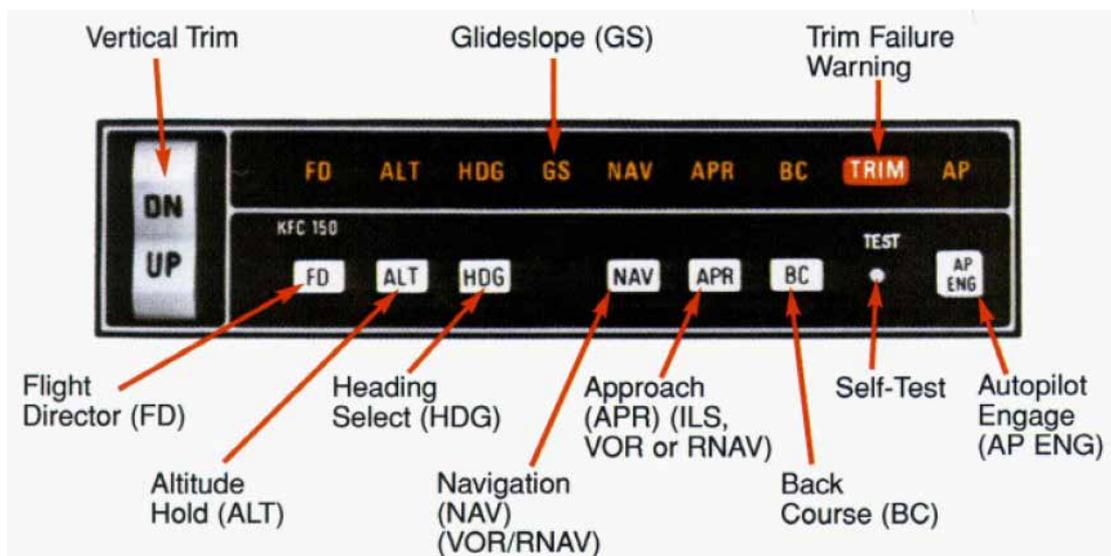
**Figure 7**

A Bendix/King KFC150 3-axis autopilot system was fitted. This system incorporated a KC192 Flight Computer (Figure 7) and four servos controlling the elevator, elevator trim, aileron and the rudder. The rudder servo provided a yaw damper function. The aircraft was also fitted with the optional KAS297B Altitude/Vertical Speed (VS) Selector. The autopilot was engaged by pressing the AP ENG button on the KC192 which engaged the autopilot in an attitude hold mode unless another mode button was also pressed. Selecting 'ALT' engaged the altitude hold mode and the autopilot maintained the selected altitude. Selecting 'HDG' engaged the heading mode and the autopilot turned the aircraft to the pilot's selected heading<sup>14</sup>.

KC192 Flight Computer (autopilot control panel)  
 (YD yaw damper caption not shown but it was to the left of the FD caption)  
 (image copyright Honeywell)

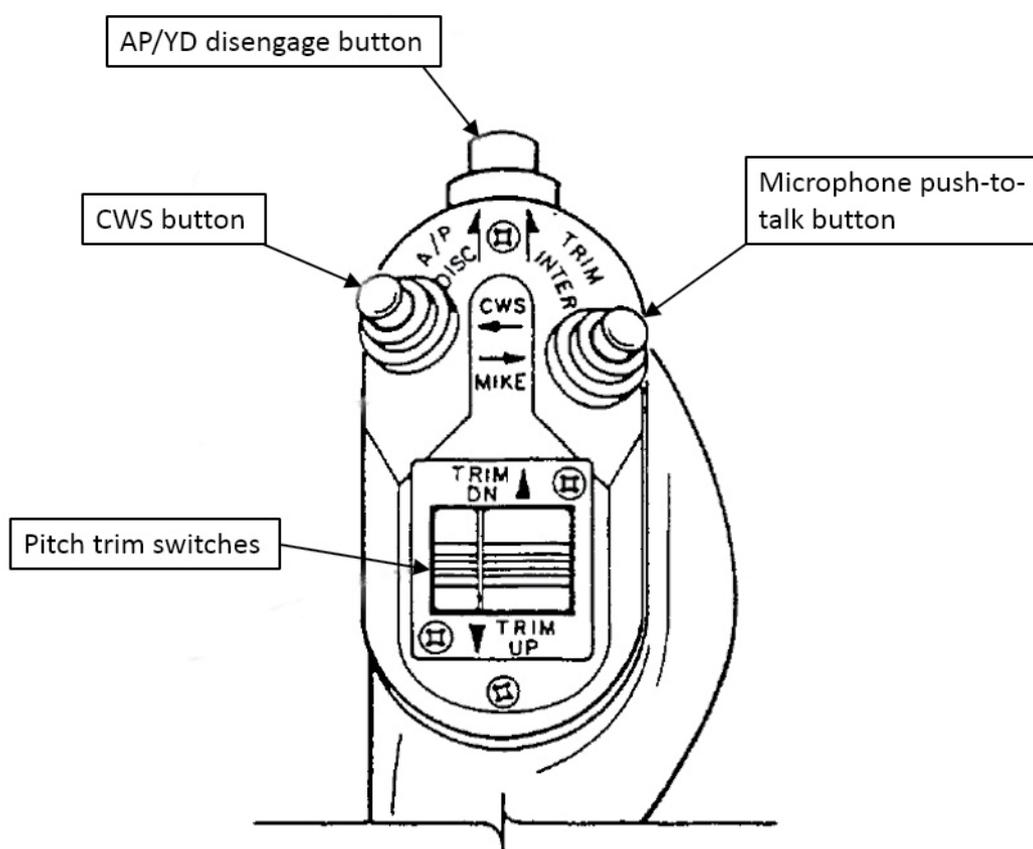
**Figure 8**

The primary means of disengaging the autopilot was by pressing the Autopilot/Yaw Damper (AP/YD) disengage button<sup>15</sup> on the control wheel (Figure 8). Pressing this button would disengage the autopilot, yaw damper and the flight director. Pressing the pitch trim switches on the control wheel or the 'AP ENG' button on the KC192 would also disengage the autopilot but would leave the flight director and yaw damper on, together with any associated modes (eg ALT, HDG, NAV). Pitch rates in excess of 8° per second (between pitch angles of ±15°) or roll rates in excess of 14° per second, for a period of 1 second, would also cause the autopilot to disengage and would leave the flight director and yaw damper engaged<sup>16</sup>.

Control wheel switches  
(image copyright Honeywell with AAIB annotations)

For the above reasons, the investigation considered that the pilot may have initiated a descent manually from 2,000 ft, without first pressing the AP/YD disengage button on the control wheel (or he pressed it and it did not function), and started to overpower the autopilot, causing it to trim in the opposite direction. The Altitude/VS selector showed 2,000 ft and 0 fpm as its final settings, so there were only two other ways to descend below 2,000 ft without disengaging the autopilot. One method would have been to press the Vertical Trim DN button on the KC192 (Figure 7), which would have targeted a 500 fpm descent. However, the actual descent rate was about 1,100 fpm, so this was unlikely. Alternatively, the pilot could have pressed and held the CWS button to initiate a descent but, according to his instructor, he did not use this feature.

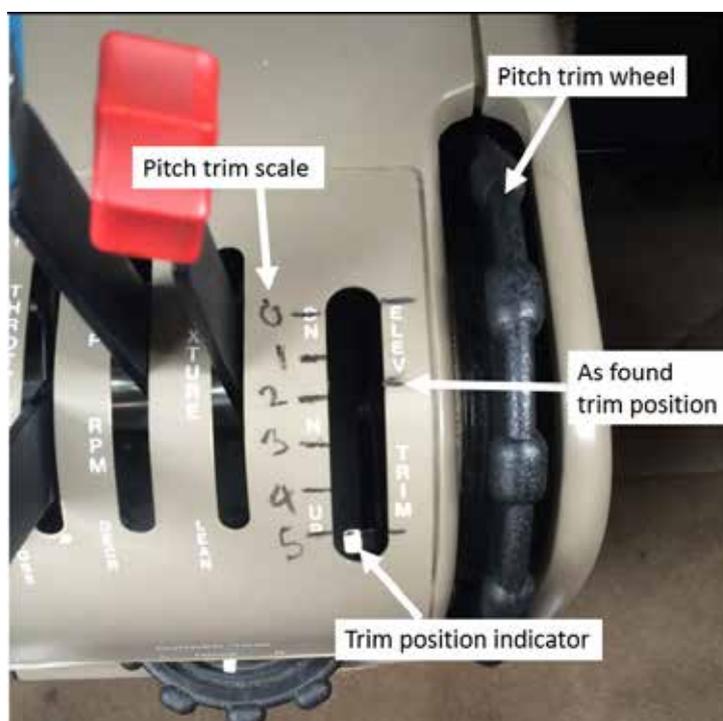
**Figure 10**

In order to determine the corresponding trim position relative to the aircraft's airspeed, the trim wheel in the cockpit was graduated with five positions, evenly distributed across the range of trim movement available. Position 0 was full forward (nose-down) trim and position 5 was full aft (nose-up) trim (Figure 10). It was found that 19 mm extension of the elevator trim actuator equated to a position of 1.7 on the trim wheel scale. The flight evaluation revealed that, with an aft CG, in level flight, at a stabilised airspeed of 150 KIAS (which was the estimated airspeed of N186CB shortly before it climbed rapidly) and the aircraft 'in trim', the trim wheel position was about 0.9.

Pitch trim wheel and scale used on the PA-46-350P aircraft for the flight evaluation

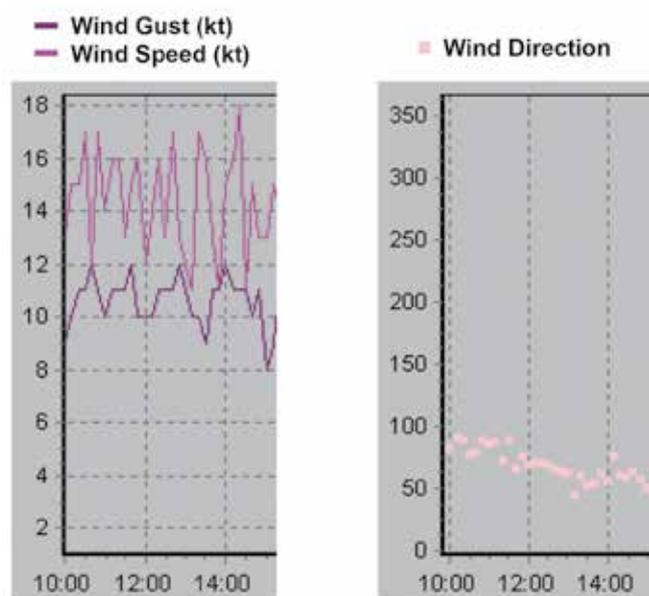
**Figure 1**

The tower, where the Aerodrome Flight Information Service Officer was located, was equipped with an uncalibrated computer-based weather station that recorded the wind speed and direction every 10 minutes, as measured by an anemometer located on a pole at the eastern boundary of the airport. A copy of the wind’s strength and direction over the period of the two flights is shown at Figure 1. During the instructional flight it recorded wind from about 050 to 060° at 10 to 12 kt gusting 17 kt. During the accident flight it was from about 080° at 11 to 12 kt with gusts up to 16 kt.

Recorded wind speed and direction at Peterborough Airport

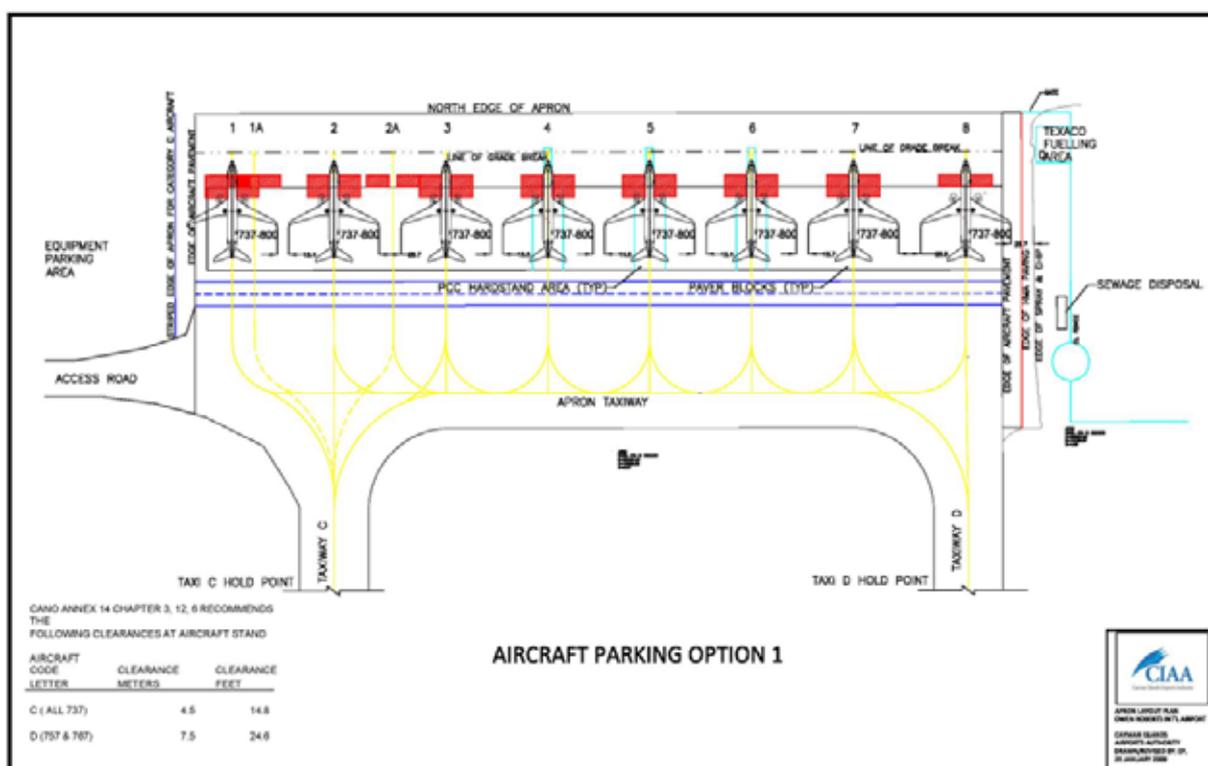
**Figure 1**

A member of staff of the contracted handling company, a ramp dispatch agent, marshalled N683GA on to the stand, without the presence of wingmen. He stopped the aircraft short, to avoid conflict with any possible obstacles and to ensure clearance from the wings of the two parked aircraft on either side. Additionally, this allowed space for the aircraft to self-manoeuvre off the stand, once the passengers had disembarked.

Aircraft parking geometry, commercial ramp, Owen Roberts International Airport

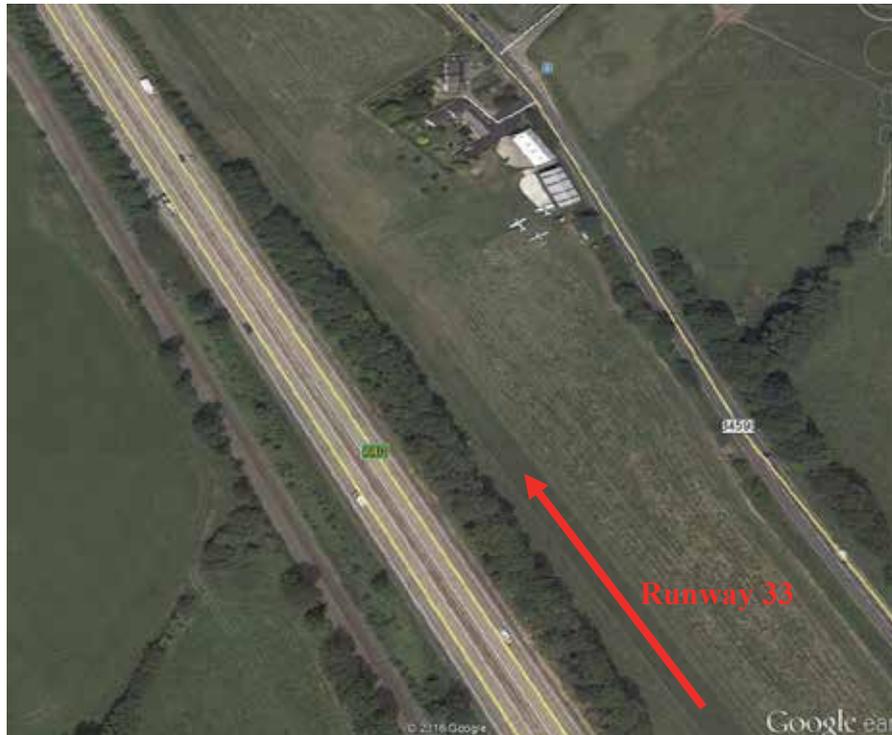
**Figure 1**

This was intended to be a training flight, with the student conducting the takeoff. After completing the appropriate checks, 10° of flap was set and full power was selected. The pilot released the brakes and commenced the takeoff roll on Runway 33. As the aircraft passed over the crest of a small hill, approximately halfway along the grass strip, it started to veer to the left. The left side of the runway is located close to a line of trees that borders the A40 trunk road and, in the instructor's words, "there is not much room for error". (See Figure 1.) The instructor took control and applied right rudder and aileron in an attempt to steer the aircraft away from the trees. The aircraft became prematurely airborne at around this time and the instructor pitched the nose down slightly and continued the climb, but the left wing started to contact some tree branches. Despite the application of more right rudder and aileron, the instructor felt the wing contact more branches. His intention was to try to fly the aircraft away into the circuit but the wing continued to contact the trees. Finally, there

Aerial view of airfield, showing proximity of trees to mown strip

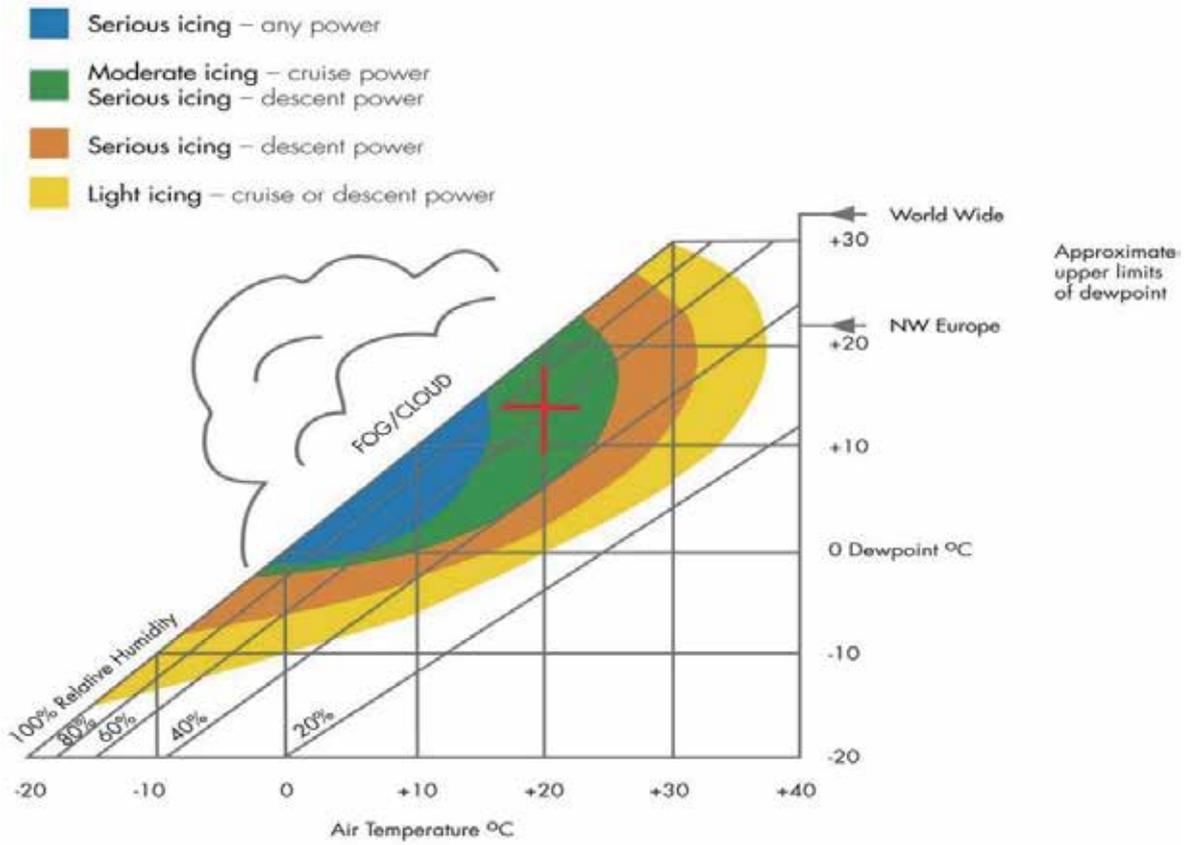
Figure 1

When the temperature and dew point were plotted on the CAA icing conditions chart contained in '*Safety Sense Leaflet 14, Piston Engine Icing*', it indicated that moderate icing could be expected at cruise power and serious icing at descent power. (See Figure 1.)

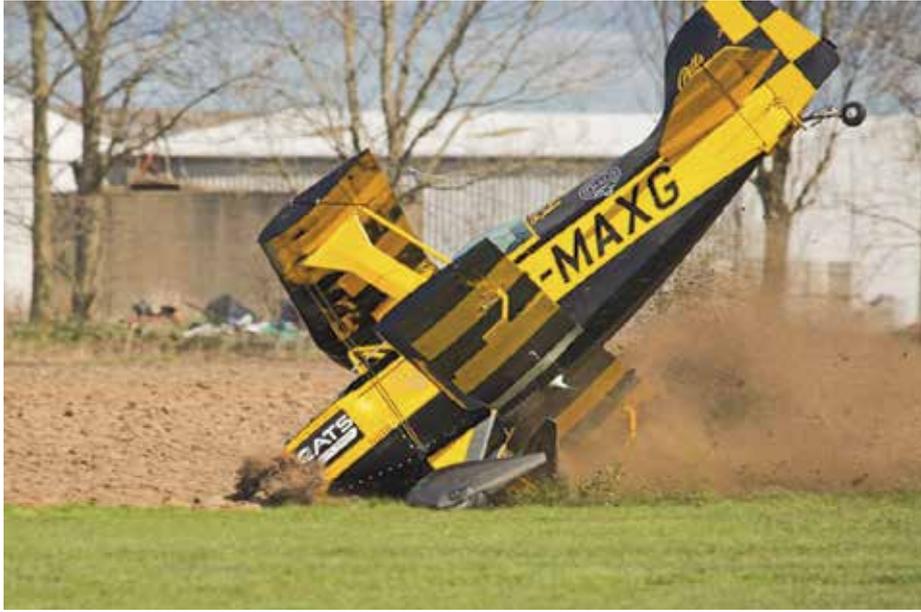
**Figure 1**

The pilot was on approach to landing after completion of his final flight during an aerobatic competition. Due to an area of the grass runway being waterlogged he had been advised to use the right side of the runway of the grass runway in use, Runway 28L, which was marked by cones. During his final approach, behind other landing traffic, he held off until the runway was clear and then set up for a normal three-point landing. The aircraft touched down close to the runway edge and after a small bounce the aircraft violently pitched forward and rotated through approximately 210°, coming to rest off the runway. The landing gear, propeller, wings, rudder and rear fuselage were damaged during the incident. The pilot was uninjured. Figure 1 shows the accident taking place.
