Rail Accident Investigation Branch

Rail Accident Report

Structural failure caused by scour at Lamington viaduct, South Lanarkshire 31 December 2015

Report 22/2016
November 2016

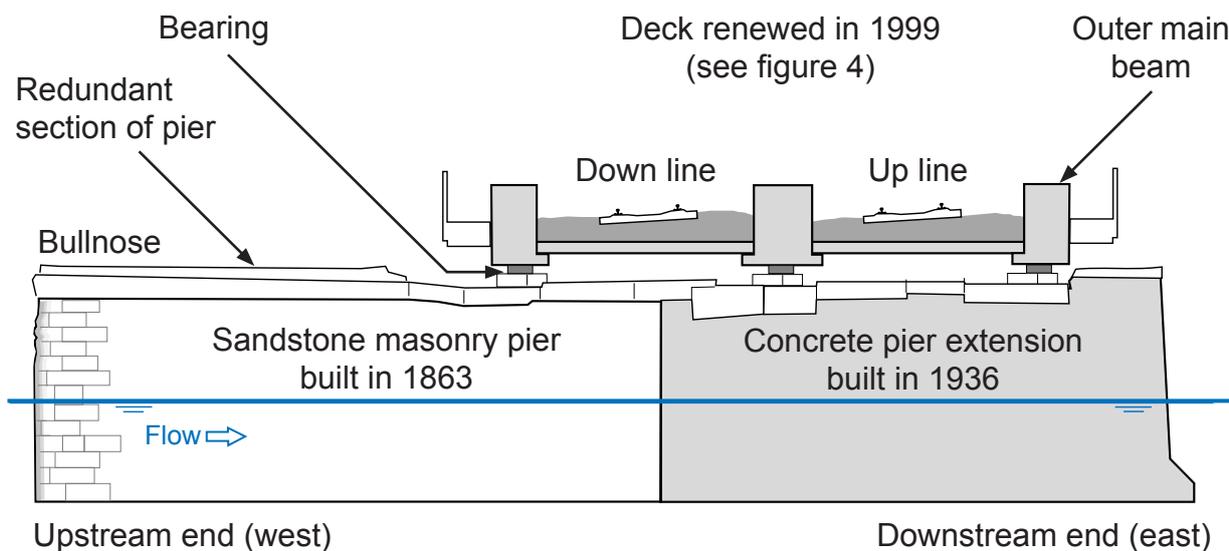
Figure 3: South face of pier 2 looking north, showing the position of current bridge deck in relation to the substructure. The up line is carried on the concrete pier extension (see also appendix D).

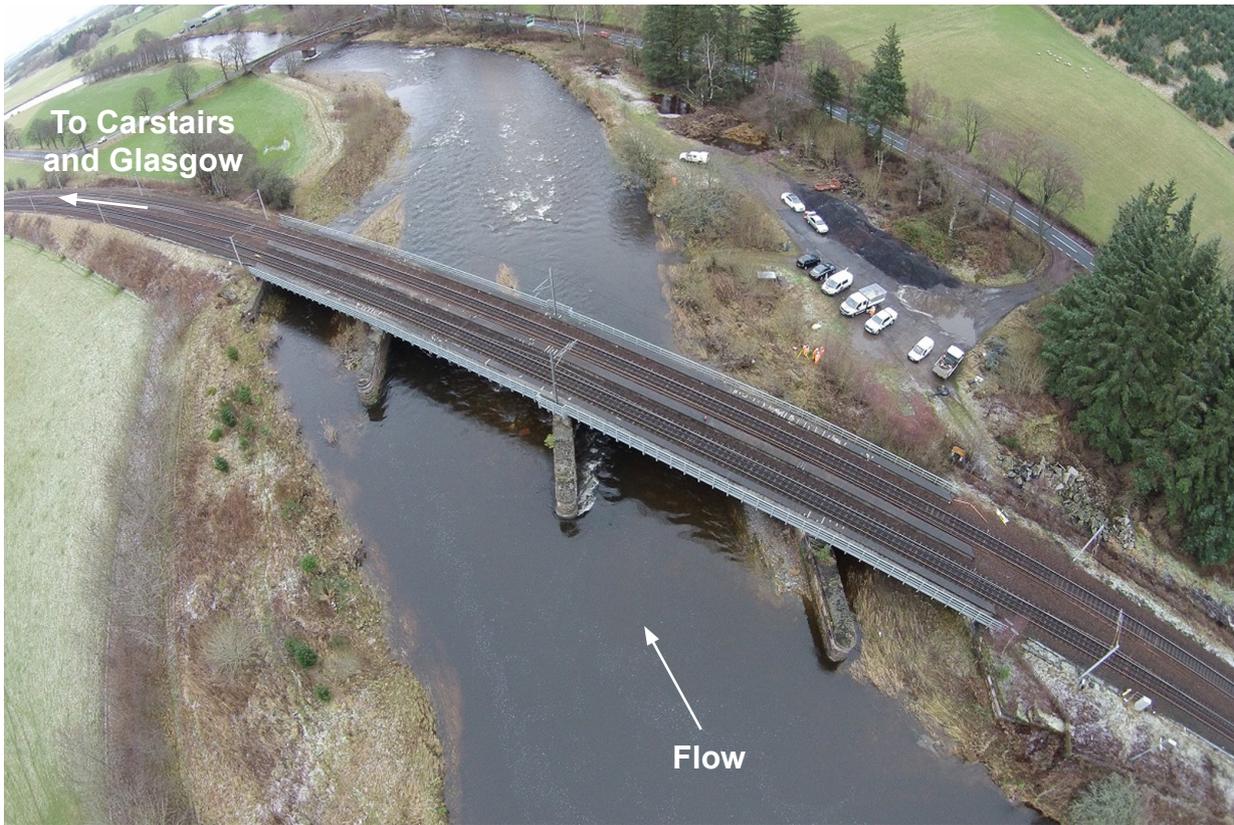
- 50 An underwater survey was attempted by divers on 1 January, but abandoned until the following day because the river flow was still too fast (figures 10 and 11). The survey found substantial scour damage affecting the masonry section of pier 2 and a void under the full width of the concrete pier extension.
- 51 Pier 2 continued to move after the line was closed. By early January, the outer main beam adjacent to the down line had dropped by 130 mm. The pier had also tilted by 180 mm towards the south abutment, displacing the bearings supporting the main beams (figure 12), causing the deck to subside and twist. A civil engineering contractor, brought in by Network Rail to stabilise and repair the structure, imposed an exclusion zone on and below the deck because of the risk that the pier might overturn or collapse.

Figure 10: Aerial view on 1 January 2016 (photograph courtesy of Network Rail Air Operations)

- 65 The missing masonry blocks were not found above river bed level by the divers and would have been too heavy to wash downstream. In addition, there is no abnormal surface turbulence visible in photographs taken on 31 December 2015 and 1 January 2016 (figure 9, figure 10 and figure 11). This evidence suggests that a scour hole had developed in the river bed that was of sufficient size and depth to accommodate the missing masonry from the pier. Once the angular masonry blocks started to pile up on the scoured river bed, they will have created a weir-effect, increasing turbulence and the risk of further scour occurring upstream and downstream.

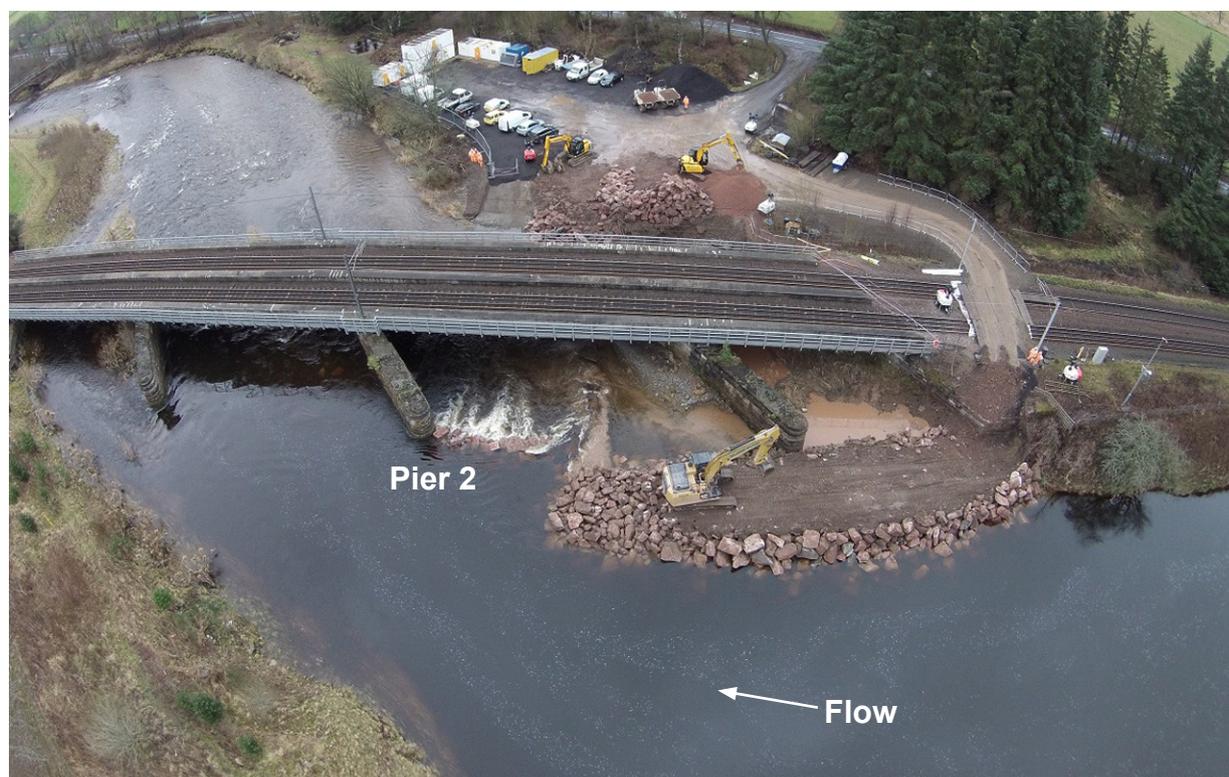
- 52 Network Rail did not notify the RAIB of this incident until 7 January 2016 due to an administrative oversight.
- 53 A stone causeway was built into the river on the west side of the viaduct to protect the south face of pier 2 and to provide access for emergency stabilisation works. This forced the river flow through the two northern spans (figure 13). The void under pier 2 was filled using approximately 50 m³ of concrete. To prevent further pier rotation, a further 400 m³ of concrete was placed on the south side of this pier in a major operation that ran continuously from 9 to 12 January. The total weight of concrete placed in the river exceeded 1000 tonnes.

Figure 13: Stone causeway under construction from the south abutment to provide access to pier 2 on 6 January 2016 (photograph courtesy of Network Rail Air Operations)

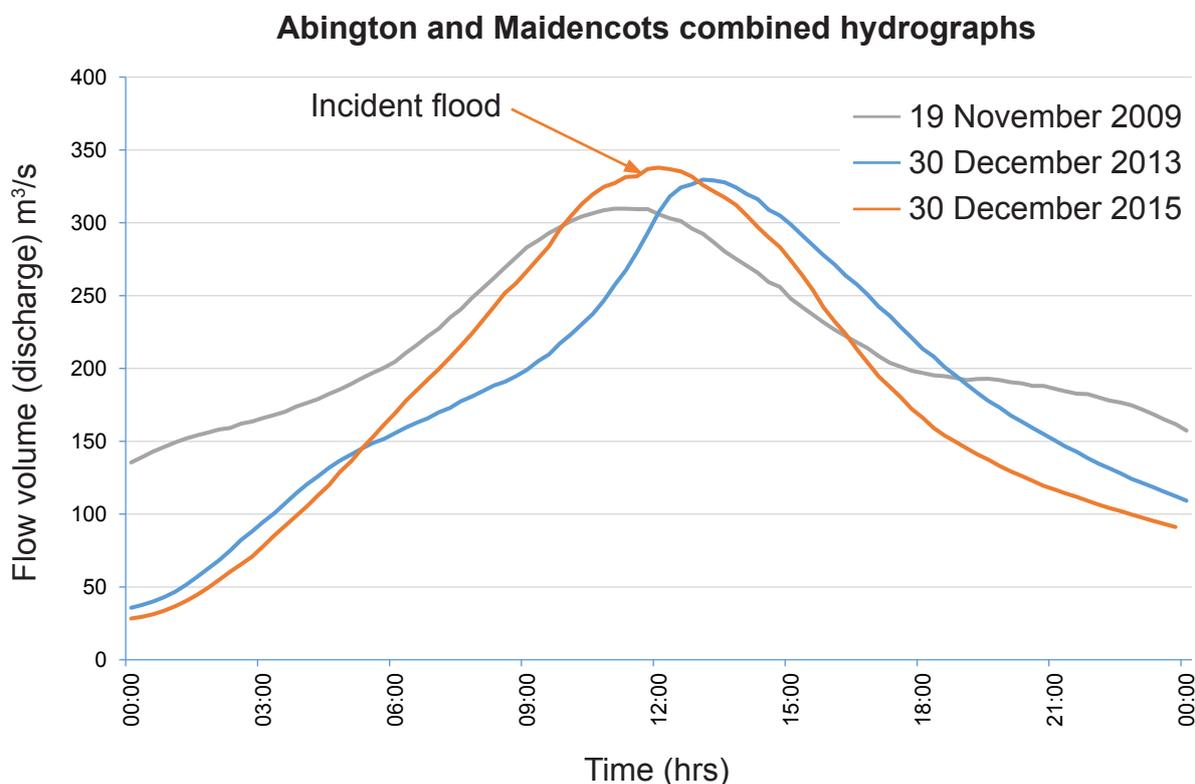
- 67 Historic river flow evidence is consistent with this assessment of probability. Although the river level on 30 December 2015 was high, witnesses confirm that it was not unprecedented. Comparable floods⁹ also occurred on 20 November 2009 and 30 December 2013 without apparently damaging the structure (figure 19). Although the structure may have been at significant risk during these events, the absence of significant damage shows that previous behaviour may not be a reliable indicator of risk.

Figure 19: Hydrographs for flood events in 2009, 2013 and 2015, recorded by SEPA's Abington and Maidencots gauging stations

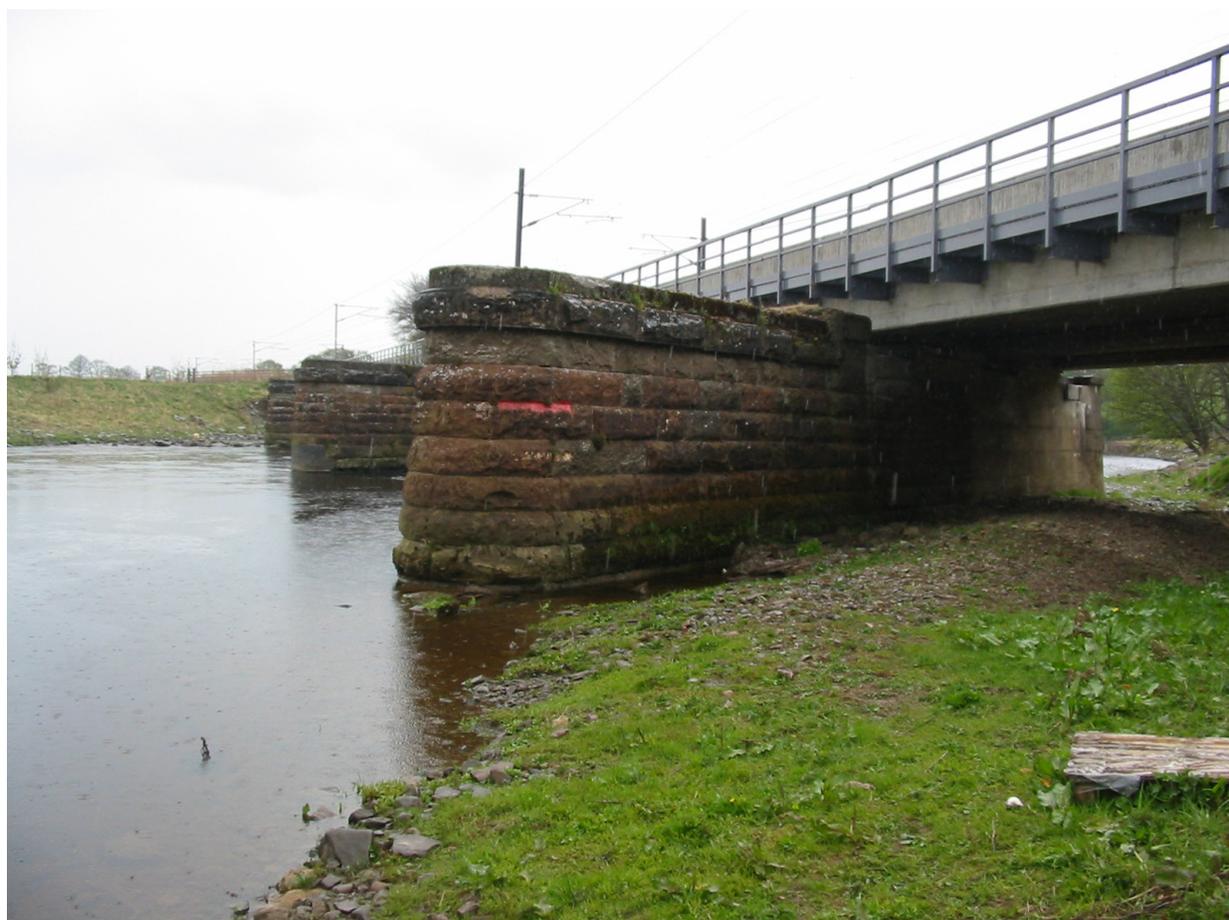
Figure 20: Red marker visible on upstream end of pier 1 in 2003 (photograph courtesy of Network Rail)

- 116 The level of the marker may originally have been set to avoid the risk of debris, carried by a flood, from striking the deck. As the structure was at risk of scour, the red marker should also have been set to correspond with a river flow at which line closure was justified by scour risk. No evidence was found that the red marker level had been set to take account of this.

- 118 The water level and velocity at Lamington peaked during the afternoon of 30 December 2015 and was sufficient to cause scour (paragraph 60). A post-incident survey²¹ of debris on the river bank suggests that the water level may not have reached the level of the red marker line, and therefore, even if a watchman had been monitoring water levels and relying on this line (if still visible), they may not have taken the action needed in response to the risk of scour damage. Damage below water level was not visible until the water level had dropped sufficiently, in this case some 12 to 18 hours later (figure 7). During this period, trains continued to run normally so, even if the Flood Action procedure had been implemented, the line would probably have remained open after significant scour damage had occurred.

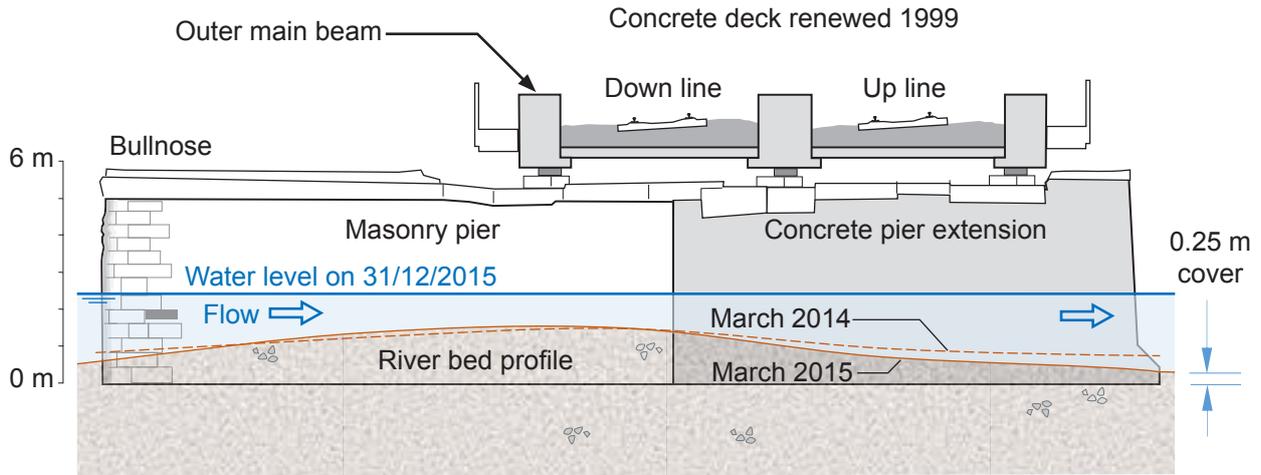
D1: South face of pier 2 prior to the incident, showing river bed profile as recorded in March 2015
