SAFETY FLYER TO FISHING INDUSTRY

Fishing vessel *Our Sarah Jane* (NN710), fatal man overboard, 9 June 2016

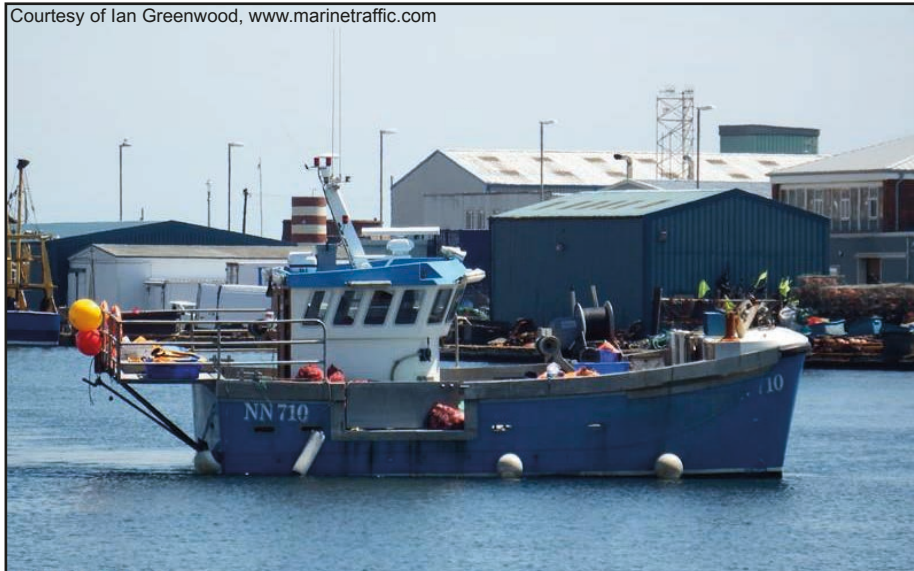
Our Sarah Jane

On 9 June 2016 a crewman on the 9.8m potter *Our Sarah Jane* was lost after he had jumped into the sea to cut a line that was fouling one of the vessel's propellers.

At about 1200, the starboard propeller of *Our Sarah Jane* had been fouled by a string of pots as they were being shot away, and this effectively anchored the vessel in the middle of the English Channel. During the next 30 minutes the crew tried to reach and cut the backrope leading to the seabed, but the line was too taut to pull inboard using a grapple and it could not be reached even with a knife cable-tied to the end of a broom handle. As the vessel's skipper was arranging for a nearby fishing vessel to assist, one of the vessel's two deckhands took off his wellington boots and oilskins and jumped overboard to cut the backrope. He immediately started to struggle and was carried away from the vessel by a 2kts tidal stream.

The skipper tied a polysteel mooring rope to a lifebuoy and threw it towards the man overboard, but it fell short. The skipper then parted the backline by putting both engines ahead at fast speed, but when the vessel was manoeuvred close to the man overboard he was face-down and motionless. The lifebuoy was again thrown, but the man overboard did not respond. The other deckhand jumped into the water to assist but he also quickly got into difficulty and started to lose his strength. He was not wearing a lifejacket and was being weighed down by the polysteel rope from the lifebuoy, which he had used as a lifeline. The skipper pulled the deckhand back on board but, by then, the man overboard was no longer in sight. Despite an extensive air and sea search he was not found.

The MAIB investigation identified that the man overboard had possibly been using recreational drugs, and had jumped into the water despite the skipper instructing him not to do so. He and the other deckhand almost certainly suffered from cold water shock following immersion. In addition, the assistance to the man overboard was initially impeded by the vessel's inability to manoeuvre, and valuable seconds were lost by not having at hand a lifebuoy with a lifeline already attached.

1. Many fishermen work long and unsociable hours in arduous conditions, which makes the use of recreational drugs appealing to some. However, drugs such as amphetamine are not only illegal, their effects on behaviour are potentially lethal on board fishing vessels. At sea, drug users put the lives of others at risk.

3. It is essential that lifesaving equipment is available in an emergency situation. However, over time, such equipment is frequently damaged, misplaced, or goes 'out of date'. Owners and skippers should not rely on routine surveys to identify what is missing, but ensure they conduct regular checks to ensure the equipment will be available and effective if needed.

6. Entering the water to assist an incapacitated person need not be unsafe provided the action is incorporated in a vessel's manoverboard procedures. This means minimising the risk through the provision of appropriate equipment such as a dry suit or immersion suit, a lifejacket and a buoyant lifeline. Volunteers to enter the water should also be suitably trained and be aware of their role.
