# **Service Inquiry**

Watchkeeper 006

2 Nov 15

**SERVICE INQUIRY INTO AN ACCIDENT INVOLVING A WATCHKEEPER UNMANNED AIRCRAFT (UA) WK006 AT MoD BOSCOMBE DOWN (BDN), WILTSHIRE ON 2 NOV 15**

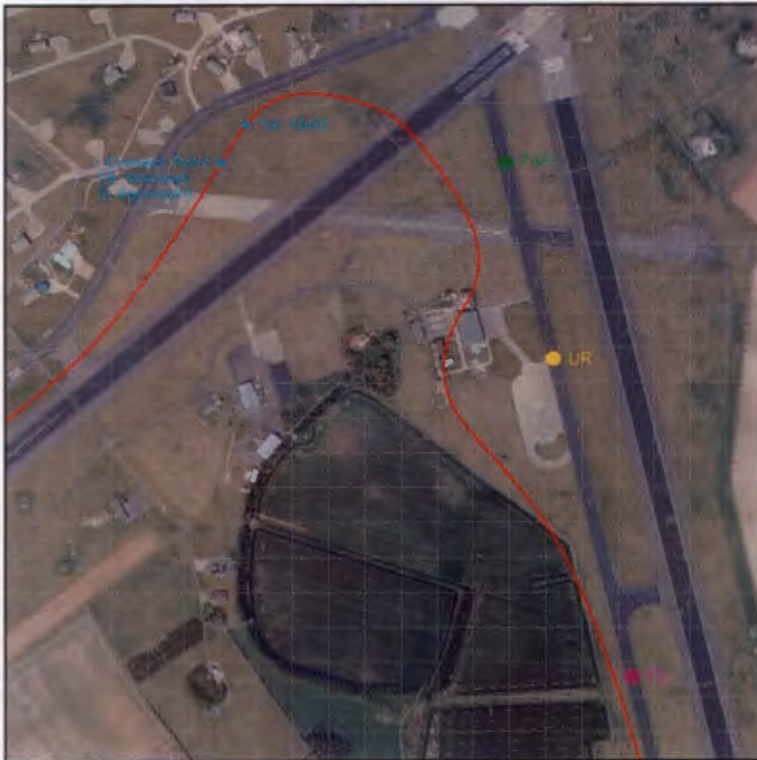
Figure 6 - First Approach to Rwy 17(W)

**1.3.33. First Approach.** Figure 6 provides an overview of the first approach. At 15:33:40, with the aircraft in the circuit at BDN and approaching

the *Connect Point* (CP), the crew selected the ATOL override for Altitude Deviation<sup>6</sup> (*Alt Dev*) due to the prevailing weather conditions (fog/cloud), in accordance with the Flight Reference Cards (FRCs). The override *Alt Dev* remained selected for the remainder of the flight. The UA registered the CP at 1538:05 hrs and transitioned from *Flight* to *Approach* mode. Shortly after, the UA automatically aborted the approach and displayed the caution *LAND STATUS TIMEOUT* on the operator's display screens. The crew then re-commanded *LAND*, in an attempt to ensure that the original command had been received by the UA and recommence the recovery profile. As illustrated in Figure 6, the UA did not re-join the landing profile, instead navigating towards the beginning of the recovery route. The crew then manually aborted the landing; the UA then turned back towards the runway and flew to the Go-Around Point.

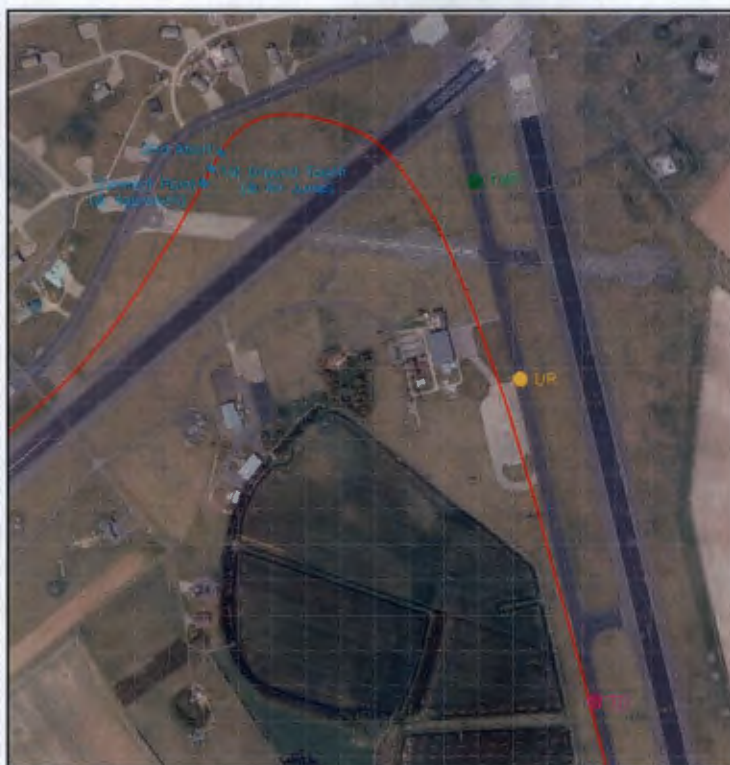
Figure 7 - Second Approach to Rwy 17(W)

1.3.34. **Second Approach.** At 15:42hrs, the UA crossed the CP for the second landing attempt and transitioned to Approach mode. Shortly after, as depicted in Figure 7 below, the UA aborted the approach with a *LAND STATUS TIMEOUT* caution displayed on the operator's screens. The UA climbed and flew to the Go Around Point.

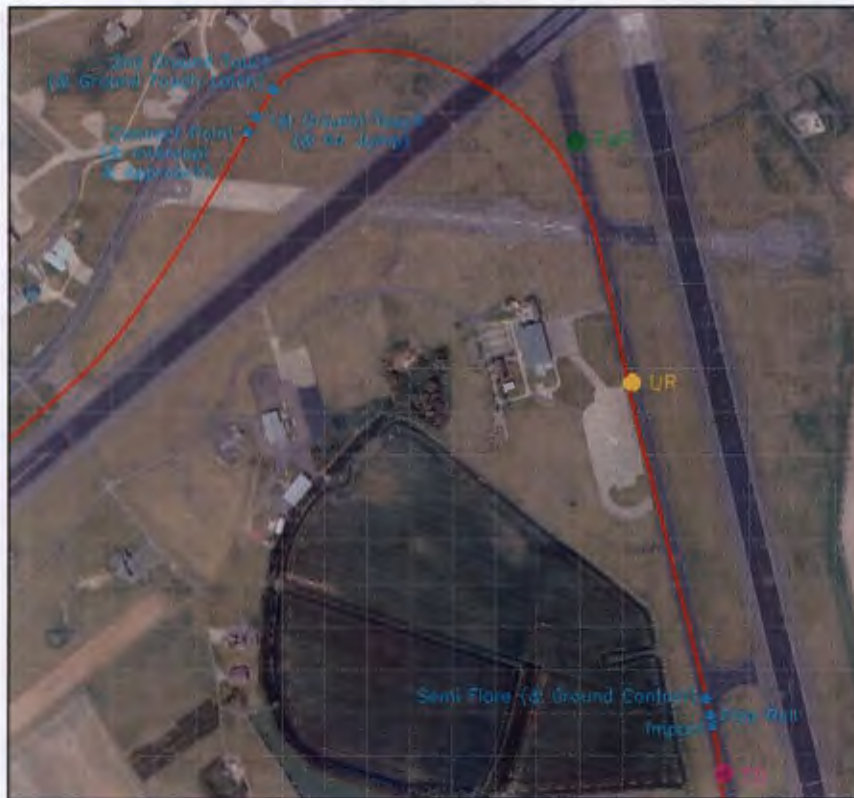
Figure 8 - Final Approach to Rwy 17 (W)

1.3.35. **Final Approach.** The crew discussed the situation with AO in the GCS. At 1545hrs, the crew selected *MASTER OVERRIDE*<sup>7</sup> (MO) to ensure that the UA would not abort the landing. At 1549:46hrs (approximately 62 seconds from impact), the UA passed through the CP and transitioned to *Approach* mode, turning and descending to intercept a 3 deg glideslope and positioning for runway centreline, as shown in Figure 8. The UA continued on the approach, until over the runway at a height of 23 ft, a deflection to the V-tails was applied, resulting in a 35 deg nose down attitude, which led to the nose of the UA impacting the runway. The UA travelled along the runway for approximately 120 metres, before coming to rest on the Western side of the runway, as shown in Figure 8.
