## SECTION 1.4.5 – LEVELS OF PLANNING AND PREPARATION

1. Watchkeeper number 006 (WK006) was the second Watchkeeper (WK) air vehicle to crash in just over 12 months, the first being WK031 at West Wales Airport in Oct 14. Both crashes were as a result of the Vehicle Management System Computer (VMSC) commanding post landing actions (V-tail deflection) whilst the vehicles were still airborne. In both cases, the VMSC sensed and latched a false Ground Touch, although the hazard entry condition in each case was different, WK031 being a gust of wind and WK006 a pitching manoeuvre (to capture the glideslope) both of which produced negative accelerations to the point of the VMSC registering Ground Touch. In both accidents the laser altimeters were reading erroneously during periods of the approach either due to fog below the air vehicle or a wet runway causing reflections. These conditions set the scene for the vehicle to believe it was on the ground during the semi-flare when it was in fact still airborne. It is of concern that further unforeseen technical hazard entry conditions existed which meant that mitigation of known system issues was insufficient to prevent reoccurrence. Accordingl

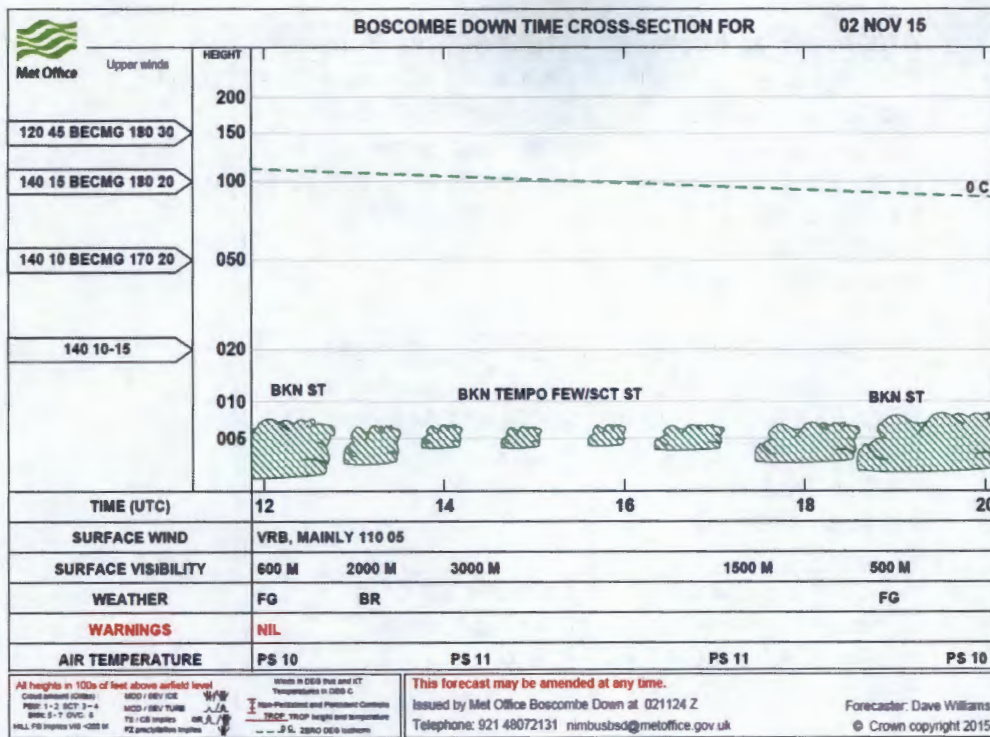
Figure 20 - BDN Cross-Section, Issued at 1124 hrs. (post take-off)

- b. **Updated Cross Section.** A second BDN Cross-Section was issued at 1124 hrs (after WK006 had taken off) and is shown at Figure 20. If viewed in isolation, the cross section presented an improved forecast, with cloud reducing during the recovery window from BKN to temporarily FEW/SCT, albeit with a more pessimistic forecast improvement of surface visibility.

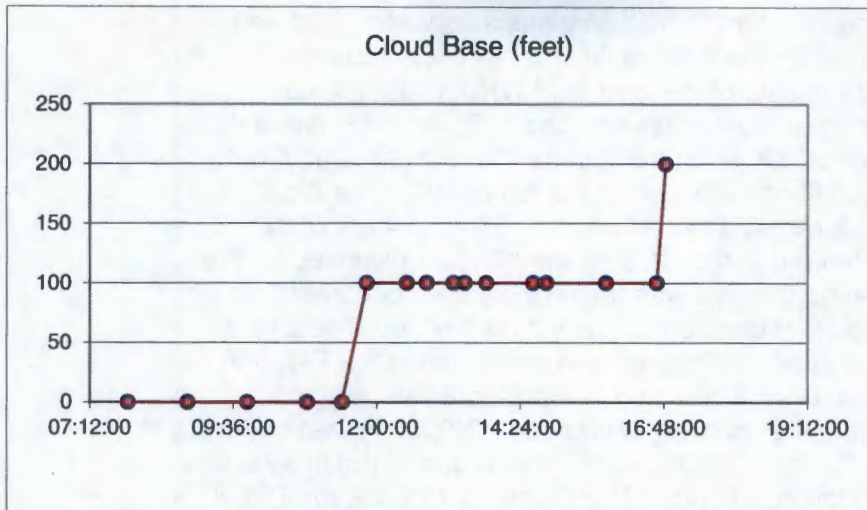
Figure 22 - BDN Actual Surface Visibility 2 Nov 15

1.4.5.9. **Actual conditions.** Figure 22 and Figure 23 show the actual recorded visibility and cloud base recorded during 2 Nov 15 by the BDN Met Office and passed to BDN ATC. BDN airfield was recorded as colour code RED<sup>58</sup> from 0750 hrs until 1641 hrs. A slight improvement was detected after the crash of WK006 at 1650 hrs, with conditions reported as AMBER<sup>59</sup>. The cloud base remained at/below 100ft throughout the flight of WK006, and there was only a temporary improvement in surface visibility in the early afternoon, to 1600 metres (YLO2).
