# Rail Accident Report

## Collision at Plymouth station 3 April 2016

Report 02/2017  
February 2017

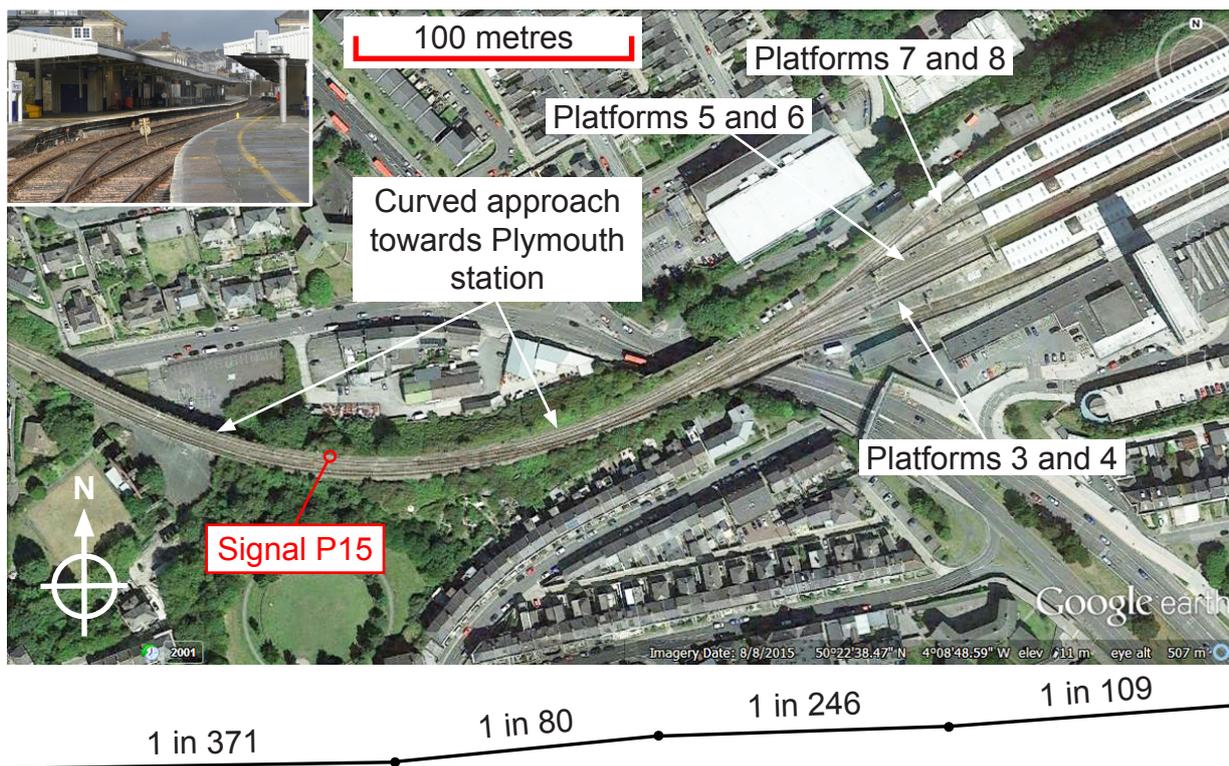
Figure 3: Plymouth station approach showing track curvature, gradients and platform curvature (inset image)

- 7 A maximum permitted speed of 25 mph (40 km/h) applies to trains approaching platforms 4, 5, 6, 7 and 8 from the west. Trains approaching from this direction have to negotiate an uphill gradient (about 1 in 80 at its steepest) and a left-hand curve, this becomes a right-hand curve as trains enter platforms 6, 7 and 8 (figure 3).

- 70 The presence of track curvature, vegetation and railway buildings (figures 3, 4 and 12) meant that the driver of 2E68 could not see platforms 7 and 8, and so could not establish the location of platform 6 by counting across from platform 8, until about 13 seconds (125 metres) before the collision. Counting at this stage would have revealed that train 1A91 was in platform 6 and would have given the driver sufficient time to stop his train safely. He did not count platforms at this stage because he had concluded that there was insufficient room for his train to share the platform occupied by train 1A91, and so had discounted the possibility of his train being routed into this platform. Although the driver of train 2E68 was competent to drive the route to Plymouth, he was still gaining practical experience driving it. It is possible that a more experienced driver would have recognised that train 1A91 was occupying platform 6 in time to prevent a collision (paragraphs 66 and 67).

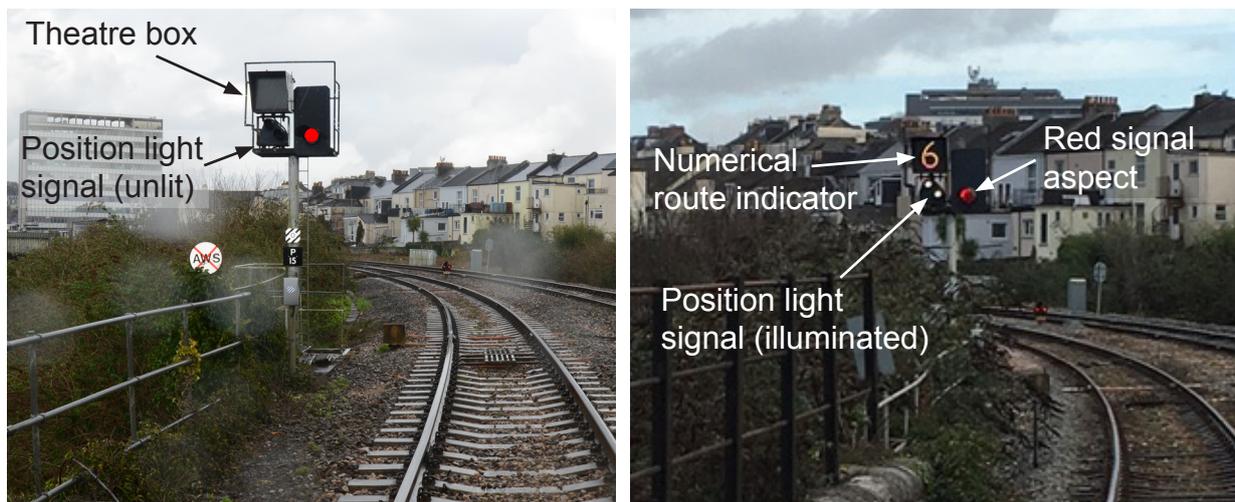
Figure 5: Signal P15 showing a stop indication (left image) and a permissive working authority towards platform 6 (right image)

- 15 Train movements approaching Plymouth station from the west (the route followed by train 2E68) are controlled by signal P15. This signal is located 270 metres from the western end of platform 6. It moved to its current position in the late 1980s and the signal's head (displaying the coloured lights) was replaced in 2007<sup>2</sup> with a light emitting diode type signal head (known as LED). Signal P15 is capable of signalling trains into any of the platforms at Plymouth. When displaying a proceed indication, the appropriate platform number is displayed adjacent to the signal head (figure 5).
- 16 If a platform is already occupied, another train can be signalled into the same platform under permissive working arrangements (paragraph 32). In these circumstances signal P15 will display two white lights (known as position lights), at an angle of 45° adjacent to the red aspect.

- 17 There is no evidence that the functioning of signal P15 was a factor in the accident. Although the signal was re-positioned before the current Railway Group standard was introduced, the distance of 270 metres between the signal and the platform is compatible with Railway Group standard GK/RT0044 'Controls for signalling a train onto an occupied line'. The December 2014 version of this standard required the distance to be 'minimised, as far as reasonably practicable', and the previous version (February 2000) required that the spacing 'shall not be greater than 400 metres'.

- 33 Where permissive working is authorised, distinctive signals are provided. Signal P15 approaching Plymouth is of this type (paragraph 16, figure 5). When the position lights illuminate at this type of signal, a train is allowed to proceed past the red *main aspect*. In these circumstances, the railway rulebook<sup>4</sup> states that 'The driver must be prepared to stop short of any train, vehicle or obstruction'.

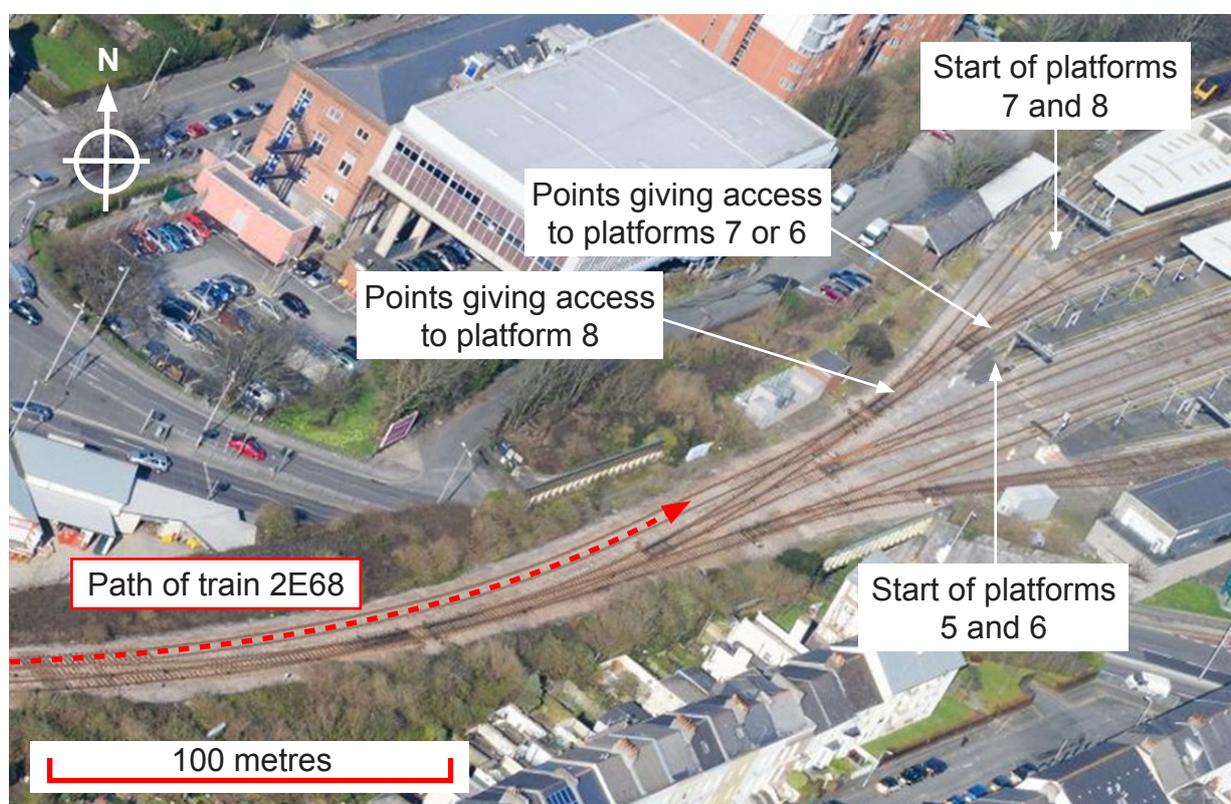
Figure 6: The points giving access to platform 8, and platforms 7 and 6 (image courtesy of Network Rail)

- 18 Around 46 metres after passing signal P15, trains pass over a set of *facing points* which provide routes to platforms 3, 4, and 5. A second set of *points*, located around 32 metres before the western end of platform 6, provide a left-hand route to platform 8 or a straight-ahead route towards platforms 6 and 7. A third set of points, located at the start of platform 6, provides a straight-ahead route into platform 7, or a right-hand route into platform 6 (figure 6).

- 68 About 10 seconds (91 metres) before the collision, train 2E68 approached the points giving access to platform 8 (figures 6 and 14). The driver stated he looked at the points and saw that they were set for the straight ahead route, and continued to believe that his train was not going into the platform occupied by train 1A91.

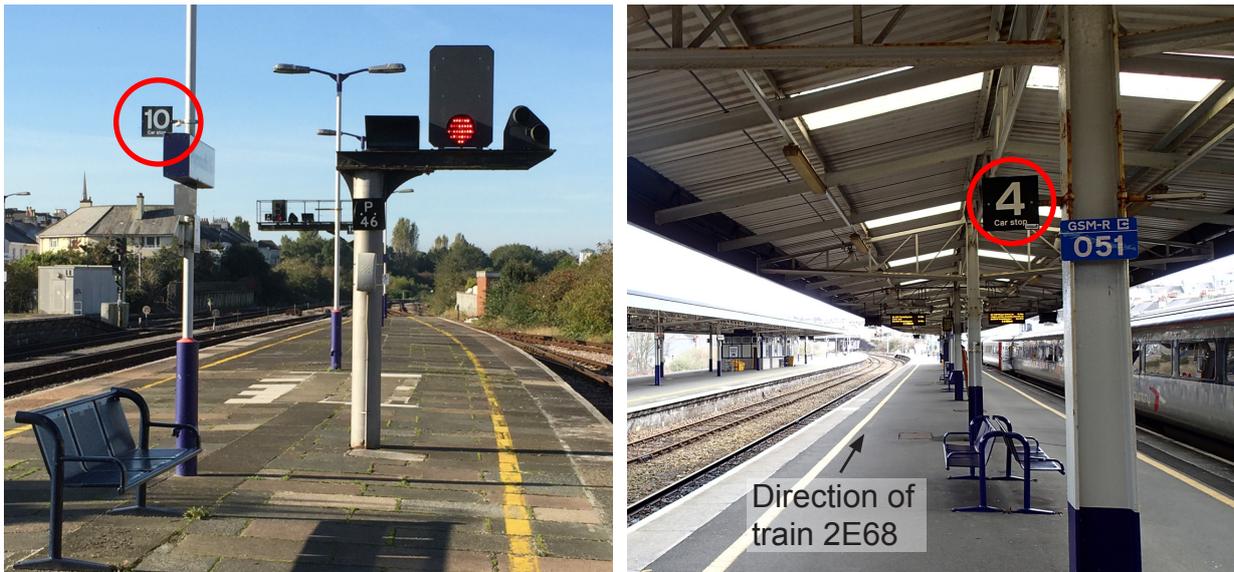
Figure 7: 10-car and 4-car stop signs relevant to the accident

- 19 Signs are provided on each platform to indicate to drivers where to stop the front of their train. Because trains of different length serve the station, each platform has several of these signs; these are referred to as *car stop signs* in this report. The signs relevant to the accident are listed below (figures 7 and 8):
- A 10-car stop sign on platform 6 applicable to trains from the east (the direction train 1A91 came from). This is located adjacent to signal P46, about 47 metres from the western end of the platform.
  - 4-car stop signs applicable to trains from the west (the direction train 2E68 came from). These are located approximately midway along platforms 8, 7, and 6, with the sign on platform 6 being around 165 metres from the western end of the platform.

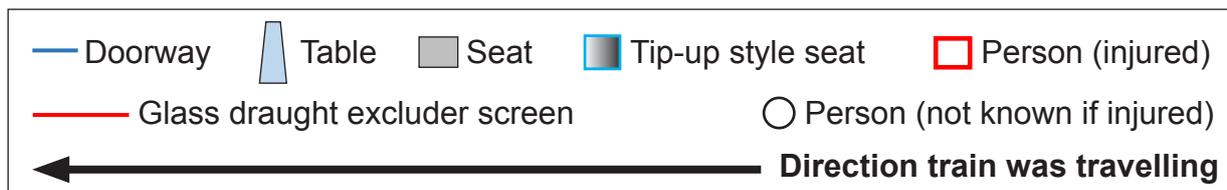
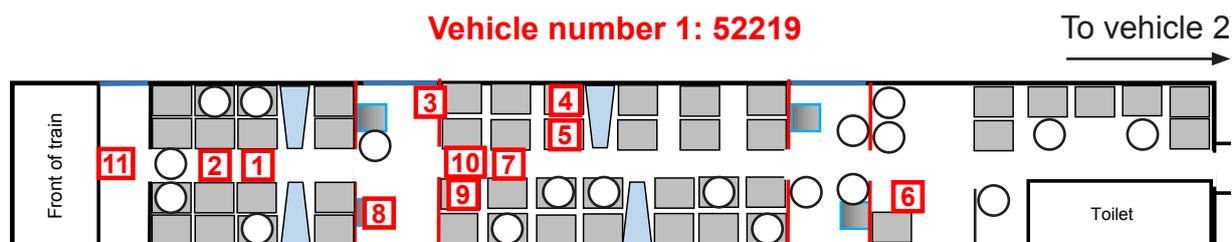
## Appendix D - Passenger locations and injuries on train 2E68

Identifier	Seated/standing	Cause
1	Standing	Fall to floor
2	Standing	Elbow possibly struck door handle. Other passengers falling on them caused other injuries.
3	Standing	Impact with glass partition
4	Seated	Movement during collision
5	Seated	Movement during collision
6	Standing	Impact with pole they were holding and overhead luggage falling on them
7	Standing	Hit arm rest and floor
8	Standing	Possibly hit head on floor
9	Seated	Possible impact with glass panel. Also other passenger contact.
10	Standing	Impact with other passengers
11	Standing	Impact with door frame

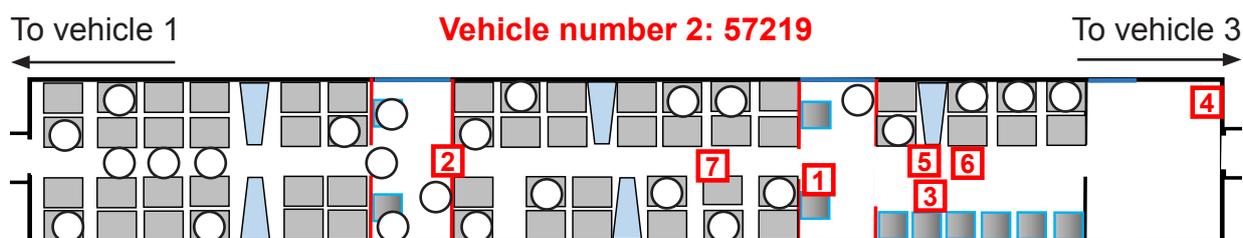
Identifier	Seated/standing	Cause
1	Standing	Fall to floor. Secondary impacts from other passengers.
2	Standing	Hit head on lower partition (not glass part)
3	Standing	Impact with glass partition
4	Standing	Impact with partition wall between driving cab and vestibule
5	Standing	Impact with floor
6	Standing	Impact with floor
7	Standing	Impact with seat
