Rail Accident Report

Dangerous train door incident at Bank station on the Docklands Light Railway 6 February 2017

Report 12/2017
September 2017

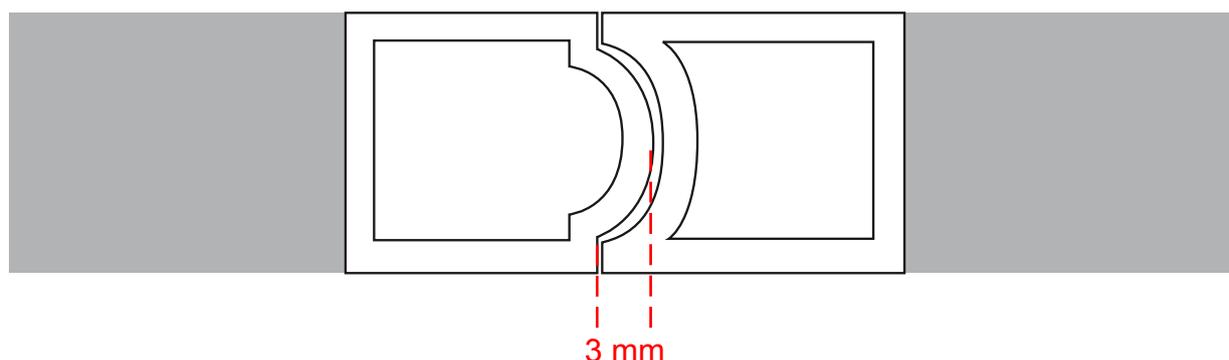
- 65 The nosing rubbers are able to compress around small objects when the doors close, but are intended to have sufficient flexibility, when combined with a *pushback mechanism*, to allow trapped objects to be withdrawn. The shape, flexibility and friction characteristics of the nosing rubbers affects the ease with which trapped objects can be pulled from the doors. The interlocking between the two halves of the nosing rubbers on the DLR cars is around 16 mm. It is greater than that on LUL vehicles² (figure 12), which is around 3 mm. Although the RAIB has not carried out any comparative tests, it is evident that the more convoluted the path that a flexible object, such as a piece of trapped clothing, has to take to be extracted the greater the extraction forces are likely to be, for a given type of nosing rubber design.

- 66 The RAIB also carried out testing using a piece of clothing trapped in the doors of DLR cars and found that forces in excess of 200 N were required to withdraw a fabric test piece. By comparison, the maximum force criteria used by LUL in its tests using a fabric test piece is 90 N.

Figure 12: Nosing rubber elements on the LUL trains
